# *The Conservation of Asian Lacquer*

Case Studies at the Asian Art Museum of San Francisco

By Jane L. Williams

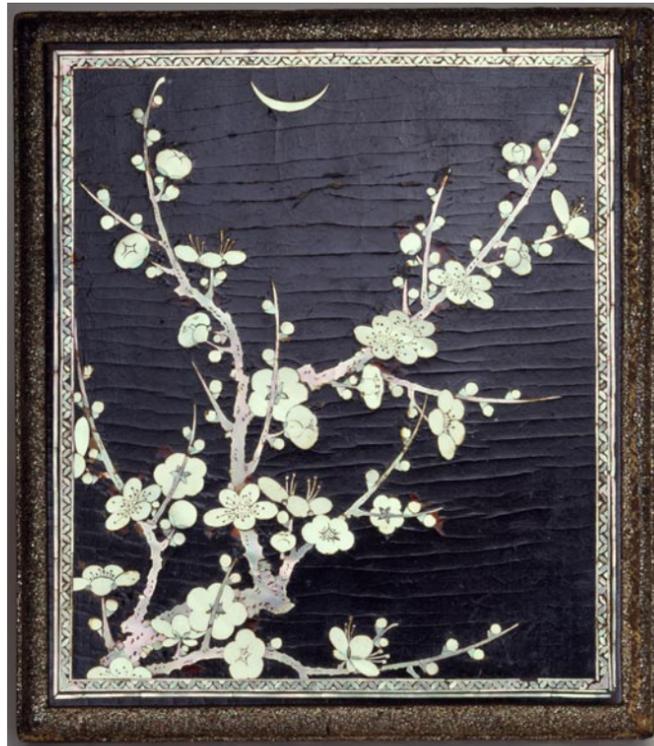
Fig. 4.11. Inlaid lacquer box lid. Japan, Ryukyu (16th century), lacquer, mother-of-pearl. Courtesy, Freer Gallery of Art and Arthur M. Sackler Gallery, Smithsonian Institution, Washington, D.C., S1987.386. Lid, showing many old lacquer fills in areas of loss.

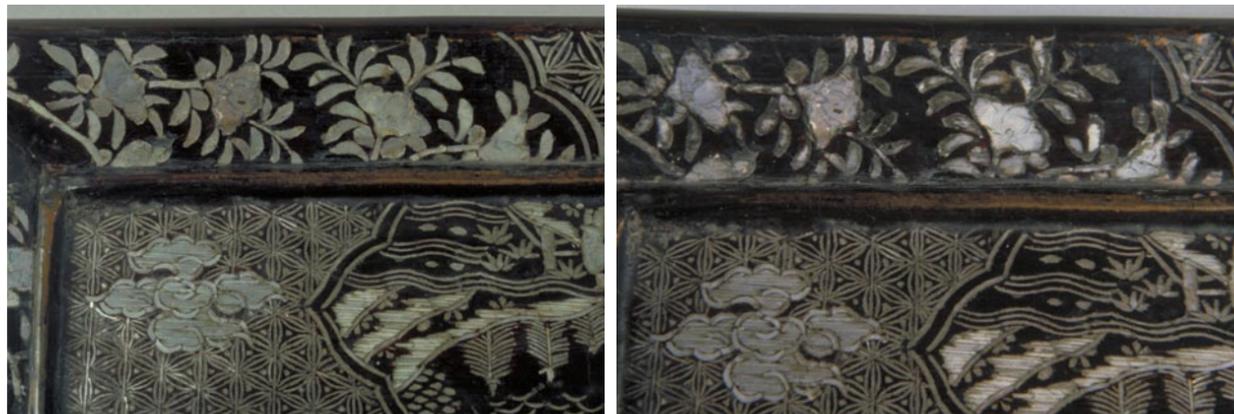
Left: fig. 4.14. Tray (B60M163), before treatment; detail of restoration lacquer and black residue obscuring mother-of-pearl.

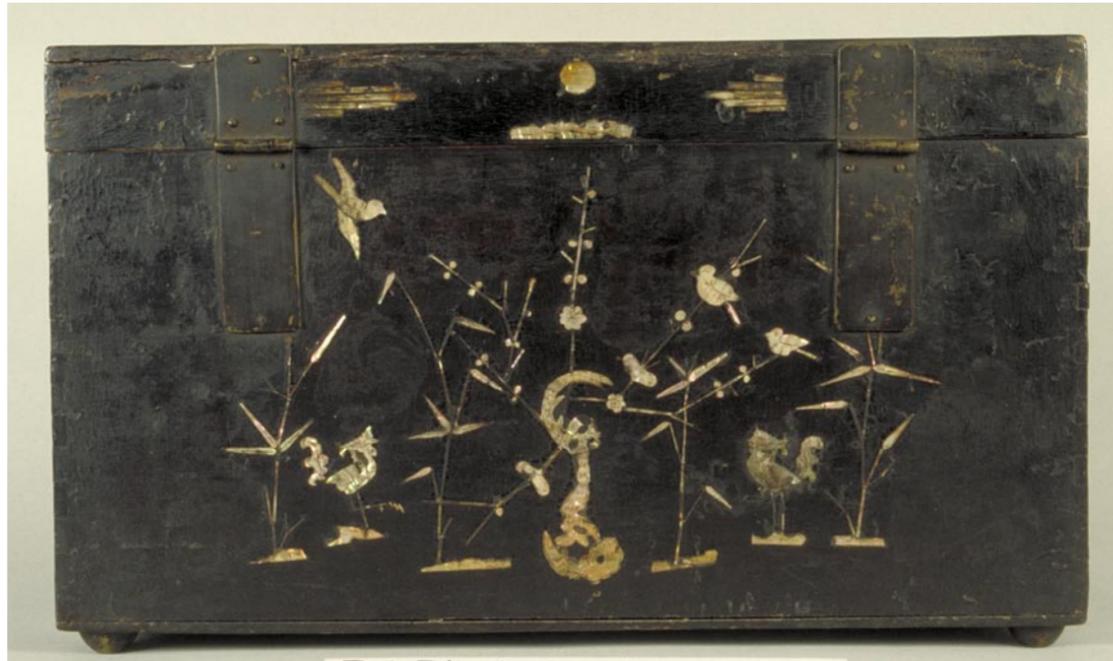
Fig. 6.3. Box (B60M292), detail of back side before cleaning test; old white fill material is visible along gap in lid.

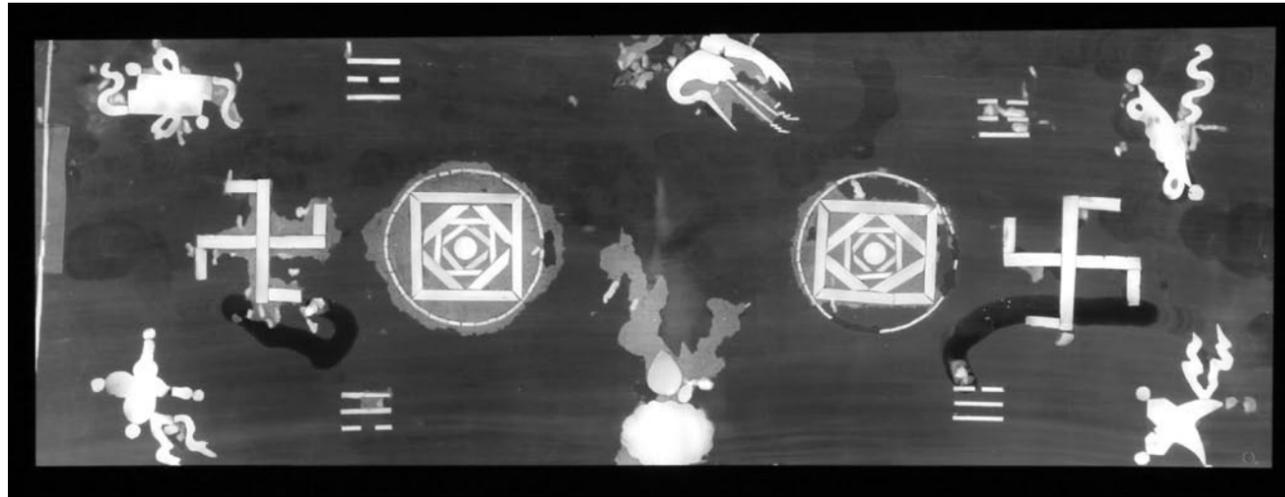
Fig. 6.6. X-radiograph of lid, Box (B60M292); large (1-cm diameter) insect tunnels are visible, as are lacquer repairs, particularly at center. Technical data: Norelco X-ray unit (150 kV max.), Kodak Industrex M film, 35 kV, 4 mA, 90 seconds, distance from tube, 36 inches.

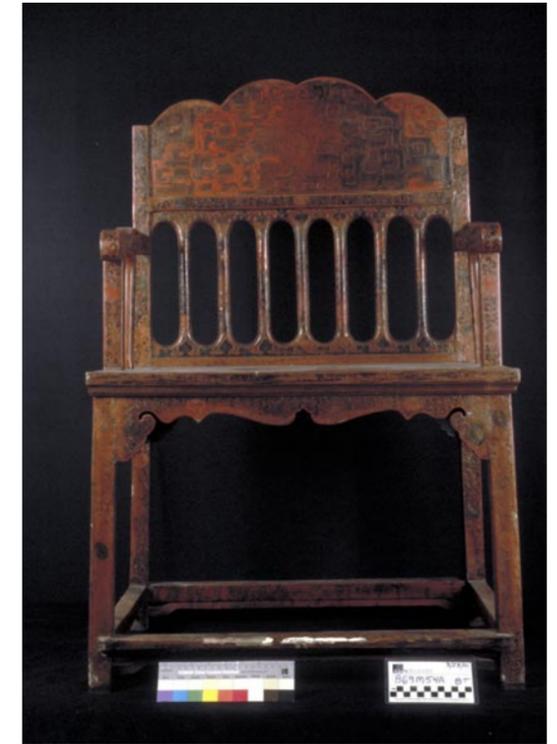
Fig. 6.25. Lacquer chair (B69M54a), before treatment; note the brown shiny surface and wear on front stretcher.

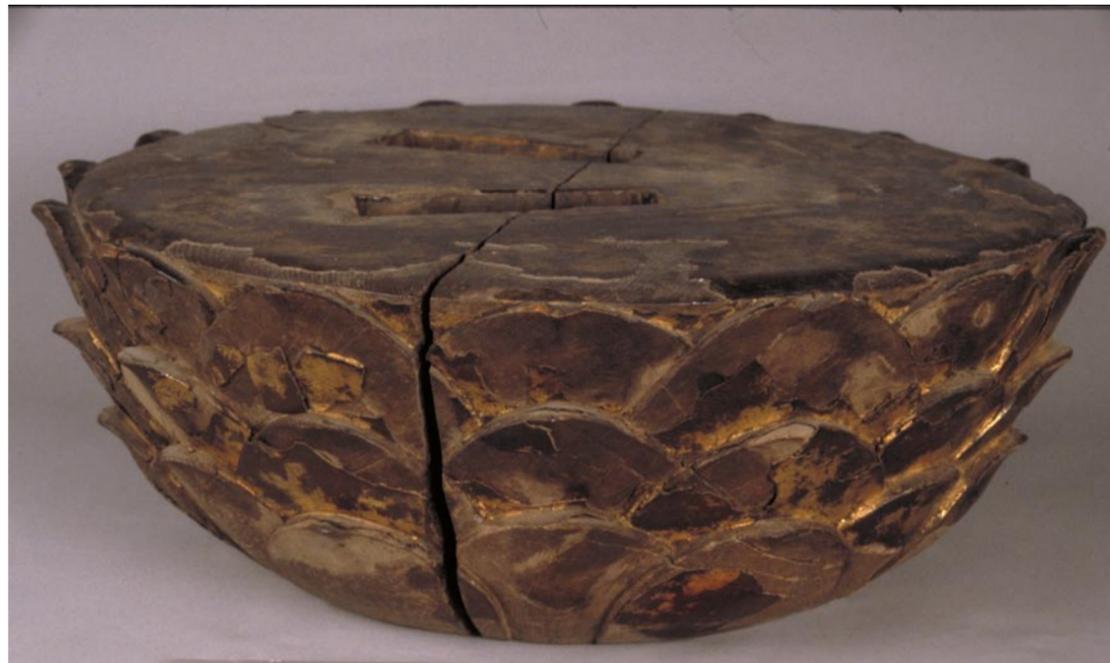
Fig. 7.2. Lotus base, Sho Kannon (B6oS420), showing the gap that has opened between the halves of the base.

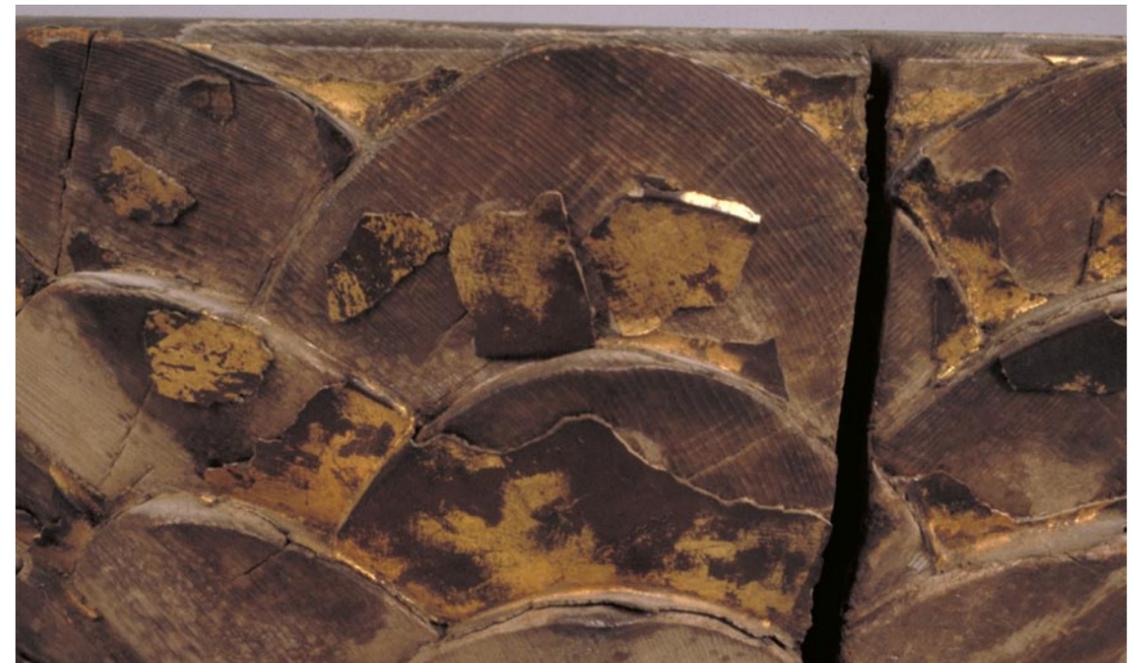
Fig. 7.3. Detail showing lifting and mispositioned lacquer on lotus base, Sho Kannon (B6oS420)

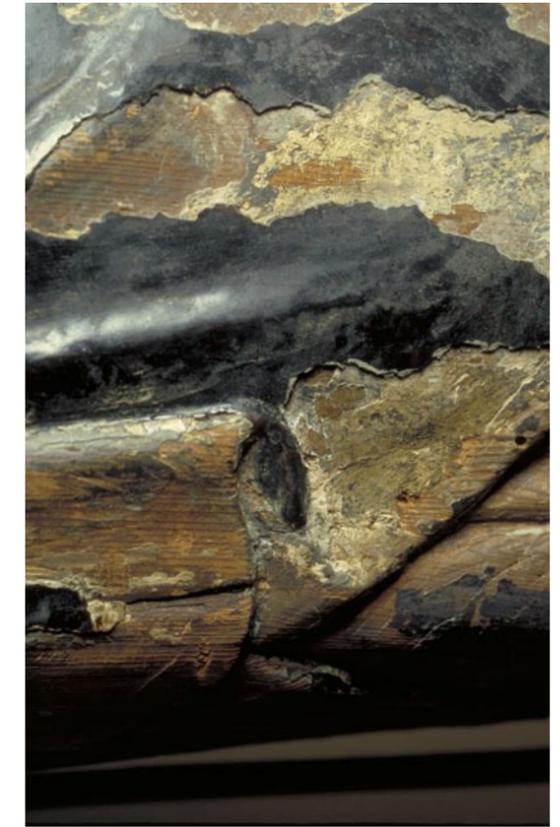
Fig. 7.7. Detail showing layers of lacquer and gilding on right side of Sho Kannon (B60S420); note sharp tool marks around edges of islands of later lacquer coated with black paint.

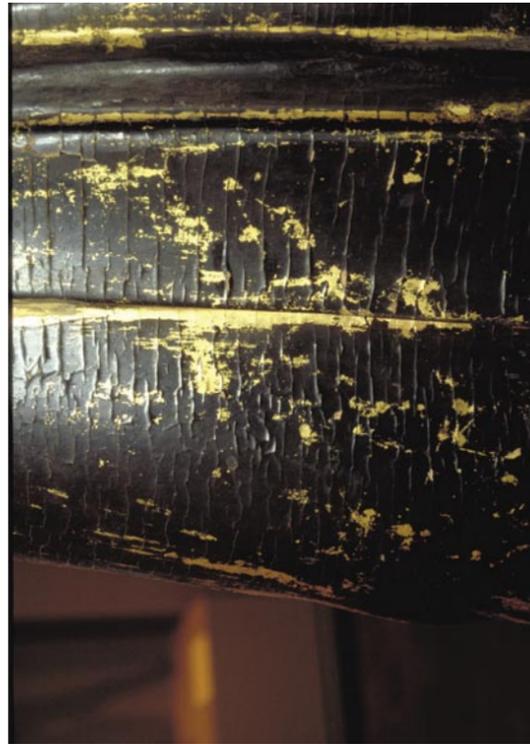
Fig. 7.11. *Amida sculpture (B6oS10+)*, detail showing cracked and lifting surface layers on right side.

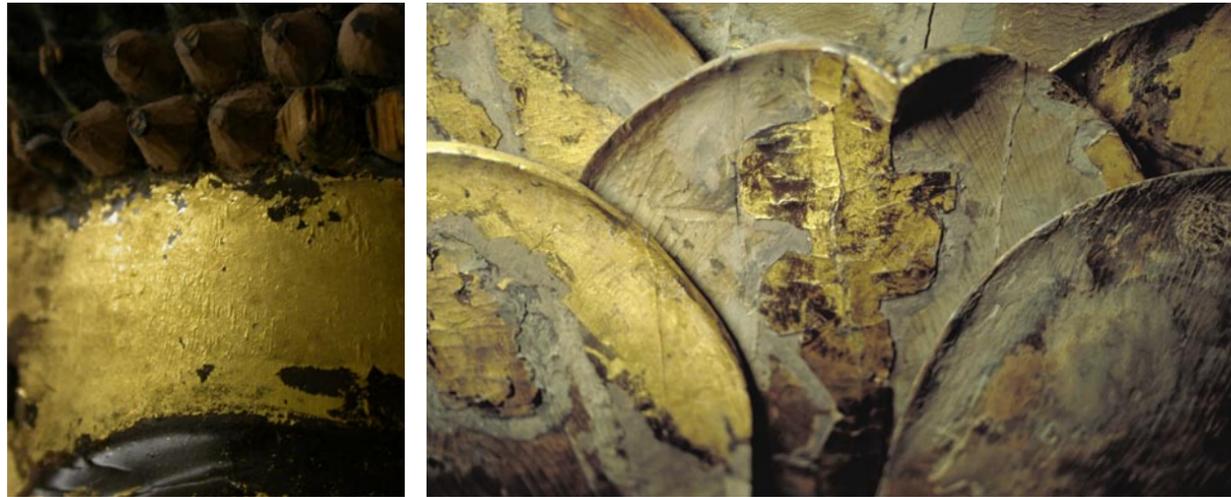
Fig. 7.20 *Amida sculpture (B6oS10+)*, detail of forehead showing bubbled gold leaf.

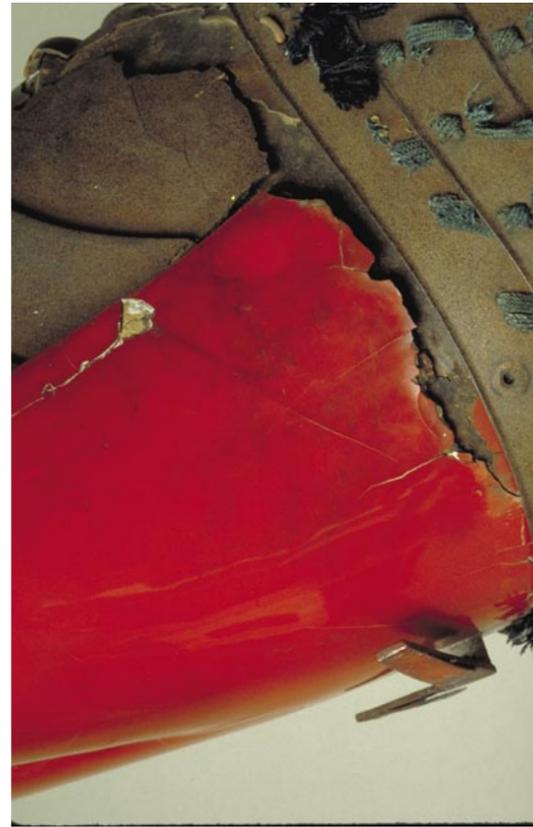
Fig. 7.28. *Helmet (B87M22a)*, detail of lower right side, showing lifting surface layers due to separation between laminated paper structure and the iron helmet bowl.

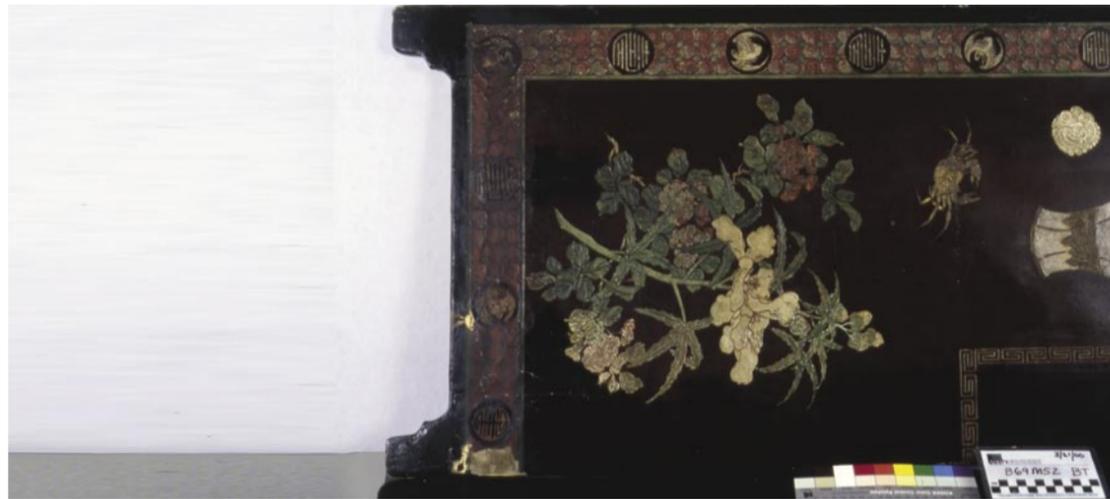
Fig. 8.4. Detail, screen (B69M52), before treatment, showing black overpaint and cracking.

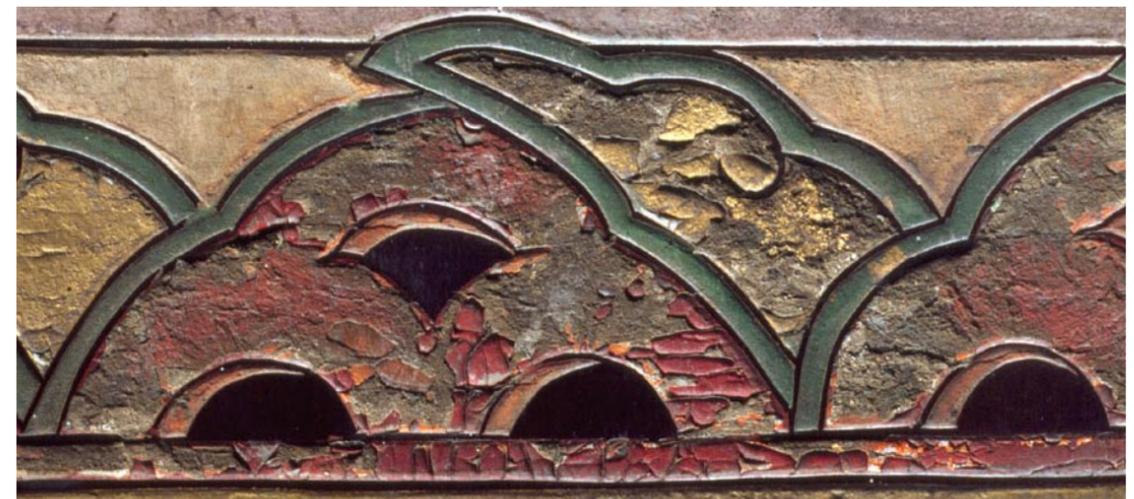
Fig. 8.5. Red paint on screen (B69M52), showing cupping of paint and flaking of surface; before treatment.
