# *The Conservation of Asian Lacquer*

Case Studies at the Asian Art Museum of San Francisco

By Jane L. Williams

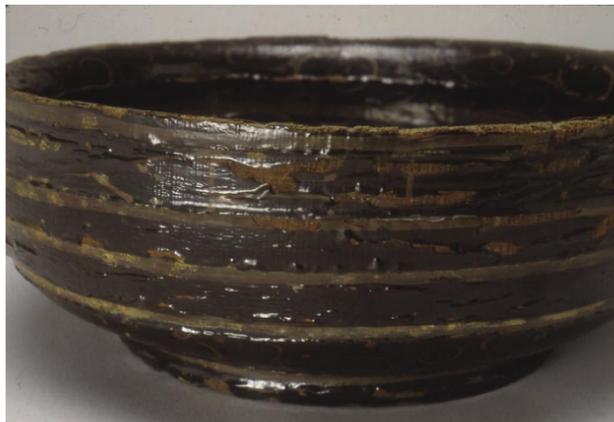
Fig. 4.02. Bowl (B65M26), before treatment

The lacquer layer is very thin. Losses to the lacquer expose the underlying wood substrate. This bowl was excavated and was once waterlogged. Some burial dirt remains on the surface (see fig. 4.02). The wood substrate is intact, but in drying it shrank, causing many areas of the lacquer surface to shrivel, become tented, and flake away.

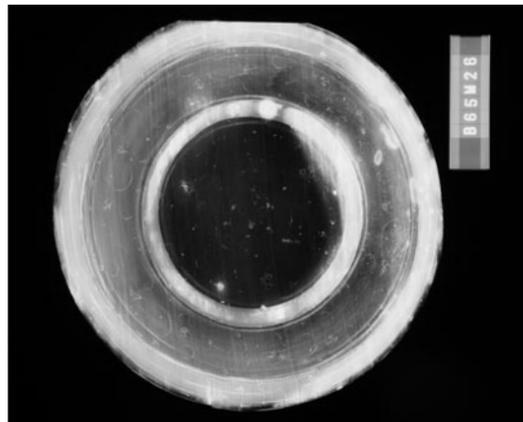
Fig. 4.03. X-radiograph of bowl (B65M26). Technical data: Norelco X-ray unit (150 kV max.), Kodak Industrex M film, 40 kV, 4 mA, 90 seconds, distance from tube, 36 inches.

X-radiography confirmed that the bowl was carved from a single piece of wood (see fig. 4.03). A ground layer is not visible on the bowl, but is visible in cross-section samples of the lacquer (see fig. 4.04). The dull mustard-

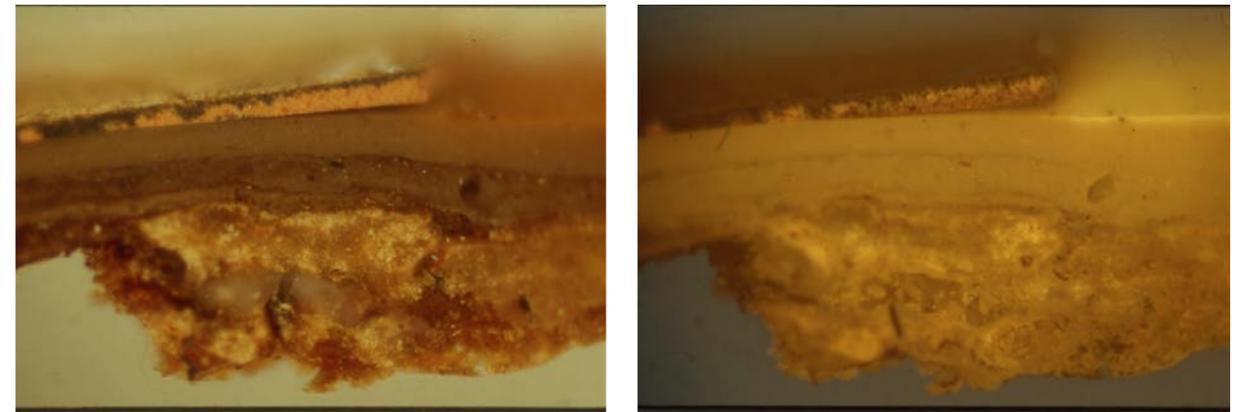
Fig. 4.04. Bowl (B65M26), cross-section sample of surface layers from an area with a thin black line painted over a red line on unpigmented lacquer, shown in reflected light (left) and ultraviolet light (right); photo taken at 200x magnification.

yellow autofluorescence of this layer is consistent with that of the lacquer layers. The opaque tan or brown overall lacquer layer is unpigmented. Its color appears to be the result of the bowl's aging, burial, and being waterlogged. The red pigment was identified as cinnabar. Analysis of the black pigment suggested a mixture of materials that may include iron ochre, clay, gypsum and bone black.

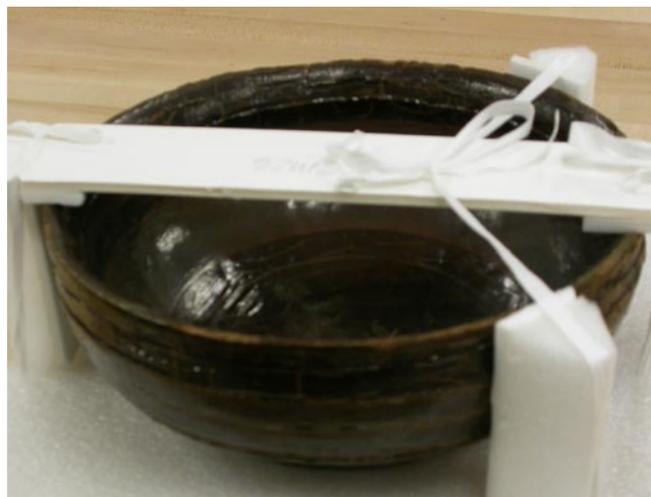
Fig. 4.05. Bowl (B65M26), after treatment, showing support used for transport and storage, designed to stabilize movement while limiting contact between the lacquer surface and support.

A passive support was constructed to secure the bowl for transit and for long-term storage (see fig. 4.05). It will also be kept covered from now on to protect it from dust and light. □

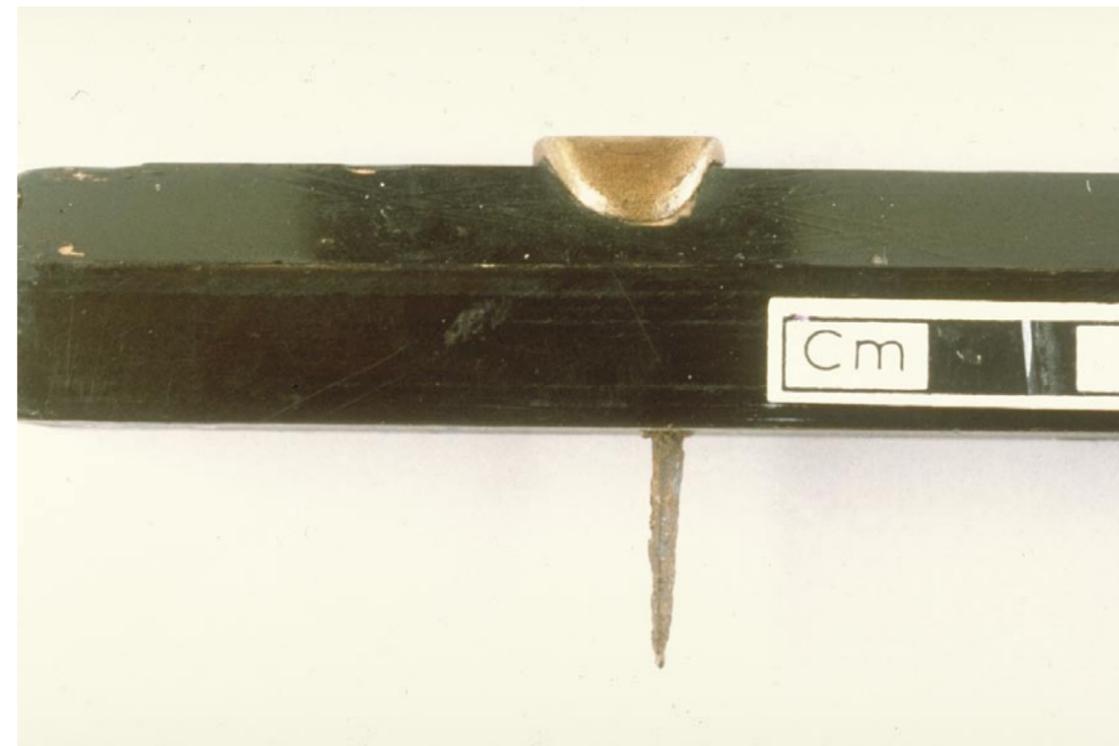
Fig. 4.07. Frame from two-fold screen. Japan, Edo period (1615–1868), lacquer. Courtesy, Freer Gallery of Art and Arthur M. Sackler Gallery, Smithsonian Institution, Washington, D.C., F1970.22. Detail of a test cleaning on a black lacquer frame that has been dismantled from the screen; cleaning resulted in a marked improvement to the clarity and luster of the lacquer. Analysis by Py-GC/MS showed no identifiable lacquer in the removed material.

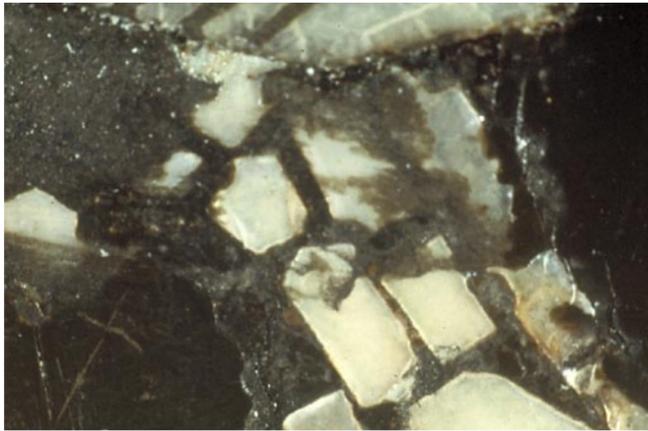
Fig. 4.08. Tray. China, Ming dynasty (1368–1644), lacquer, mother-of-pearl. Courtesy, Freer Gallery of Art and Arthur M. Sackler Gallery, Smithsonian Institution, Washington, D.C., S1997.34. Mother-of-pearl inlay, highly magnified; the thin black layer obscuring some of the inlay is the result of relacquering where the excess lacquer was not removed.

The brown lacquer residue surrounding many of the mother-of-pearl sections is quite thick in some areas and masks the inlay's fine detailing. It is usually possible to remove some of this excess lacquer mechanically, using a fine, pointed bamboo skewer (a sharp tool such as a surgical scalpel might scratch the mother-of-pearl). Although this work is not necessary and time may not permit such a slow task, the overall effect could be a notable improvement (see figs. 4.08–4.10).

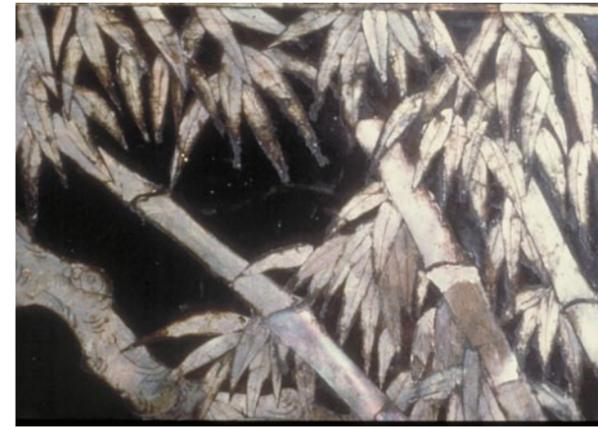
Left: fig. 4.09. Table. China, Ming dynasty (1368–1644), lacquer, mother-of-pearl. Courtesy, Freer Gallery of Art and Arthur M. Sackler Gallery, Smithsonian Institution, Washington, D.C., F1995.5. Before treatment (detail). The inlay is extensively covered in previous relacquering.

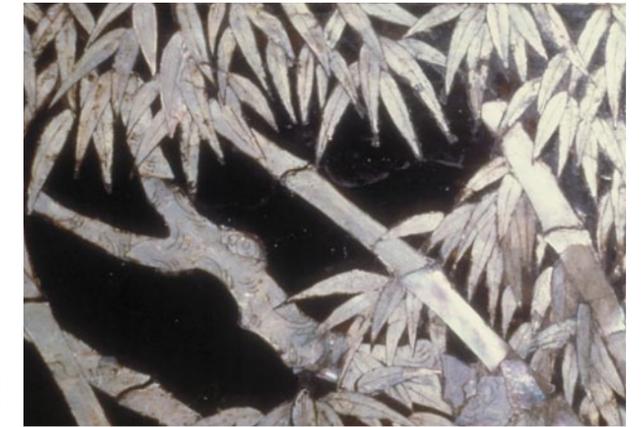
Right: fig. 4.10. Table. China, Ming dynasty (1368–1644), lacquer, mother-of-pearl. Courtesy, Freer Gallery of Art and Arthur M. Sackler Gallery, Smithsonian Institution, Washington, D.C., F1995.5. After treatment (detail). Mechanical removal of the lacquer covering the inlay resulted in a more attractive appearance.

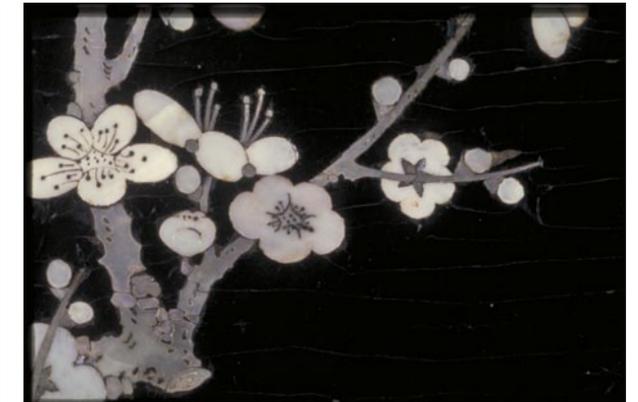
Right: fig. 4.13. Inlaid lacquer box lid. Japan, Ryukyu (16th century), lacquer, mother-of-pearl. Courtesy, Freer Gallery of Art and Arthur M. Sackler Gallery, Smithsonian Institution, Washington, D.C., S1987.386. Lid, after treatment (detail); old lacquer fills were overpainted with acrylic paints and coated with Primal WS-24.

the surrounding surface. Discolored repaired areas can be overpainted easily with acrylic polymer paints. If the gloss on the overpainted areas needs adjustment (often acrylic paints are duller than the surrounding lacquer surface), one or two coats of Primal WS-24 (an acrylic colloidal dispersion) is a recommended material. As an aqueous solution, it is easily applied to an acrylic painted surface and can be thinned with water to alter the gloss. It is commercially available as a 36% solution but, when diluted to an 18% solution, it is frequently a good match for a black lacquer surface (see figs. 4.11–4.13).

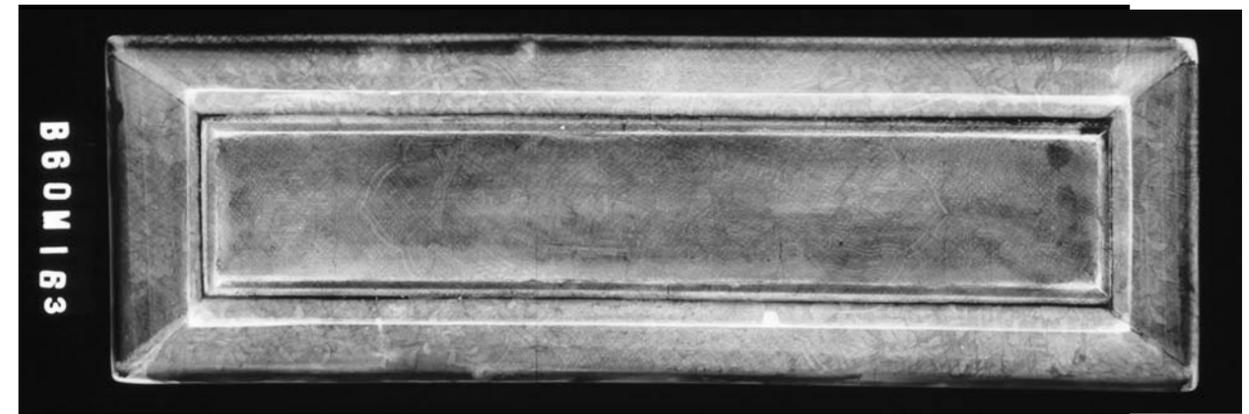
The tray has been completely relacquered over extensive fills with a fine pinkish beige material. The fill material is visible through the translucent restoration lacquer and in losses or fine cracks to this layer. The restoration covers crosswise cracks in the older lacquer that are now detectable only in the X-radiograph (see fig. 4.16). It also covers extensive insect damage. Tunneling and frass left by wood-boring insects are visible in a hole in the lacquer on the underside. Additional evidence that the damage is extensive is that none of the original brownish gray ground remains in this area, only the pinkish beige restoration ground. Insect tunneling cannot be precisely identified in the X-radiographs, though there are areas where the wood appears less dense. The restoration fill material was not applied meticulously. It is smeared over the inlay in a few areas. Also,

Second from bottom: fig. 4.16. X-radiograph of tray (B60M163). Technical data: Norelco X-ray unit (150kV max.), Kodak Industrex M film, 45 kV, 6 mA, 45 seconds, distance from tube, 36 inches.

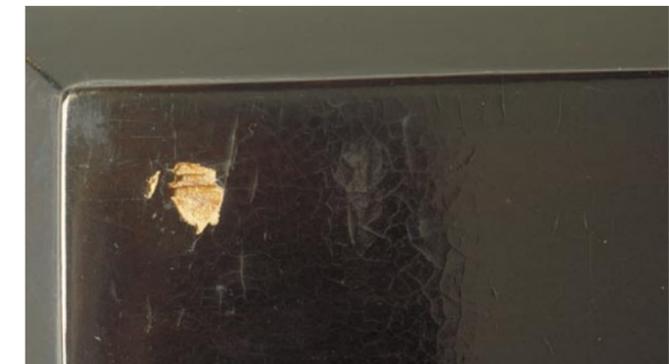
Above: fig. 4.17. Tray (B60M163), before treatment; detail of loss to lacquer on underside revealing insect tunneling of wood.

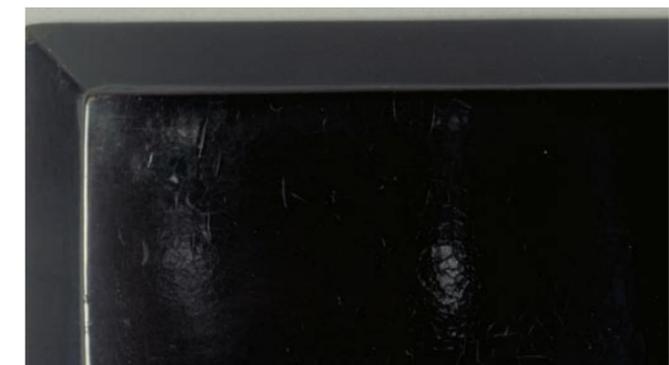
Below: fig. 4.18. Tray (B60M163), after treatment; detail of loss to lacquer on underside after filling and inpainting.

The ground in lifting areas of lacquer and inlay was consolidated with 5% B-72 in 4 : 1 acetone : ethanol. The consolidant was flowed in with a small brush, and then the area was covered with polyester film and weighted to slow the evaporation of the solvent and optimize penetration of the consolidant. A thicker solution, 15%–20% B-72 in acetone, was used to adhere lifting lacquer and inlay. The color of the inlay did not change as the result of the consolidation treatment. After being sealed with dilute B-72 in acetone, the larger loss to the lacquer on the bottom and the smaller isolated losses were filled with a mixture of 6% polyvinyl alcohol in water and 1 : 1 calcium carbonate : kaolin. The fills were smoothed as much as possible when applied, and then were sanded with successively finer Micromesh up to 12,000 grit. The fills were painted with Rowney FW acrylic inks. Several coats of ink were used to build up the color in thin smooth layers on the larger fill. This was not visually necessary for the smaller (1/8-inch) fills. Primal WS-24, diluted slightly from the stock solution with deionized water until it brushed out well, was mixed with the final coats for gloss. The Primal made the surface harder and made it possible to sand with fine-grit Micromesh between the last few coats. Fig. 4.18 shows the larger loss after filling. □

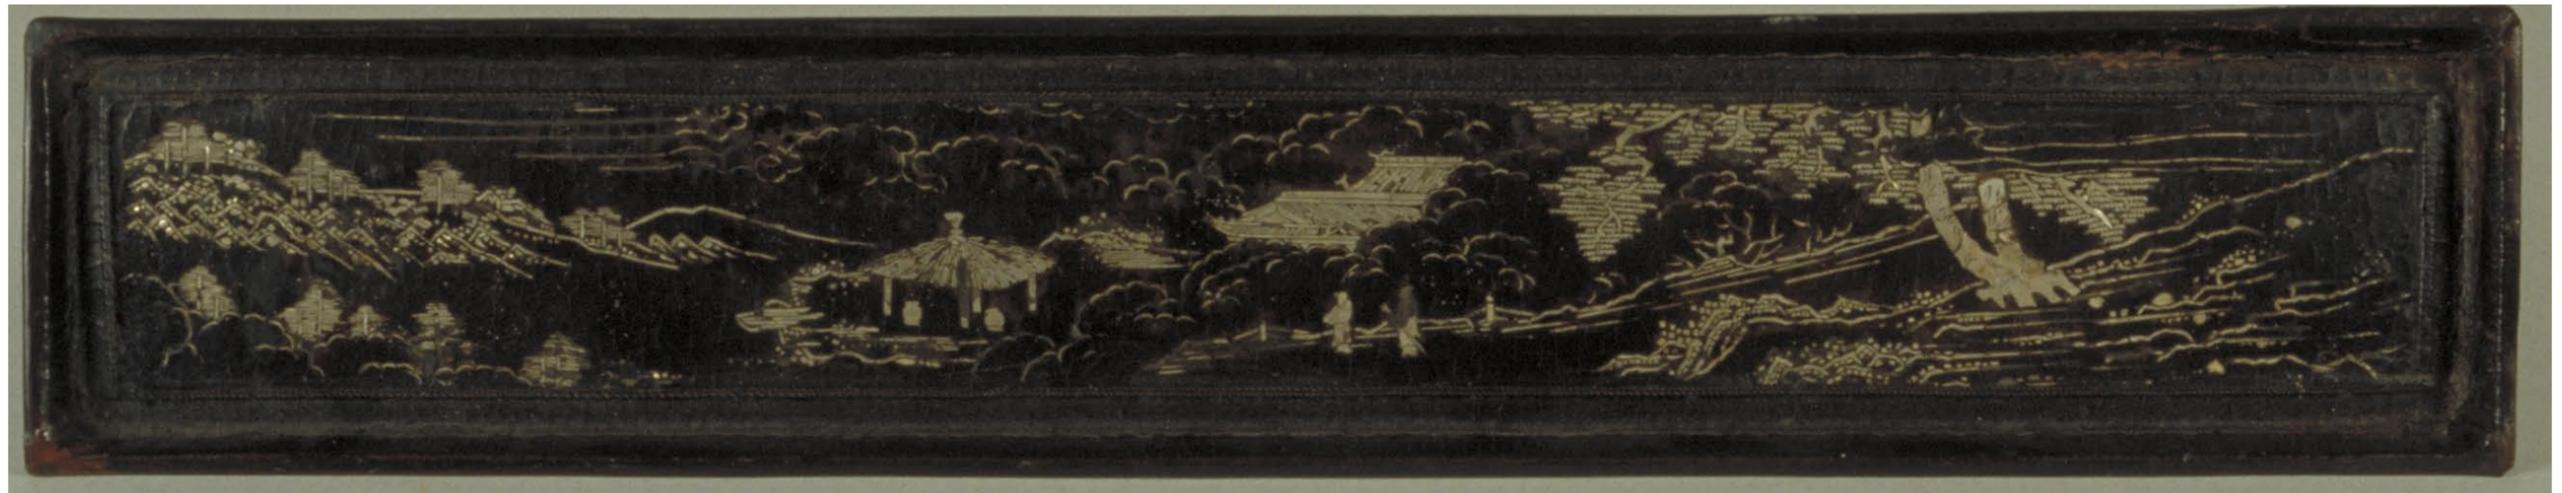
crack in the lacquer runs around the perimeter of the rim on the front side (see figs. 4.20 and 4.21). The surface also has many smaller cracks. All the corners have been previously restored with a somewhat rough, dark material, possibly lacquer. There are two paper labels on the back. The surface is soiled and dusty. The mother-of-pearl and the lacquer appear stable at this time.

Top: fig. 4.20. Tray (B60M164), before treatment.

The tray has a wood substrate. The evenly spaced wood grain and my knowledge of traditional woodworking techniques suggest to me that the wood may be fir. The tray appears structurally sound. The interior lacquer surface has a crackle pattern, and there is a wider crack running round the interior perimeter. There is evidence of previous repairs to the proper left end. There are two self-adhesive paper labels on the bottom. The lacquer is not of high quality or purity and looks very dull (see fig. 4.20).

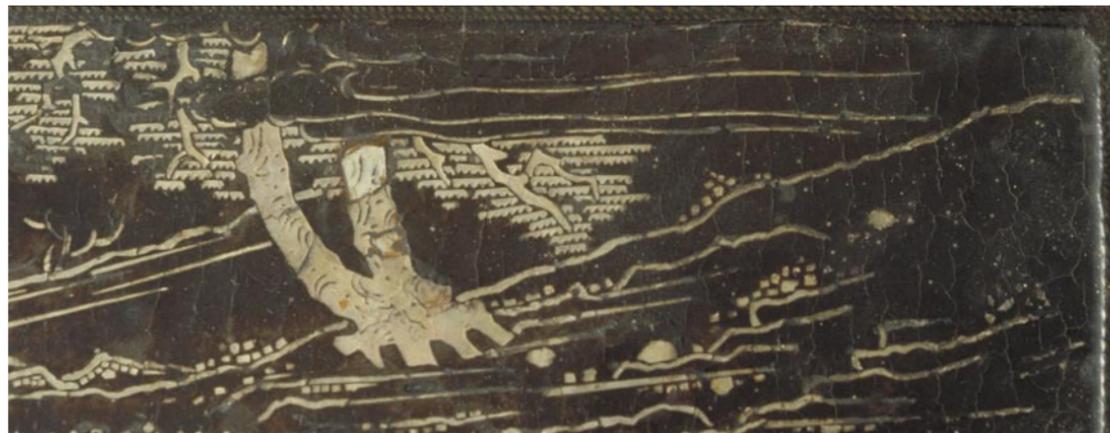
Second from top: fig. 4.21. Tray (B60M164), detail before treatment, showing a deep crack in the lacquer.

The most recent campaign involves repairs to one end and corner that, because of the materials used, were probably done by Western restorers (see fig. 4.21). The end broke off and a crack opened along the join on the adjacent long side. A shiny, dark, slightly sticky material that is soluble in acetone was used as an adhesive in the join at the end and in the corners. A reddish beige material was applied very sloppily to fill the cracks and is smeared over the surrounding surface. The repair areas were covered generously with a thin, shiny, dark paint, perhaps an oil paint, which fluoresces a dull green color in UV light and is somewhat soluble in acetone.

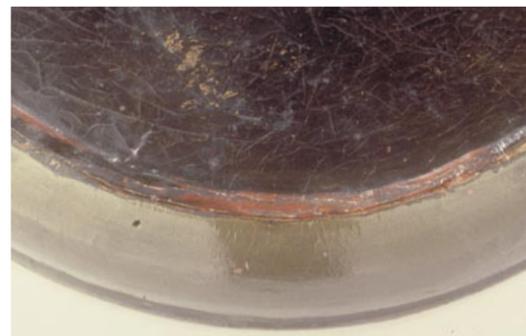
Above right: fig. 4.23. Dish. China, Yuan dynasty (1297–1368), lacquer, mother-of-pearl. Courtesy, Freer Gallery of Art and Arthur M. Sackler Gallery, Smithsonian Institution, Washington, D.C., S1987.369. After treatment; the crack was filled with a tinted wax mixture; see note 8 for the formula.

The wide crack appears to be old and reasonably stable, suggesting that it does not need further support from an adhesive at this time. For aesthetic reasons, it might be desirable to minimize its appearance by filling it, but this is not structurally necessary. Consultation with a curator may be appropriate at this point. A fill material would need to be relatively soft in case there is future movement along the crack. Wax compounds tinted with black pigment can be used for this purpose (see figs. 4.22 and 4.23).<sup>9</sup>

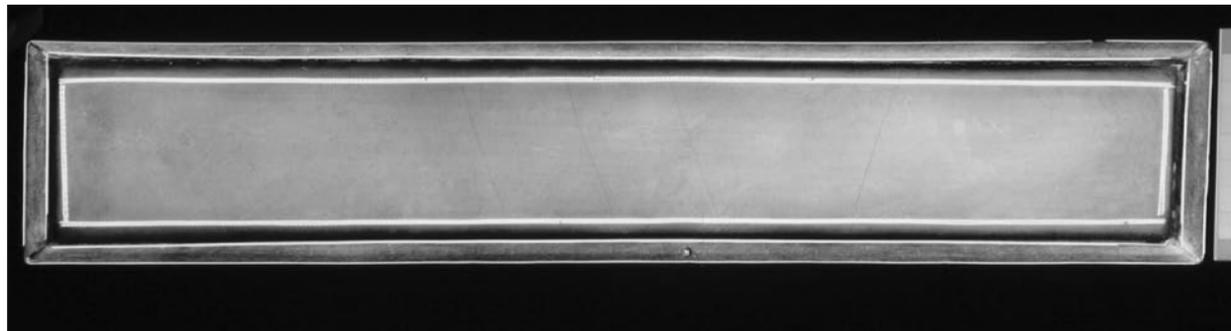
Fig. 4.24. X-radiograph of tray (B60M164). Technical data: Norelco X-ray unit (150kV max.), Kodak Industrex M film, 45 kV, 6 mA, 45 seconds, distance from tube, 36 inches.

The structure of the tray was confirmed by X-radiography (see fig. 4.24). The tray was constructed from five glue-joined pieces of wood—one for the central rectangle and four for the narrow sides.<sup>10</sup> The wood appears to be a softwood. Its even grain and the pronounced difference in density between the earlywood and latewood are visible in the X-radiograph. The front surface only was covered with a layer of plain-weave textile, presumably to reinforce the joins, before the lacquer ground layers were applied.<sup>11</sup> A coarse, brownish gray ground, visible in cracks and small losses to the lacquer, was applied next. The very thin mother-of-pearl inlay pieces were cut, adhered to the ground and incised with linear details. The inlay decoration was applied to the

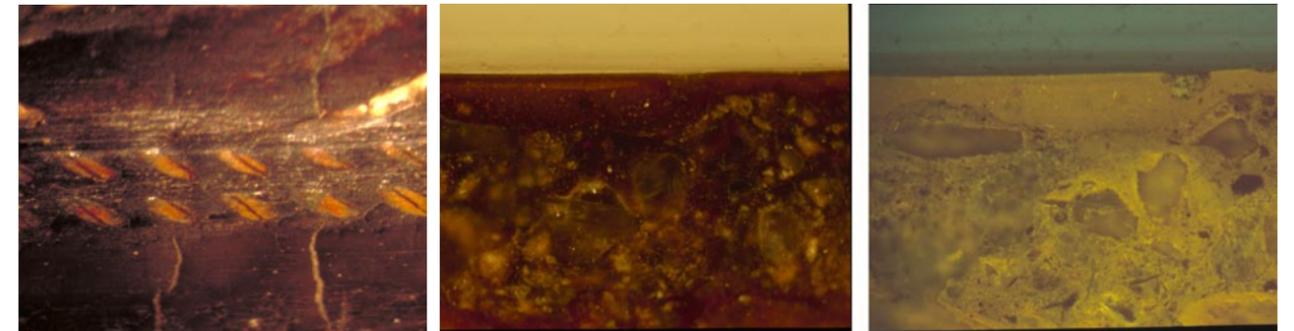
The tray was then coated with layers of dark brown lacquer. In cross-section samples of the lacquer there is no evidence of pigments added to the lacquer (see fig. 4.26). When these layers had

Fig. 4.25. Tray (B60M164), photomicrograph showing wire structure.

Fig. 4.26. Tray (B60M164), cross-section sample of surface layers, shown in reflected light (left) and ultraviolet light (right), photo taken at 200x magnification.

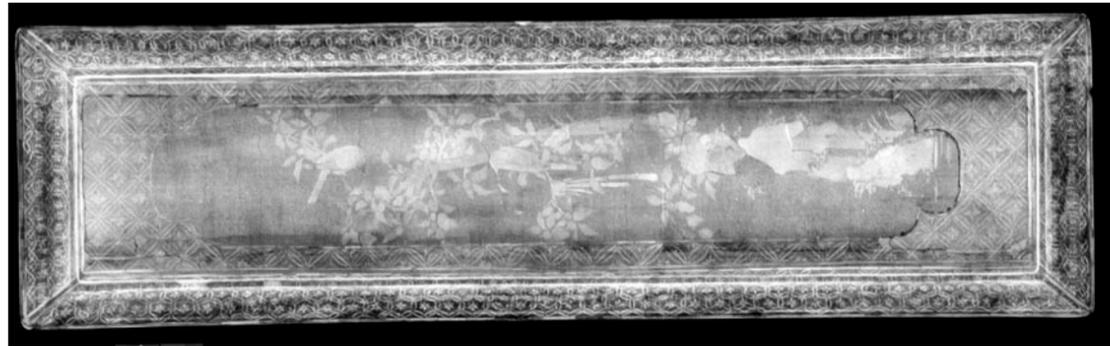
The tray is made of slats of wood fitted and adhered together, covered with a woven textile (see fig. 4.29), and then a clay and lacquer compound as a ground for the black lacquer sur-

Fig. 4.29. X-radiograph of tray (B79M7) showing construction. Technical data: Norelco X-ray unit (150kV max.), Kodak Industrex M film, 35 kV, 6 mA, 90 seconds, distance from tube, 36 inches.

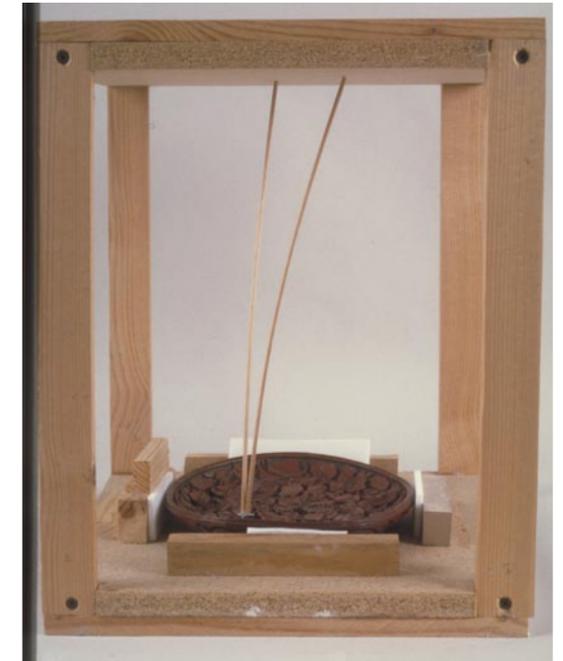
Fig. 4.30. Dish. China, Ming dynasty (1368–1644), lacquer. Courtesy, Freer Gallery of Art and Arthur M. Sackler Gallery, Smithsonian Institution, Washington, D.C., S1987.384. A *shinbari* is being used for support while the dish is undergoing repairs.

a layer of Mylar film. Or one can use a *shinbari*, a Japanese six-sided wooden frame with a solid top and bottom and open sides (see fig. 4.30). The object is placed onto the bottom of the *shinbari* and gently braced with wooden blocks. Pressure is applied to the small area under repair (in this case the lifted flakes) via long, flexible wooden dowels that are inserted between the ceiling of the frame and the object. (Mylar and a dense padded material such as linoleum tile or cork serve as barrier materials between the end of the dowel and the object.) This system is best suited to lifted or detached lacquer that cannot easily be made to lie flat. The pressure exerted on the area of repair can be controlled by the length (and therefore the tension) of the dowel.

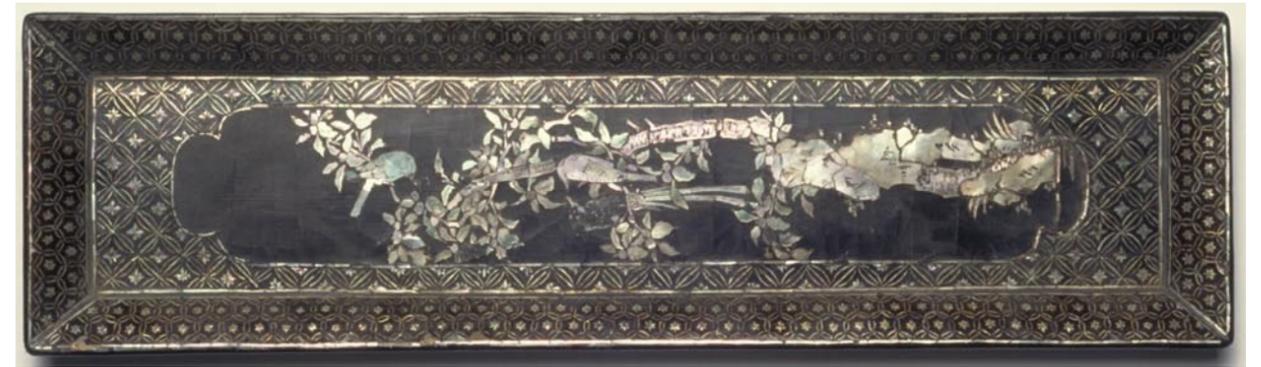
The tray is made of wood with mother-of-pearl inlay. Fir was traditionally used for such objects. The tray appears structurally sound. The lacquer layers are cracked and lifting in several locations. There are other small losses of inlay and lacquer around the edge. The inlay is also lifting in many places and a piece of shell for the bird in the center proper right is missing. One of the other mother-of-pearl birds has become detached from the lacquer layer (see fig. 4.31). The surface is extremely dusty overall.

Fig. 4.31. Tray (B79M7), before treatment.

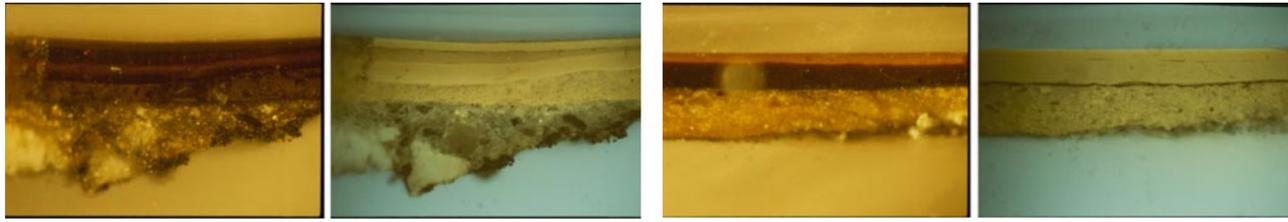
Fig. 4.32. Tray (B79M7), cross-section sample of original surface layers, taken from central design field, shown in reflected light (left) and ultraviolet light (right), at 00x magnification.

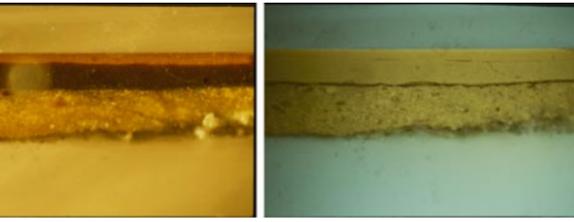
the same pattern on the central panel has foliate inlay pieces. Only traces of the gray ground layer found on the center of the tray are found on the sides (see figs. 4.32 and 4.33). Instead, the sides have a different ground layer that is much finer and pinkish in color. In cross section (see fig. 4.33) this ground layer has an autofluorescence very similar to that of the lacquer layers and distinct from the original ground. The inlay on the sides was adhered directly to the ground layers and not to a substantial wet lacquer layer. The inlay in these areas is still partially covered by an unpigmented *urushi* layer that was scraped away, rather than polished down, to reveal the inlay. The scraping tool marks are visible around the inlay and the lacquer is higher than the inlay, rather than level with it as it would be if polished down.

Fig. 4.33. Tray (B79M7), cross-section sample of restoration surface layers, taken from side of tray, shown in reflected light (left) and ultraviolet light (right), at 00x magnification.

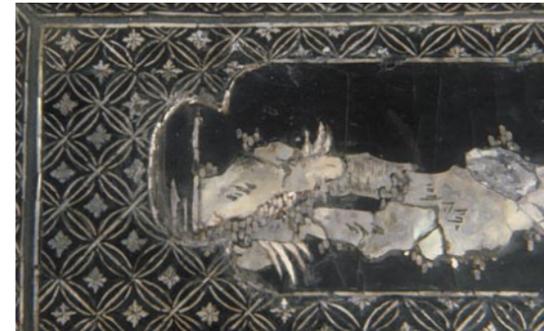
The tray is currently in unstable condition, the lacquer flaking and the inlay loose. The most unstable area is the open crack at the bottom of the cartouche (see fig. 4.34). Here a large area of the lacquer within the cartouche is lifting. Several small pieces of inlay that form the border are loose or missing, and the old white fill in the crack is now crumbly and loose. Along losses to the edges of the tray, small areas of the lacquer, ground, and inlay are lifting together. In all cases the separation appears to be occurring

Fig. 4.34. Tray (B79M7), detail before treatment.

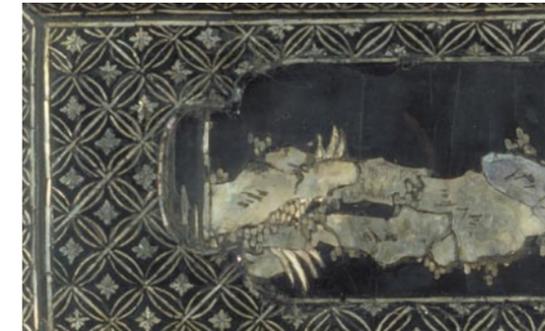
Fig. 4.35. Tray (B79M7), detail after treatment.

Losses to the lacquer were filled in order to prevent future damage and loss. Filling the losses is particularly important on objects like this one in which the numerous tiny fragments of inlay divide the lacquer into numerous islands. It is very easy for the inlay and lacquer fragments to snag or otherwise become detached. B-72 in acetone bulked with 1 : 1 kaolin : calcium carbonate and dry pigments was used. These losses were tiny and could be adequately smoothed with a spatula dampened with acetone. The fills were toned with FW Acrylic Artists' inks mixed with Primal WS-24 for gloss. Fig. 4.35 shows a detail of the damage at the bottom of the cartouche after it has been consolidated and losses filled.

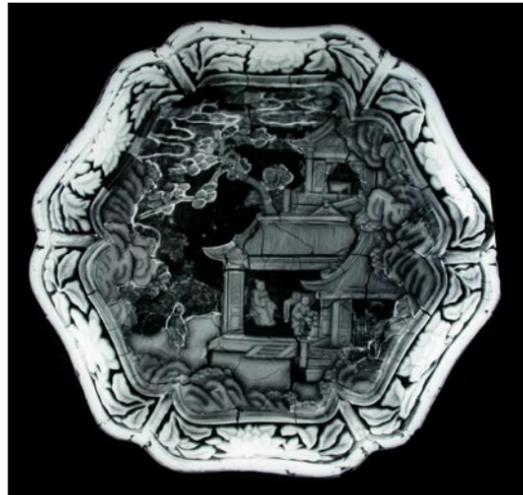
The substrate, as confirmed by existing X-radiographs, is constructed of slats of wood. Two types of textiles have been used to line the wood and may be seen in areas where the lacquer surface is lost: a nonwoven fabric on the exterior and a plain-weave fabric on the rim and interior. X-radiographs also reveal many previously restored areas of lacquer on the top of the lid. These restorations are well carved and may be very old (see fig. 4.37).

The wood structure of the box is apparent from existing X-radiographs (see fig. 4.37). Existing losses facilitate the study of the lacquer layers. In the X-radiographs many previous repairs are discernible as areas of higher density even though they are not visible on the surface. Those areas have a higher cinnabar content. The restoration lacquer covers the original lac-

Fig. 4.37. X-radiograph of lid of covered box (B77M24), showing previous restorations. Technical data: Norelco X-ray unit (150 kV max.); no exposure records available.

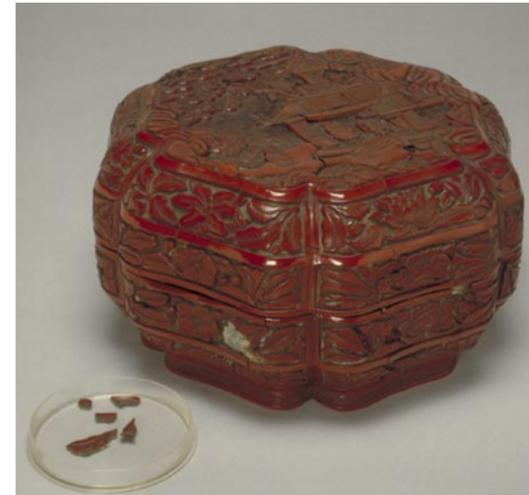
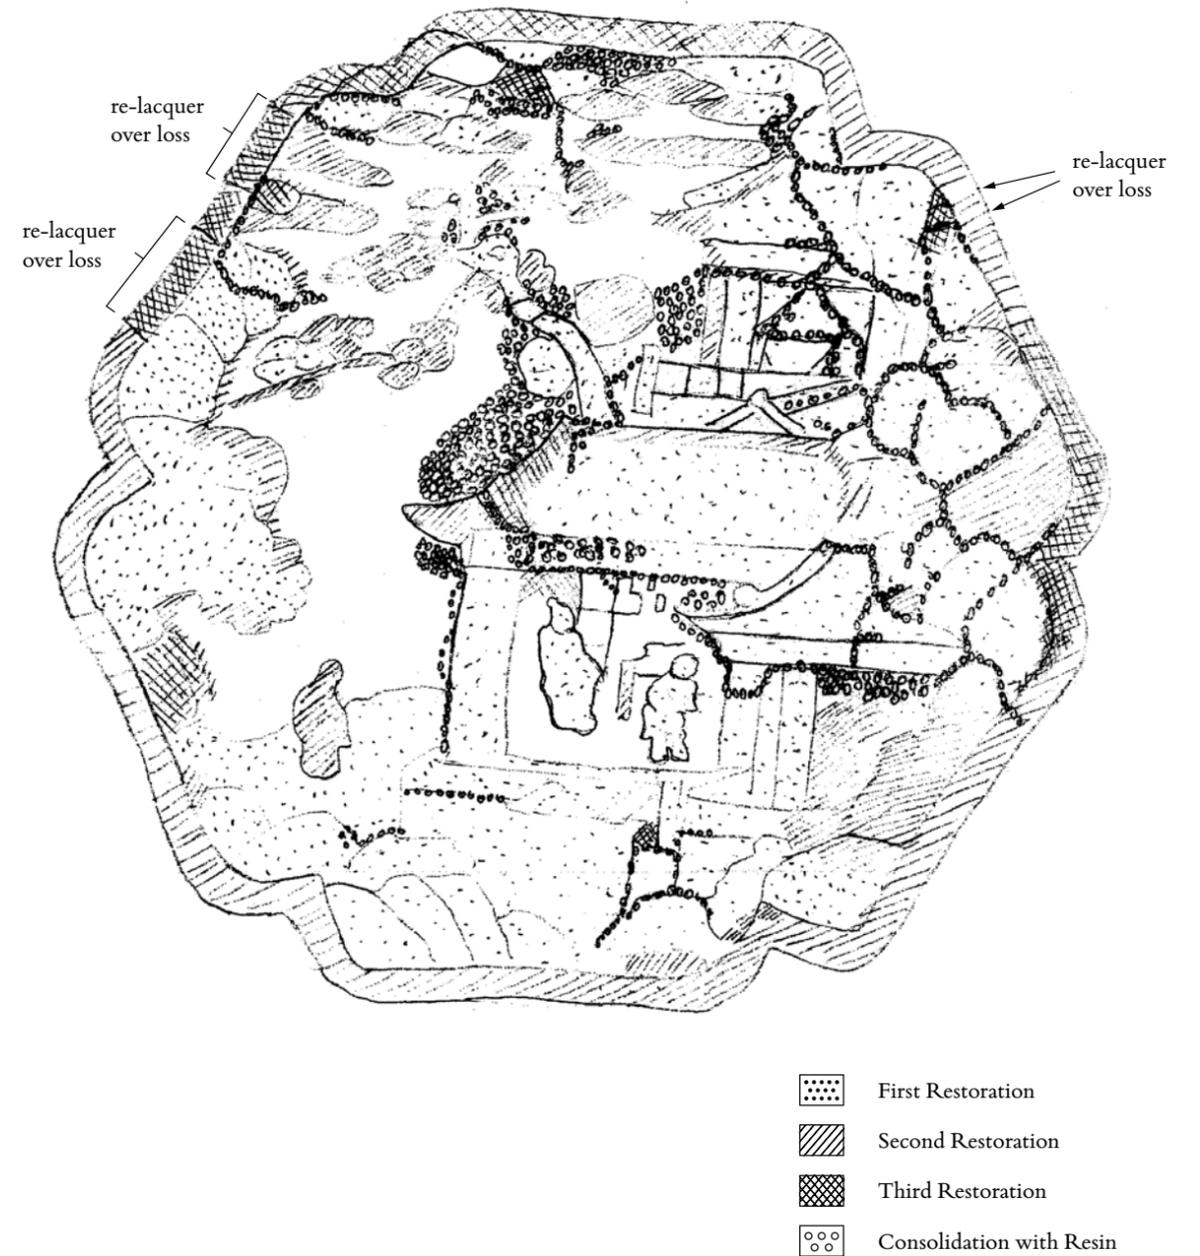
The thickly carved cinnabar lacquer is cupped and pulling away from the wood substrate in several locations. Five detached pieces have been saved. There is evidence of previous restoration campaigns; the surface of the lid is glossier in some areas, presumably from a previously applied adhesive. In these areas the lacquer has cracks or is cupping, perhaps caused by large quantities of polar solvent, such as acetone, used in the adhesive mixture. The original lacquer, ground layers, and wood have different surface tensions and will absorb the solvent at different rates, which may lead to cracks and cupping. The surface has dust and dirt overall (see fig. 4.38).

Fig. 4.38. Covered box (B77M24), before treatment.

The dust and dirt should be removed from the surface to show the bright red and pure yellow that are the original colors. (For an illustration of the effect of cleaning on a similar object, see figs. 4.39 and 4.40.) Cleaning must be done carefully as the thin lacquer background is not sound. Some cracked or broken areas may need reinforcement before cleaning. Because the lifting lacquer is so thick and hard, the conservator may need to test different reinforcement materials to find one that is effective. Surface cleaning must be done very sparingly, so that the solvent, particularly if it is a polar solvent, does not pen-

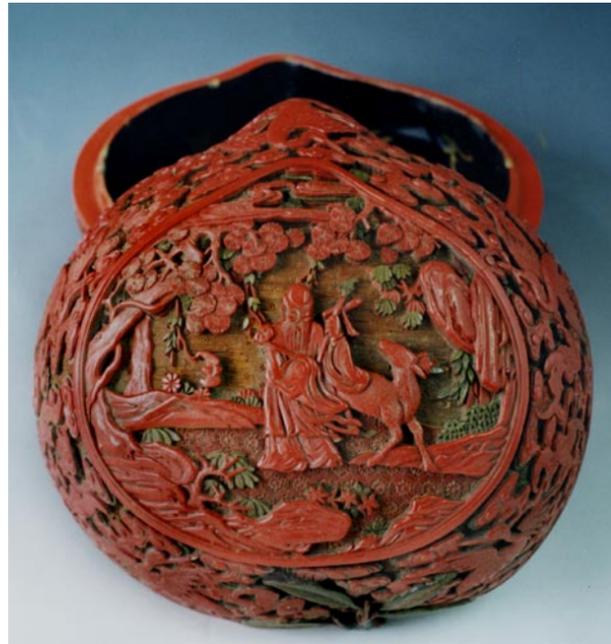
Fig. 4.39. Box with red carved lacquer before cleaning. China, Qing dynasty, Qianlong period (1736–1795), lacquer on wood, 16 x 16.5 x 7.5 cm. Courtesy, Shanghai Museum, Shanghai, China, #7556.

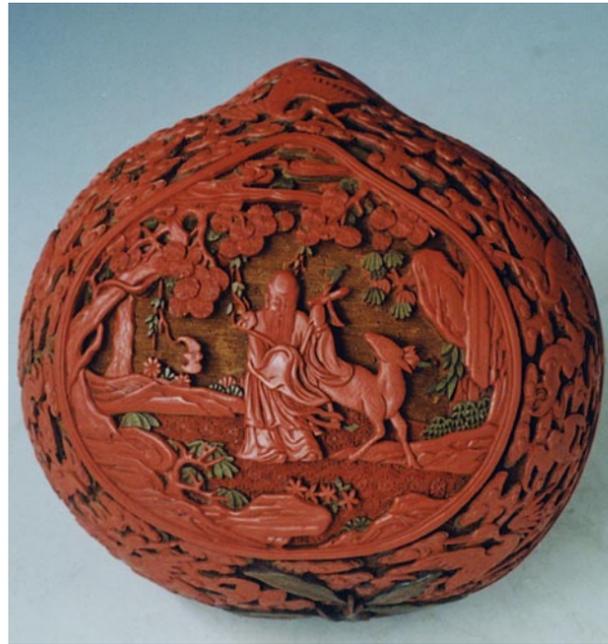
Fig. 4.40. Box with red carved lacquer after cleaning. China, Qing dynasty, Qianlong period (1736–1795), lacquer on wood, 16 x 16.5 x 7.5 cm. Courtesy, Shanghai Museum, Shanghai, China, #7556.

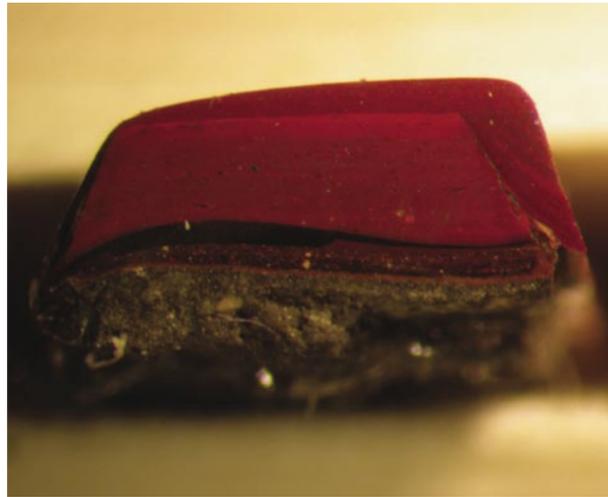
Fig. 4.41. Cross-section of surface layers on relief band on side of box (B77M24); note carved lacquer restoration layers on right side and top of sample. Separation is occurring between the original and restoration layers. The black separation layer seems to fill a loss in the top layer of brown lacquer below it, perhaps indicating flaws in manufacture.

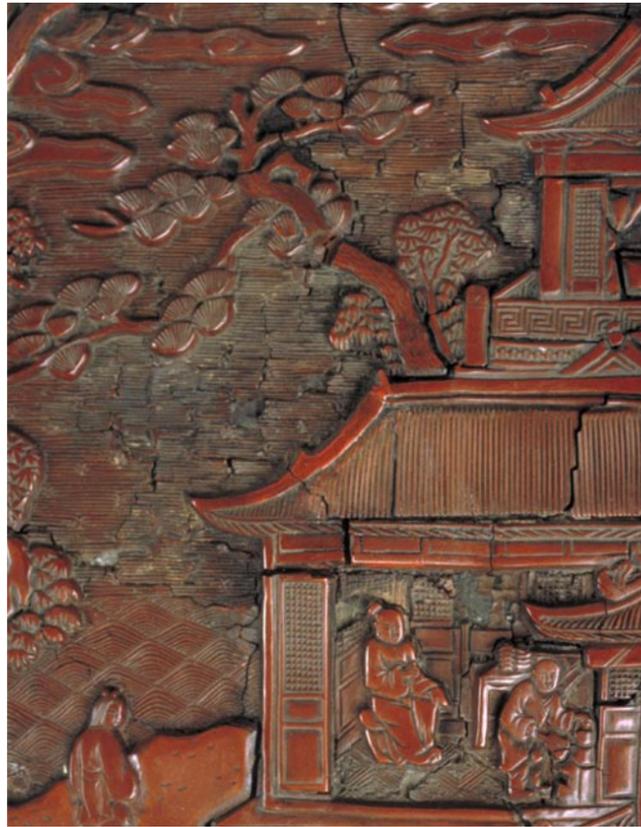
Fig. 4.44. Box (B77M24), detail of lid during cleaning; the bottom half of this area has been cleaned.

An intern in the department, Chris White, cleaned the box under magnification, using fine cotton swabs rolled onto toothpicks. The tiny swabs were dampened very slightly with deionized water. Cleaning proceeded very slowly; it took about one hour to clean a square inch of the lid. In one area, where a very thin lacquer or resin had been applied over the buff fill, water dulled the surface and so this area was not cleaned. The glossy resin on areas of the surface of the lid could be made to swell and was dulled with acetone, but could not be made sufficiently soluble to be removed completely from finely carved recesses. The cleaning of the lid removed substantial dust and grime (see fig. 4.44) but, once the homogenizing dirt layer was removed, the visual differences between the various restorations were more visible.

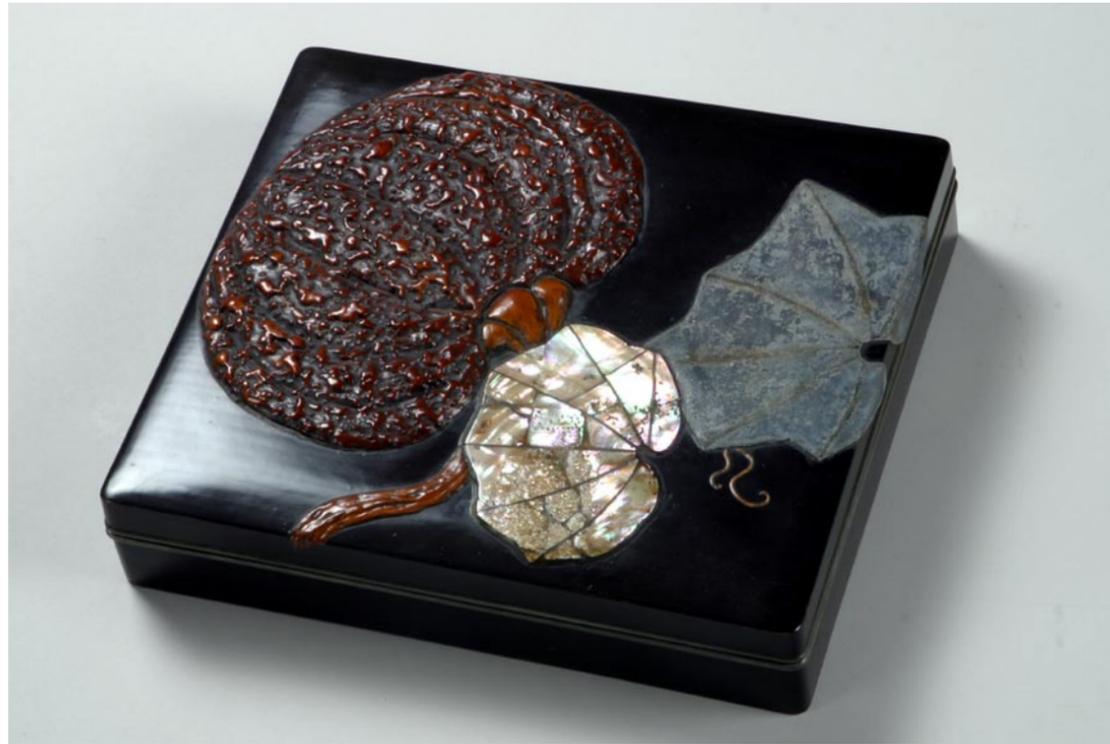
Fig. 5.2. Inkstone box (B6oM6+), overall.

The substrate appears to be made of joined flat cedar boards. There is no obvious problem with the substrate, but the cover is slightly warped.

lacquer (*nuritate shiage*) and on some parts of the *futakazura* are marks from dripping lacquer. Some areas of the foundation layers of the pumpkin show fine cracks, and there are small losses at its border with the black lacquer. The museum records state that a small missing area was filled with “hardrock” dental plaster in 1982.

On the lead inlay leaf is some corrosion and the surface appears powdery. There is a gap between the metal sheet and the black lacquer. Inside the box at some corners, there are some spots on the *nashiji* finish where the lacquer coating has flaked off, in one area exposing the surface of the ground layers.

may be cleaned with ethanol or alcohol diluted with water. The crack in the pumpkin should be filled and the ground layer around the cracks secured with raw lacquer diluted with solvent. In doing this, any excess lacquer should be removed with soft cotton swabs dampened with solvent. Larger cracks and lifting areas should be consolidated with *mugi-urushi* similarly diluted with solvent. Large gaps may be filled with *kokuso*, shaped with a knife, and painted with lacquer to match the surrounding area. Figures 5.3–5.6 illustrate this process of filling and toning a crack.

The black fill should be coated with black lacquer of the same color and sheen. The repairs to the pumpkin should be coated with brown and yellow lacquer and then coated with clear lacquer. Figures 5.7 and 5.8 show a detail of damaged *makie* on a modern tray before and after the type of treatment just described. Colored lacquer is very difficult to match correctly. Therefore, if it is not aesthetically necessary to add color, simply fill the missing parts with a lacquer ground mixture to stabilize the object and then clean the surrounding surface. The

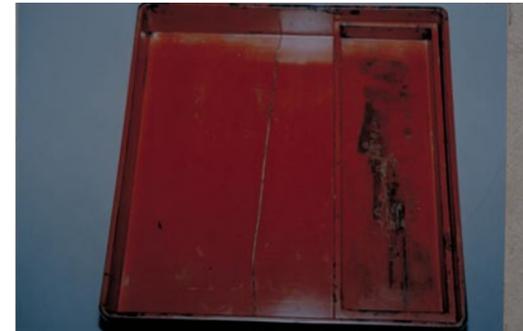
Fig. 5.3. Inkstone box with lotus and wagtail design in *makie*. Japan, middle Edo period, 18th–19th century, 21.0 cm x 22.0 cm x 4.0 cm, collection of Shosai Kitamura. Interior before treatment.

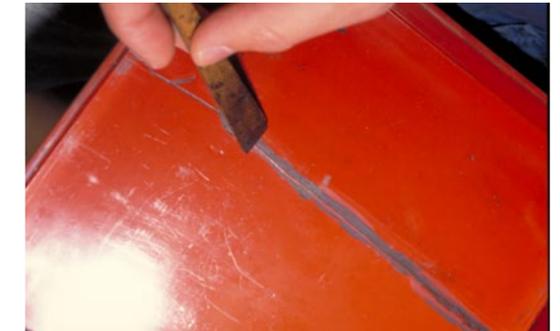
Fig. 5.4. Inkstone box with lotus and wagtail design in *makie*. Japan, middle Edo period, 18th–19th century, 21.0 cm x 22.0 cm x 4.0 cm, collection of Shosai Kitamura. Filling a deep crack with *kokuso*.

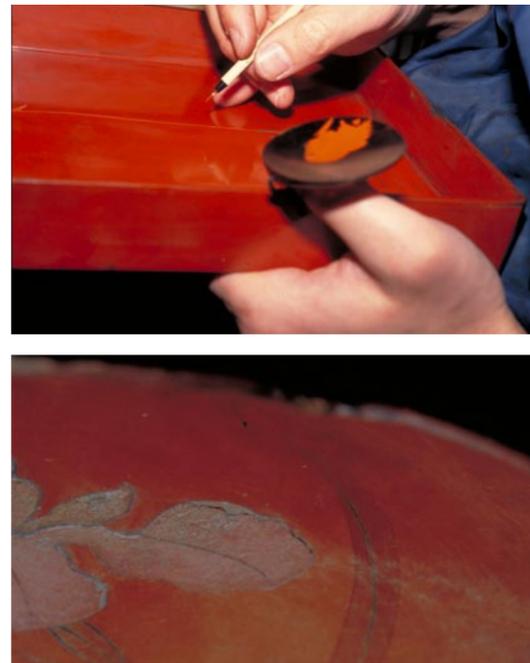
Top left: fig. 5.05. Inkstone box with lotus and wagtail design in makie. Japan, middle Edo period, 18th–19th century, 21.0 cm x 22.0 cm x 4.0 cm, collection of Shosai Kitamura. Toning the fill with pigmented lacquer.

Bottom left: fig. 5.07. Vermilion lacquer tray with iris design in makie with paper core. Japan, Taisho period, 20th century, 18 cm diameter x 3.0 cm, collection of Shosai Kitamura.

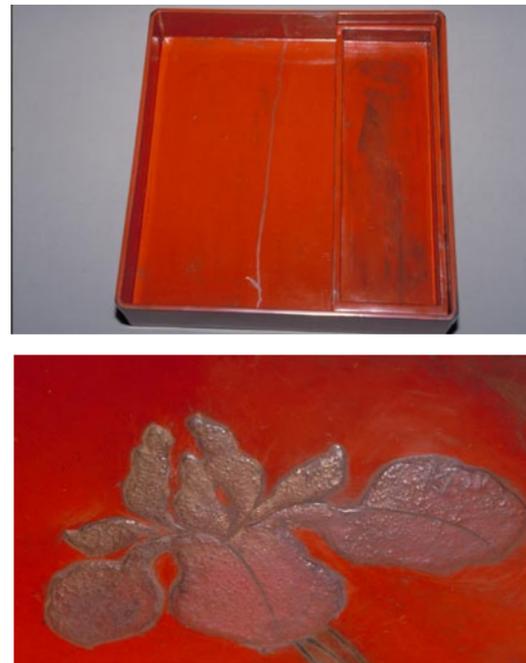
Top right: fig. 5.06. Inkstone box with lotus and wagtail design in makie. Japan, middle Edo period, 18th–19th century, 21.0 cm x 22.0 cm x 4.0 cm, collection of Shosai Kitamura. Interior after treatment.

Bottom right: Detail of damaged makie before treatment. fig. 5.08. Vermilion lacquer tray with iris design in makie with paper core. Japan, Taisho period, 20th century, 18 cm diameter x 3.0 cm, collection of Shosai Kitamura. Detail of makie after treatment.

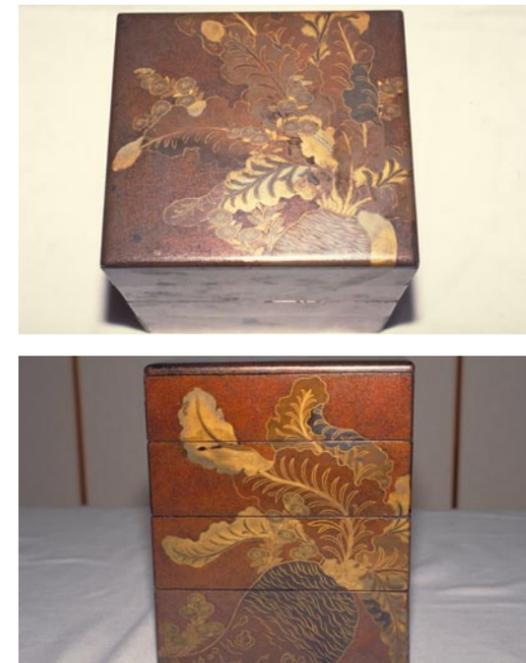
Top left: fig. 5.09. Jubako (lacquer food container) with turnip design in makie. Japan, Edo period, 1750, 22.5 cm x 20.5 cm x 25.5 cm, collection of Shosai Kitamura. Before treatment. Bottom left: fig. 5.11. Jubako (lacquer food container) with turnip design in makie. Japan, Edo period, 1750, 22.5 cm x 20.5 cm x 25.5 cm, collection of Shosai Kitamura. After treatment; note the improvement to surface gloss with *suri-urushi* treatment.

light. An early stage of deterioration shows a loss of sheen and black lacquer turns brownish. At this stage the sheen can be restored with a *suri-urushi* treatment, by which dilute lacquer is rubbed into the surface. (Figure 5.9 shows a lacquer food container (*jubako*) that has lost its sheen. Figure 5.10 shows the procedure for rubbing the surface with dilute *kiurushi* and soft cotton. Figure 5.11 shows the improvement to the surface gloss of the container after the *suri-*

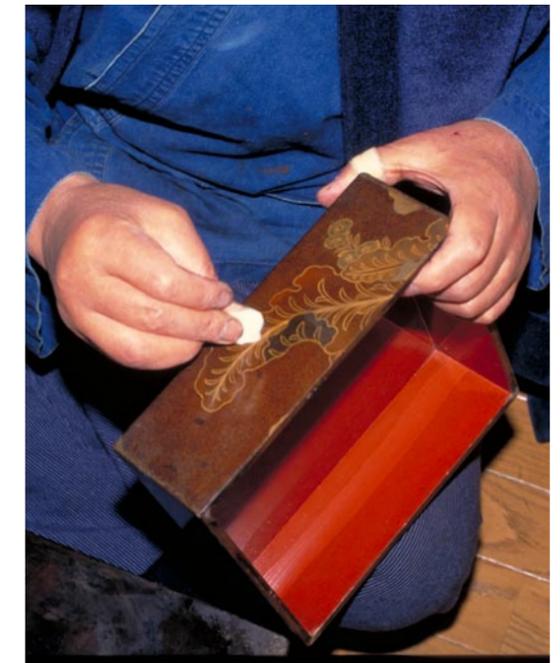
Right: fig. 5.10. Jubako (lacquer food container) with turnip design in makie. Japan, Edo period, 1750, 22.5 cm x 20.5 cm x 25.5 cm, collection of Shosai Kitamura. *Suri-urushi* process.

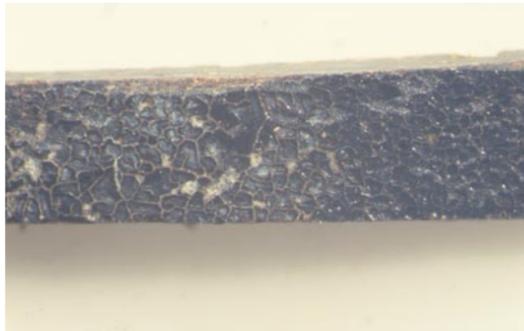
*urushi* treatment.) With further deterioration, the ground layer may become visible through the lacquer coating and, if the deterioration continues, the surface of the ground layer will crack and the lacquer and ground may separate from the substrate and flake off. Figure 5.12 shows a sample of lacquer that has deteriorated and begun to crack and flake off. The right side of the sample has been consolidated with a thin application of lacquer. Figure 5.13 shows

Fig. 5.12. A sample of badly deteriorated lacquer, viewed from above; the right side has been given a *suri-urushi* treatment, which has infiltrated the cracks and strengthened the surface. (Photo by Dr. Humio Okada).
