# *The Conservation of Asian Lacquer*

Case Studies at the Asian Art Museum of San Francisco

By Jane L. Williams

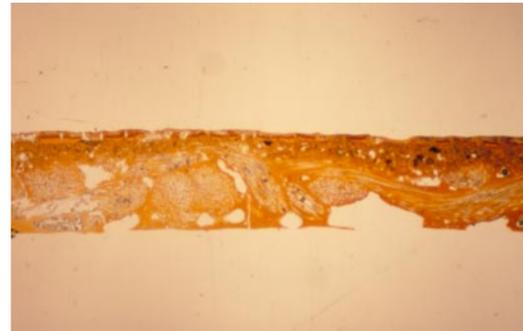
Fig. 5.13. Photomicrograph showing a thin section of the lacquer sample shown in fig. 5.12; the penetration of the lacquer into the cracks and surface losses is clearly visible on the right (Photo by Dr. Humio Okada).

the same sample in thin section. On the right side one can see the extent to which the *suri-urushi* treatment has penetrated the cracks and strengthened the lacquer.

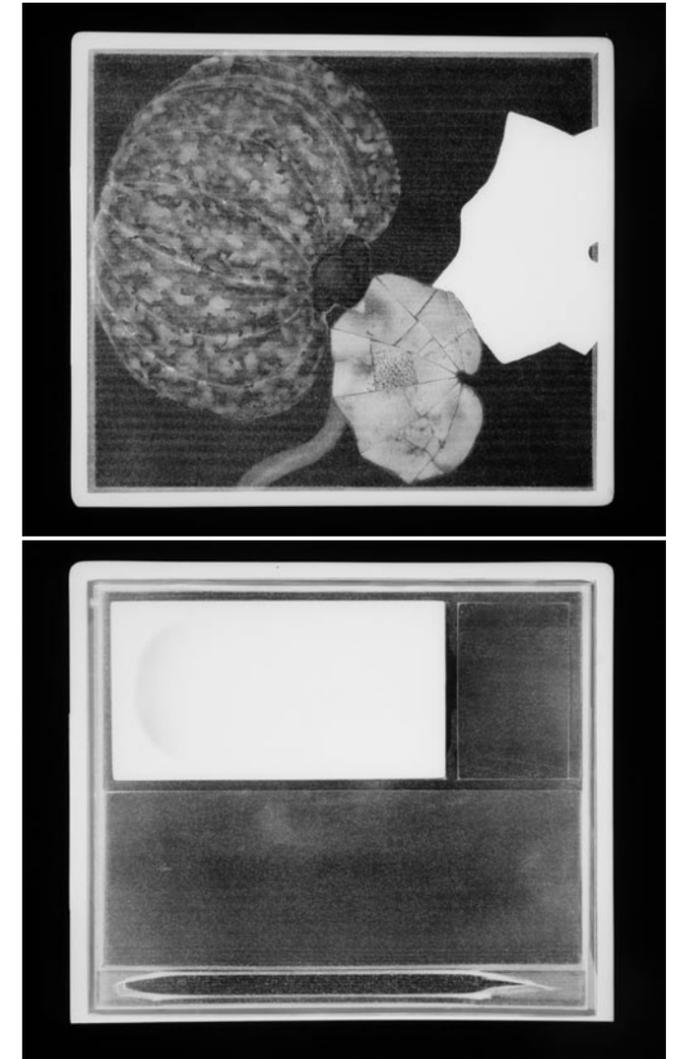
The box was constructed of softwood. It appears to be held together primarily with glue joints, but in X-radiographs faint images of what may be dowels are visible along the edges of the base (see figs. 5.14 and 5.15). There is no evidence of a textile layer over the wood.

The pumpkin is made of at least three carved pieces of wood glued together and applied to the box. X-radiographs show the joints in the substrate of the pumpkin (fig. 5.14), but the wood grain does not show up at any exposure. The wood substrate of the pumpkin could be

Fig. 5.14. Inkstone box (B60M6+), X-radiograph of lid. Technical data: Gulmay X-ray unit (320 kV max.), Kodak Industrex M film, 30 kV, 5 mA, 90 seconds, distance from tube, 36 inches.

Fig. 5.15. Inkstone box (B60M6+), X-radiograph of base. Technical data: Gulmay X-ray unit (320 kV max.), Kodak Industrex M film, 30 kV, 5 mA, 90 seconds, distance from tube, 36 inches.

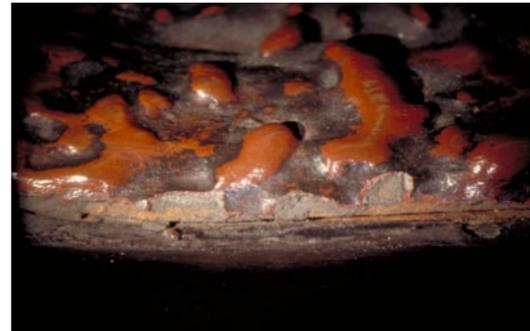
Fig. 5.16. Inkstone box (B6oM6+), photomicrograph showing wood substrate of pumpkin applied to the lid.

identified only by visual examination in areas of surface loss (see fig. 5.16). The pumpkin's bumpy texture was applied in *takamakie*, modeled in a dark gray foundation layer. The pumpkin's surface is now coated with a brownish orange lacquer or paint and, in the recesses, with black coating. The interior of the box is finished with a white metal *nashiji*. The exterior is coated with a black lacquer. It appears to have an unpigmented lacquer applied overall as the final coat. This clear layer fluoresces a very dull mustard color in near ultraviolet light and, where it has been scratched or abraded, reveals the black, UV-absorbing lacquer below.

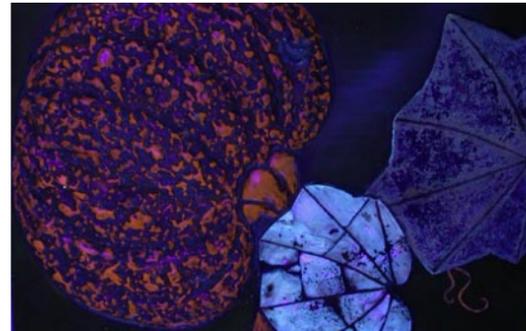
Fig. 5.17. Inkstone box (B6oM6+), lid shown in near ultraviolet light; note the strong orange fluorescence of the pumpkin and its stem.

In addition to the treatments of the box that have been recorded, the pumpkin and its stem appear to have been extensively restored and coated entirely with shellac. They fluoresce a bright orange color in UV light (see fig. 5.17). There are a few large fingerprints on underside of the lid that fluoresce the same orange color and are readily soluble in ethanol. The pumpkin was subsequently coated black with a material that absorbs UV light and that was then wiped off the high points to reveal the orange layer below.

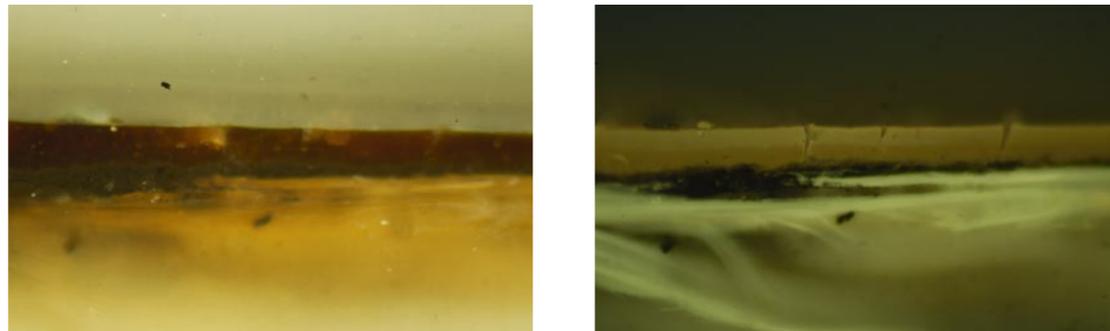
Fig. 5.21. Covered box (B62M13), cross section of layers on lid taken from under shell inlay shown in reflected light (left) and ultraviolet light (right); photo taken at 00x magnification.

unpigmented lacquer layers are visible above the black layer. The mother-of-pearl pieces were adhered directly to these thin layers (see fig. 5.21). There is no evidence in the samples of a nikawa adhesive layer, as Mr. Kitamura had originally suspected. The surface of the lid was brought up to the level of the thick inlay with two ground layers, a thin one containing only finely divided white particles (not yet identified) and a thicker layer that is bulked primarily with kaolin and quartz (see fig. 5.22).<sup>12</sup> The lid gets its brown color from an unpigmented lacquer coating applied over these ground layers.

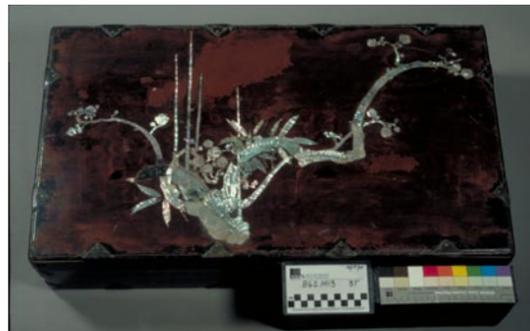
Fig. 5.23. Covered box (B62M13), lid.

boring pieces. One replacement can be identified by the visual discordance of its iridescence. There are large, irregular areas where there is a level change in the ground under the overall translucent lacquer (see figs. 5.23 and 5.24), where apparently large losses were lacquered over without the surface first being brought to the same level. In addition, one large patch and several smaller areas were filled and then coated with a pigmented paint or lacquer that does not match the surrounding surface in color, gloss, or translucency (see fig. 5.25). There are four circular patches of fill at the corners of the base, probably representing the placement of previous feet. The box has a heavy, overall coating of beeswax.<sup>13</sup>

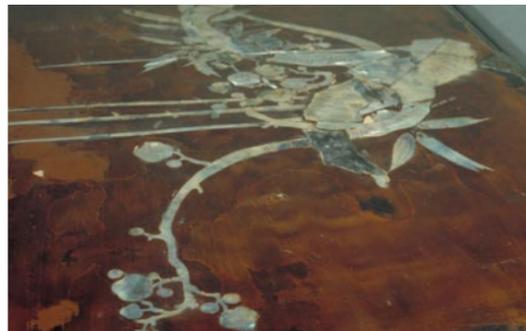
The element most vulnerable to loss is the mother-of-pearl inlay. The inlay is lifting off the lacquer surface at the area of the tree trunk, the proper left branch, and the two flowers at

the center next to the trunk (see fig. 5.24). Inlay has been lost from the tree trunk and from one of the central branches stemming from the trunk. There are scattered horizontal cracks in the lid's thin lacquer coating that generally follow the direction of the wood grain. The lacquer is slightly tented and becoming detached from the surface along some of the cracks (see fig. 5.25). A small piece of lacquer has flaked off one of the large areas of restoration and is sitting loose on the lid.

Fig. 5.24. Covered box (B62M13), detail of lid showing lifting inlay and difference in level of ground under translucent surface lacquer.

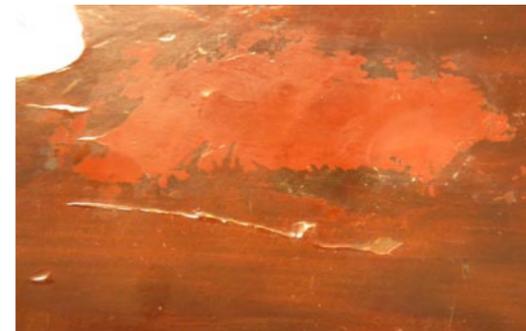
Fig. 5.25. Covered box (B62M13), detail of lid showing unsightly old fills and cracks in lacquer.

As Mr. Kitamura and Ms. Piert-Borgers observed, the large unsightly lacquer fills would

plastic film, use thin layers of acrylic ink or an acrylic resin mixed with light-stable Orasol dyes or pigment applied with an air brush.

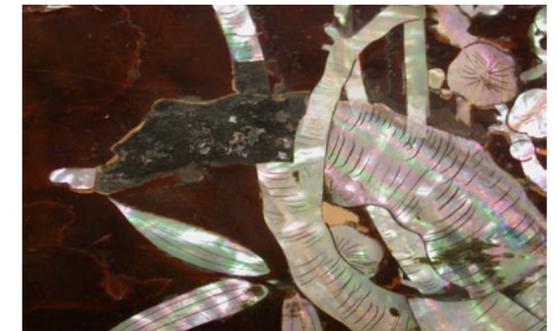
Fig. 5.26. Covered box (B62M13), detail of lid showing temporary repairs to inlay.

The replacement inlay on the lid can be detected, but the new inlay is made of similar shell of an appropriate thickness and is much less obtrusive than the large losses to the inlay. The losses are more noticeable on this box than on others examined for this project because the design is quite simple and bold, consisting of large pieces of shell, and because the losses expose the contrasting dark lacquer under the shell (rather than, as on the chest B61M16+, the white ground under the shell). If one were to try to integrate the surface aesthetically, the losses to the shell would need to be compensated. The restoration would need to match the relatively thick original inlay. If shell of appropriate sheen and texture could be found, it might be used to replace the inlay and the date incised on the reverse as a record of its replacement, in addition to the written and photographic documentation of the treatment. I would also test iridescent mica pigments on a base, such as Plexiglas, polyester film, or a flattened sheet of Milliput, of the appropriate thickness, cut to match the shape of the loss.

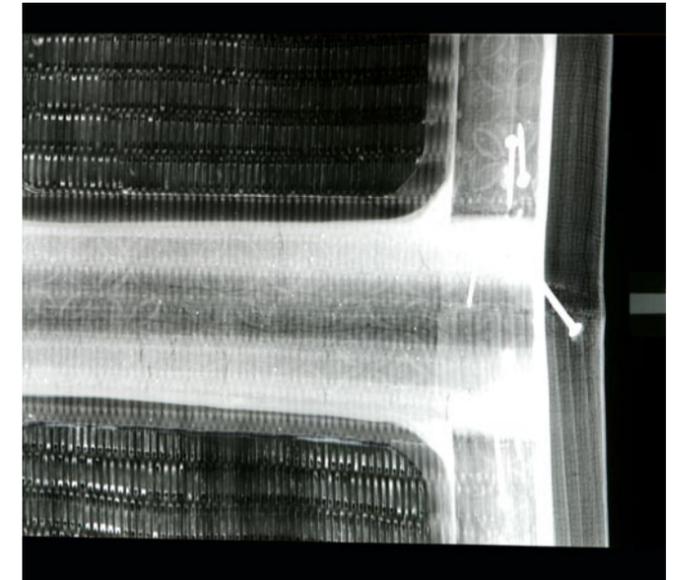
Fig. 5.29. Box (B61M16+), X-radiograph of base corner; the more radio-opaque areas framing the basketry are the wood strips that secure the basketry to the box; joins in these strips are visible near the corner and the image also shows the use of wire nails applied from interior and exterior of box. Technical data: Gulmay X-ray unit (320 kV max.), Kodak Industrex M film, 30 kV, 4 mA, 60 seconds, distance from tube, 36 inches.

Examination of the box in areas of damage and with X-radiography showed that the basketry is supported on wood. X-radiographs of the lid revealed that it is made from multiple planks of wood, glued together with no dowels. It has two thicker crossbraces glued to the underside and dowelled to the sides. A continuous, flat band of basketry made of split bamboo laced over vertical strips of bamboo (fig. 5.28) was wrapped around the sides of the lid and box. The basketry bands are held in place by strips of thin wood (3-mm thick) that overlap it and form oval frames on each side around the basketry. The wood strips are joined near the corners (see fig. 5.29), where they also serve to round the corners of the lid and box.

The X-radiographs of the corners (figs. 5.33 and 5.29) revealed twentieth-century 1/2-inch, 1-inch, and 1 1/4-inch wire nails in all corners of the base and none of the lid. The construction of the corners is otherwise the same on the base and lid, and the nails are presumed to be repairs, rather than part of the original construction. It is now more obvious that, where the lid and box meet, the corners of the lid have cracked and are missing lacquer and ground, while the corners of the box are all intact. What is significant about the presence of the nails, however, is that they date the lacquer and mother-of-pearl decoration covering these repairs to at least the beginning of the twentieth century.

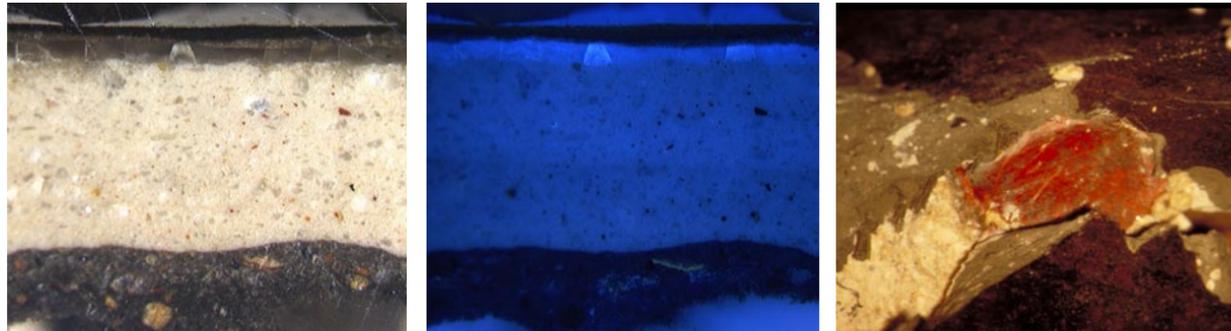
Fig. 5.30. Box (B61M16+), cross-section sample of restoration layers applied to foot above the coarse textile

layer shown in reflected light (left) and ultraviolet light (right); photo taken at 200x magnification.

The same sequence of layers is found on many different areas of the surface (see fig. 5.30). A thin, bright white foundation layer was applied first and over that a loosely woven, plain-weave vegetal fiber textile. Next comes a dark gray ground layer, which penetrates the textile

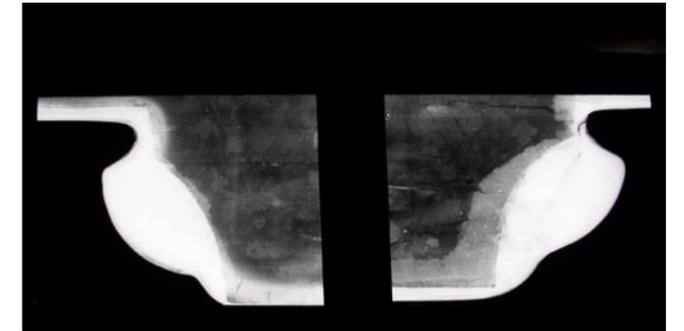
Fig. 5.32. Box (B61M16+), X-radiograph of two of the feet; radio-opaque areas are lead white containing putty applied over the original finished feet to build them up to their current, more baroque shape. Technical data: Gulmay X-ray unit (320 kV max.), Kodak Industrex M film, 30 kV, 4 mA, 60 seconds, distance from tube, 36 inches.

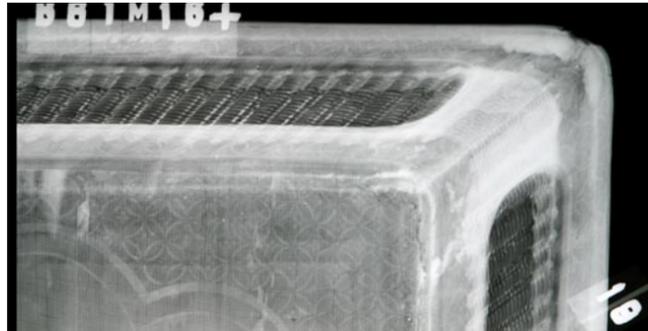
Fig. 5.33. Box (B61M16+), X-radiograph of lid corner; note the absence of dowels or nails in the joints and the way in which the basketry is applied as a band that wraps around the corner. Technical data: Gulmay X-ray unit (320 kV max.), Kodak Industrex M film, 30 kV, 4 mA, 60 seconds, distance from tube, 36 inches.

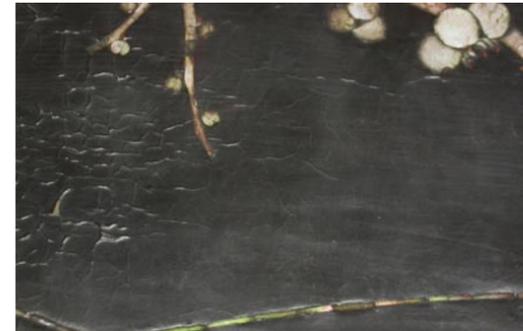
Although it took some time to recognize that all of the lacquer and inlay decoration visible on the box is modern, it was easier to determine that the surface had been subsequently renewed with an overall coat of unpigmented lacquer. This restoration lacquer overlaps the mother-of-pearl slightly and, where it coats the overall craquelure on the lid more thickly, there are pools of lacquer with no fissures (see fig. 5.34). Like other Chinese objects in the collection that have been relacquered, such as the tiered box (B77M21) and the small panel (B83M1), in small areas around the inlay the underlying darker lacquer can be seen to be level with it. The top of the lid has only a translucent, brownish, grimy coating on it that absorbs long-wave ultraviolet light.

Fig. 5.34. Box (B61M16+), detail of lid showing fine cracking and evidence of relacquering; note pooling of restoration lacquer obscuring craquelure in areas and overlapping inlay.

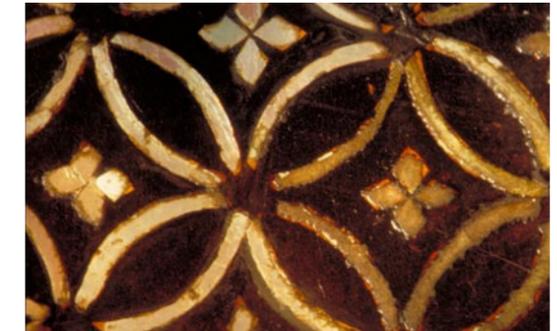
Fig. 5.35. Box (B61M16+), detail of lid; the left side has been cleaned.

losses to the lacquer, primarily at the corners of the lid where it rests on the base. The lacquer and ground adjacent to some of the losses are cracked and/or lifting. Apart from the chipped areas, the lacquer is in stable, good condition overall, particularly on the sides of the box. The central field of the lid is covered with a network of fine, short cracks intersecting at right angles. There are tiny corners of lacquer lifting along these cracks, but in general at this time the lacquer does not appear vulnerable to loss as the result of the cracking. The lacquer is cracked along the top of the wood strip running below the basketry. This cracking appears to result from the slight separation of the wood from the underlying structure.

The surface of the box was cleaned first with a soft brush and vacuum. Before the evidence of resurfacing had been gathered, the solubility of the brownish coating on the top of the lid was tested. Where it coats the inlay it is slowly soluble only in water and insoluble in ethanol, acetone, Stoddard solvent, and xylene. Cleaning tests on the lacquer show that it can be cleaned to a shiny surface by being wiped with a soft cotton cloth dampened with ethanol or Stoddard solvent. This suggests that a thin wax coating may have been rubbed on the lacquer over the brownish coating. With a combination of cleaning the inlay surfaces with tiny swabs, very slightly dampened with deionized water, and wiping the surface overall with soft cotton dampened with Stoddard solvent, the appearance of the lid could be brought to match the color and gloss of the rest of the box (fig. 5.35 shows a small test area that has been partially cleaned. The cleaning process was, however, too time-consuming to be completed during this project.

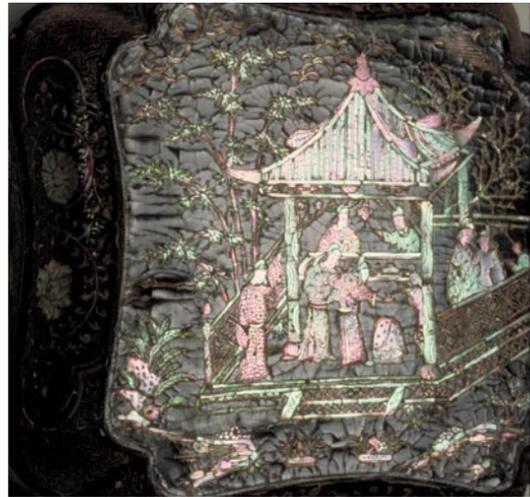
Fig. 5.37. Tiered box (B77M21), lid shown in raking light, before treatment.

Although there is no structural damage, the lacquer coating is lifting from the ground layer, and the lacquer surrounding all the mother-of-pearl on the exterior is cracked and tented (see fig. 5.37). The ground layer visible in damaged areas is brownish, and the appearance of the cracks suggests that the ground contains some lacquer. The interior has a thick coating of previous relacquering and has developed long and deep cracks in the coating. These cracks may originate at the ground layer.

If black lacquer is used as a consolidant around the mother of pearl, lacquer may penetrate under the shell and turn it bluish, no longer matching the milky white shells nearby. Therefore, it would be better to use animal glue diluted with water to consolidate lifting layers. As described for the panel (B83M1), moderate moisture should be added to cupped layers to soften them and then the correct amount of pressure added. However, if too much moisture is introduced, the coating may stretch, therefore, a careful test should be made before starting the treatment. Where it is difficult to secure the lacquer, it may be necessary to use a clear, solvent-based resin. Large, deep cracks and areas of missing lacquer around mother-of-pearl may be filled with a mixture of lacquer mixed with tonoko and then coated with black lacquer. Cracks in the coating on the inside of the container may be filled with raw lacquer diluted with solvent and the coating may be readhered with *mugi-urushi*, adding proper pressure. Areas that are difficult to reattach can be secured by simply filling underneath them with *sabi-urushi*.

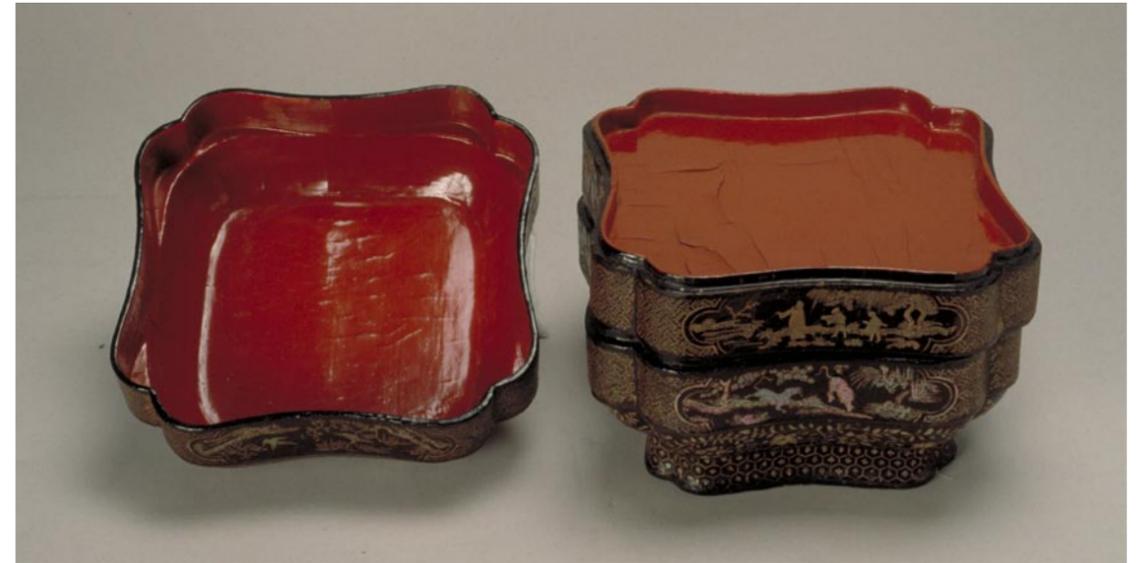
The present tiered box shows the damage typical of a finish structure that has been destroyed by a later relacquering. In the interior of the box we find relatively wide cracks that render the wooden construction visible (see fig. 5.38). In the area of the large board these cracks run across the grain and, at the smaller, glued cross-board, the cracks first run across the grain and then curve to the glue joint. The exterior surfaces seem likewise to have been coated with a hard, glossy urushi layer. Here we see several vertical, gaping cracks, some of which curl or cup upward at the edges. The mother-of-pearl

Fig. 5.38. Tiered box (B77M21), interior before treatment.

inlays are grimy and lacquered over. Missing inlays have been imitated in lacquer painting, and lacquer losses painted over in large areas. This piece evinces all the disadvantages of an inexperienced restoration with Asian lacquer. The damage is worsened by the irreversibility of the measures.

The final lacquer layer inside the box will probably have to be retained. The retouchings and overpaintings on the outside surfaces and mother-of-pearl decoration can be partially removed, but by mechanical means only. A sharpened bamboo stick or a scalpel with a ceramic blade might be used to expose the mother-of-pearl inlays and flake the paint layers off. In certain areas, pointed pieces of charcoal or soft wood dipped in charcoal powder could be used to polish or burnish the lacquer surface.

mother-of-pearl decoration. It has to be kept in mind, however, that mother-of-pearl may regain color and change from a pale white to its original iridescence. This effect may not be desired by curators or collectors. An infiltration of this glue might perhaps permit the raised cracks and flakes to be flattened and adhered. In Western restoration shops, electric spatulas or warmed mats are often employed. To my mind, this is an additional and unnecessary source of risk. The crucial thing is to apply sufficient pressure, as is the case when consolidating by using *urushi* and the *shinbari* method).<sup>24</sup> To re-adhere the flakes inside the box, sturgeon glue is suitable, as is polyvinylacetate.

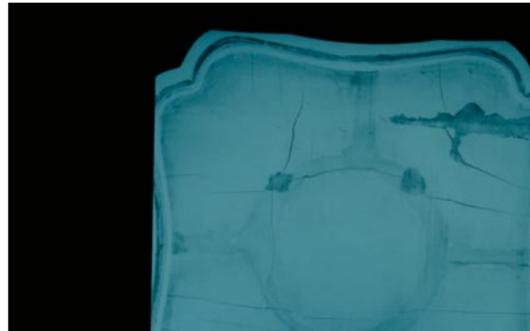
Fig. 5.39. Tiered box (B77M21), X-radiograph of middle tier. Technical data: Norelco X-ray unit (150 kV max.), Kodak Industrex M film, 45 kV, 6 mA, 60 seconds, distance from tube, 36 inches.

The box was constructed from strips of wood that were glued together (in X-radiographs there is no evidence of pins or dowels). X-radiographs show that the flat parts of the lid and bottom tray are each made of two parallel strips of wood with rub joints. The middle tray is composed of three parallel strips of wood with rub joints and a fourth perpendicular strip butt-joined to the others, a structure that has been widely observed in X-radiographs of Chinese lacquer objects from various periods. In the X-radiograph (fig. 5.39) one can see that this tray originally was compartmented, with a central circular compartment surrounded by four equal-sized sections. The shallow divider walls were originally secured with glue and two pegs (the filled holes are visible in the X-ray). The sides of the box are separate strips of bent wood glued at the corners.

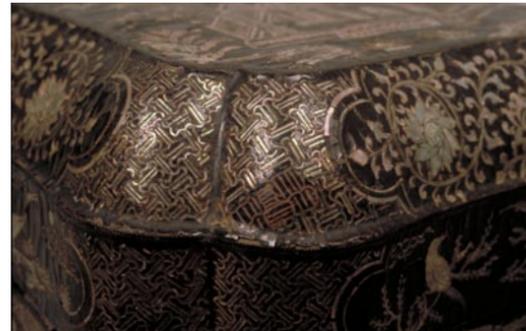
Fig. 5.40. Tiered box (B77M21), detail of corner, before treatment, showing use of red lacquer lines on old restoration to imitate inlay pattern.

differentiate the different restorations—in UV light the surface of the box looks very uniform and nonfluorescent. The entire surface has been thickly recoated with a translucent, unpigmented lacquer. This layer was then chipped off the surface of most of the inlay (jagged outlines from this process are visible around the inlay), but in several locations the inlay remains partially obscured. At some point subsequent to this, the interior was completely recoated with a more orange shade of red lacquer. At a later date, a few isolated losses in this red coating were filled with a brighter red lacquer. All of the edges have been recoated with black lacquer. Large losses to the lacquer at some of the corners on the sides were also filled with a beige material and coated with lacquer that is blacker than the surrounding surface. The mother-of-pearl inlay patterns were reproduced on the surface of the fill with red lacquer (see fig. 5.40).

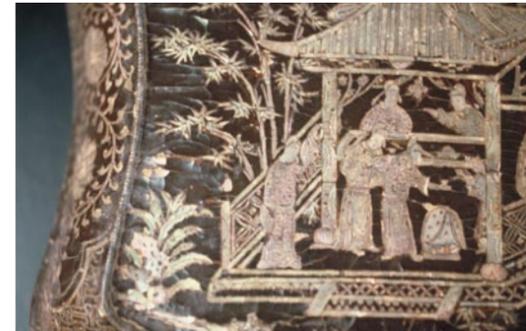
Fig. 5.41. Tiered box (B77M21), detail of lid, before treatment.

ble condition, but the lacquer surface is cupped throughout and pulling away from the wood in several locations. The worst area of lifting is on the lid, to the proper right side of the pavilion (see fig. 5.41). The separation is occurring in the weaker ground layer. The lifting and cupping appear related to a thick restoration lacquer having been applied over the weaker, thinner original lacquer and ground layers. Minor losses to the lacquer, the shell inlay, and the wire throughout (the wire has been largely obscured by restoration—losses to it are discernible mainly in X-radiographs) have been noted on diagrams.

After consolidating the inlay in an area, I carefully removed the restoration lacquer over the mother-of-pearl inlay, working under a binocular microscope and using a Beaver miniscalpel blade that had been polished using Micromesh abrasive sheets to remove any irregularities in the blade edge that could scratch the inlay. A sharp blade does pose the risk of scratching the surface and in many cases a thin tool formed from Plexiglas or another hard plastic might be used more safely, but I found that, in this case, the thinness and sharpness of the blade gave me more control in removing the restoration lacquer. The blade was held at a low angle and, in lifting the restoration lacquer, I avoided contact between the blade and shell as much as possible. The cupping of the res-

toration lacquer also made it easier to get under the edge of the lacquer without risking scratching the inlay. Figs. 5.41 and 5.42 show a detail of the lid before and after treatment—the removal of restoration lacquer from the inlay is particularly noticeable on the trees.

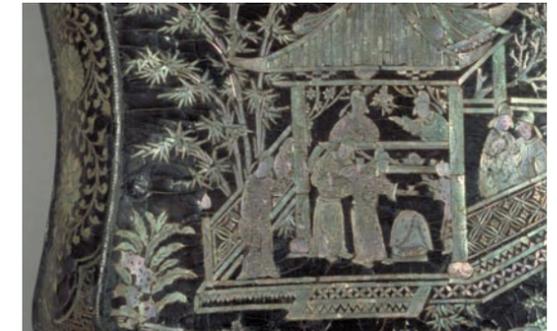
Fig. 5.42. Tiered box (B77M21), detail of lid, after treatment; the treatment consolidated the ground and readhered the lacquer to the ground, but the lacquer remains cupped; the effect of mechanically removing restoration lacquer is particularly visible in the trees at left.

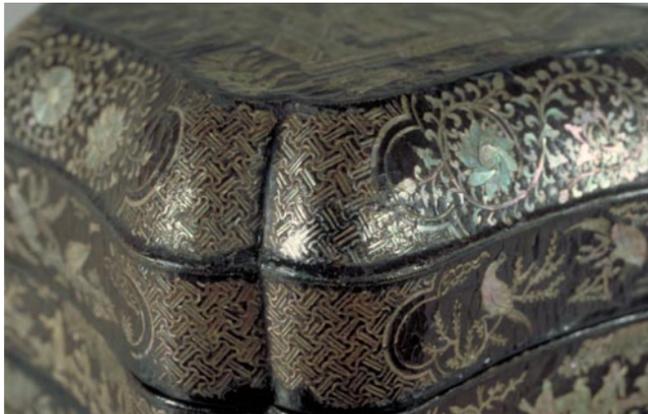
Fig. 5.43. Tiered box (B77M21), detail of corner, after treatment; cracks in the old restoration and losses have been filled; mica pigments mixed with acrylic inks were used to simulate inlay pattern on large loss, but the pattern was not recreated on smaller losses.

Because the existing lacquer-based fills are stable they were left in place. Where they overlapped the surrounding surface, they were reduced with a scalpel and then the residual fill could safely be removed from the lacquer with a swab slightly dampened with deionized water. The fills were reshaped using small sanding tools, and smoothed with sandpaper and then Micromesh. Before the losses were filled, the surfaces of the exposed ground or wood were sealed with dilute B-72 in acetone to provide a separation layer between the new fills and the original. Also, my experience has been that sealing the loss makes the fills adhere better. The larger loss to the lacquer on the bottom and the smaller isolated losses were filled with a mixture of 6% PVOH in water and 1 : 1 calcium carbonate : kaolin. Even the smallest losses were filled to protect the edges of the cupped remaining lacquer from further damage and loss. The fills were smoothed as much as possible with a steel spatula dampened with ethanol. The larger fills were then sanded with successively finer Micromesh up to 12000 grit. The fills were painted with Rowney FW Acrylic Artists' inks. Several coats of ink were used to build up the color in thin smooth layers on the larger fills. This was not visually necessary for the smaller (1/8-inch) fills. On the largest fill dry mica pigments were mixed with the ink to replicate the mother-of-pearl pattern (see fig. 5.43). Acrysol WS-24, diluted from the stock solution with deionized water until it could be brushed out smoothly, was added to the final coats of ink to add gloss. The Acrysol made the surface harder and made it possible to sand with fine-grit Micromesh between the last coats. □

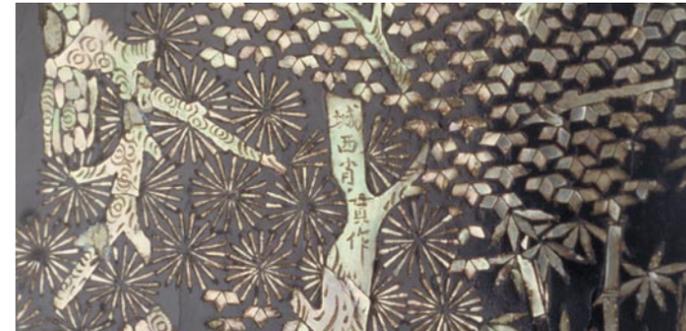
Fig. 5.45. Panel (B83M1), detail showing inscription on inlay; old inpainting to simulate mother-of-pearl inlay is visible on the tree trunks at left.

A white fill material was used to fill the largest area of loss where vertical and horizontal cracks meet in the upper proper right of the central field. The fill has been painted with black paint that absorbs UV light. Missing inlay here and in other locations across the panel (see fig. 5.45) has been simulated with gold- and silver-colored paint that also absorbs UV light.

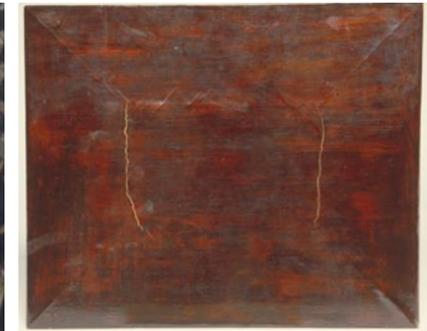
Fig. 5.46. Panel (B83M1), reverse; note cracks following edge of central panel and mitered framing pieces.

The substrate shows some distortion. The reverse has cracks through the ground layer following the joints (see fig. 5.46). The mother-of-pearl appears stable; some shell inlay is, however, missing and there is evidence of previous replacements.

It is impossible to flatten the distorted wood substrate. Raw lacquer diluted with solvent should be flowed into the cracks on the back to stabilize the ground layer. Large cracks and lifting areas can be filled with *mugi-urushi* diluted with solvent and then pressed carefully to reattach lifted areas without cracking them. Since the lifting lacquer is rather thick, it may not be possible to flatten it completely. If, however, moistening a small area softens the lacquer, it may be possible to flatten it to some extent. Moisture could be applied by placing a piece of soft, damp paper directly on the area or by placing the object in a high humidity, airtight container. Either method requires close monitoring of the state of the coating.

Some experimentation would be needed to determine whether the distortion of the lacquer can be improved. If the lacquer cannot be flattened, the distorted lacquer may be left as is. The cracks can be filled with *sabi-urushi* applied with spatula and the excess cleaned off. Surface dirt and any foreign matter may be cleaned off with alcohol.

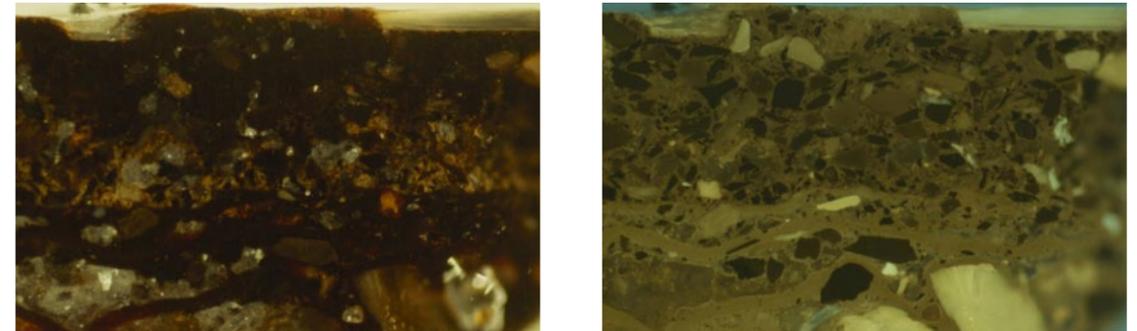
Fig. 5.48. Panel (B83M1), cross-section sample of surface layers on front of panel shown in reflected light (a) and ultra-violet light (b); photo taken at 100x magnification; note how thinly the lacquer is applied and how the inlay pieces are embedded in the upper ground layer.

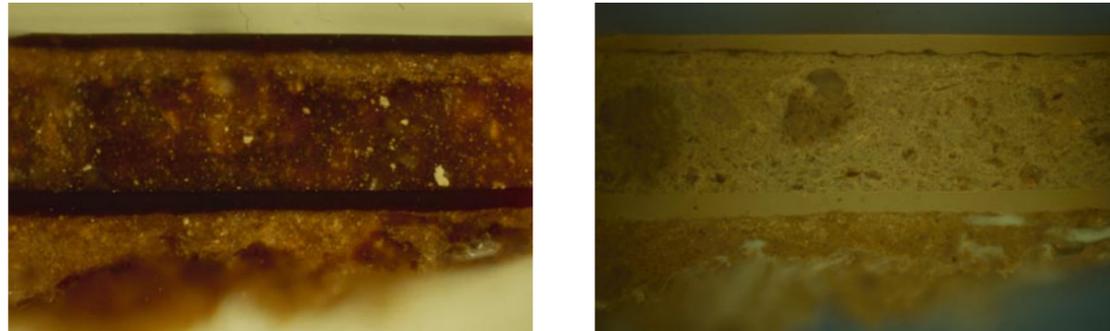
patches is greener than the surrounding lacquer surface, but still very dull. The back and edges have been recoated overall with a lacquer that fluoresces a warmer color than the lacquer on the front in UV light. A cross section from the reverse of the surface layers directly on the textile show two schemes of applied ground and lacquer that are completely unrelated to those on the front surface (see fig. 5.49). The unusual laminated structure of the panel and the difference in the surface layers on the front and back raise the possibility that the wood back panel is not original to the object, but was applied later to reinforce it.

Fig. 5.49. Panel (B83M1), cross-section sample of surface layers on front of panel shown in reflected light (left) and ultraviolet light (right); photo taken at 200x magnification; two separate campaigns of applied ground and lacquer layers are visible and have no relationship to the layers found on the front panel (see fig. 5.48).

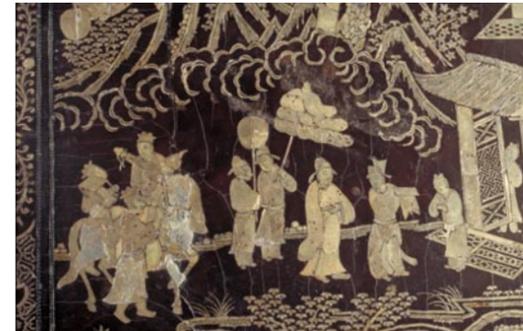
There are numerous pieces of replacement inlay (see, for instance, the replacement pieces on the horse and figure next to it—fig. 5.50), which differ from the original. Most are similar in thickness to the original inlay, but the replacement pieces on the horse are substantially thicker. The incised lines are sharper and clumsier on the replacement pieces. The color of the original inlay is warmer—it probably has a thin coating of lacquer or another material over it.

There are lifting or unstable pieces of inlay throughout the panel. Most of the larger pieces of inlay are lifting or have losses. The mother-of-pearl comprising the fan and umbrella near the center buckled because the edges of the inlay remained adhered to the surface while the wood support shrank. They are highly tented and vulnerable to being snagged or crushed. This buckling seems to have occurred primarily in one direction; the shrinkage of the wood in the central panel was primarily perpendicular to the grain.

Fig. 5.50. Panel (B83M1), detail; the replacement mother-of-pearl is particularly noticeable on the horse and the figure beside it; note also the buckled and lifting mother-of-pearl on the shield and umbrella.

The first step, even before cleaning, was to consolidate the lifting or loose inlay. This was achieved by flowing dilute (10%–15%) B-72 in acetone under the inlay with a very small brush and then covering it with Cerex (a spun-bonded nylon web), blotter paper, Plexiglas, and small lead-shot weights. This consolidation did not visually alter the color of the inlay. By applying gentle pressure to the tented inlay after introducing the adhesive under it, I was able to push it closer to the surface. It is not completely flat again, but is less vulnerable and is secured with adhesive.

On examining this panel, the curator, Michael Knight, said that, if it were to be displayed, he would want to remove the replacement mother-of-pearl inlay, particularly that on the horse. The restorations that were done with bronze or mica powder paint, while not perfectly executed, are less obtrusive and could be left. □

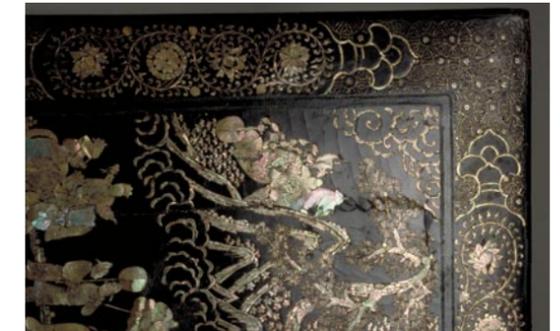
Gaps have opened between the wood of the central panel and the top and right framing members on the front (fig. 5.51). The wood along the vertical gap moves slightly under gentle pressure. The separation has caused large cracks in the lacquer; the vertical crack is larger and more open. There is cracked and distorted lacquer along the crack and a loss to

Fig. 5.51. Panel (B83M1), detail in raking light, before treatment, showing crack and distortion along wood join.

The separation between the layers of the wood could be closed under gentle pressure. The thickest solution of B-72 in acetone that could be injected here, about 25%, was introduced between the layers. The area was then clamped until the adhesive had dried. Ani-

mal glue was not used to secure the wood as I was concerned about controlling the flow of moisture through the layers and cracks. The consolidation worked the first time in one location and had to be repeated once in the second area.

The loose lacquer along the edges of the cracks was consolidated with dilute B-72 in acetone. To stabilize the movement between the joined planks and layers, the crack was filled with a pigmented mixture of B-72 in acetone bulked with a mixture of 1 : 1 glass microballoons : Whatman CF-11 fibrous cellulose powder. To disguise the misalignment of the surfaces on either side of the crack, it was filled to slightly below the surface level.

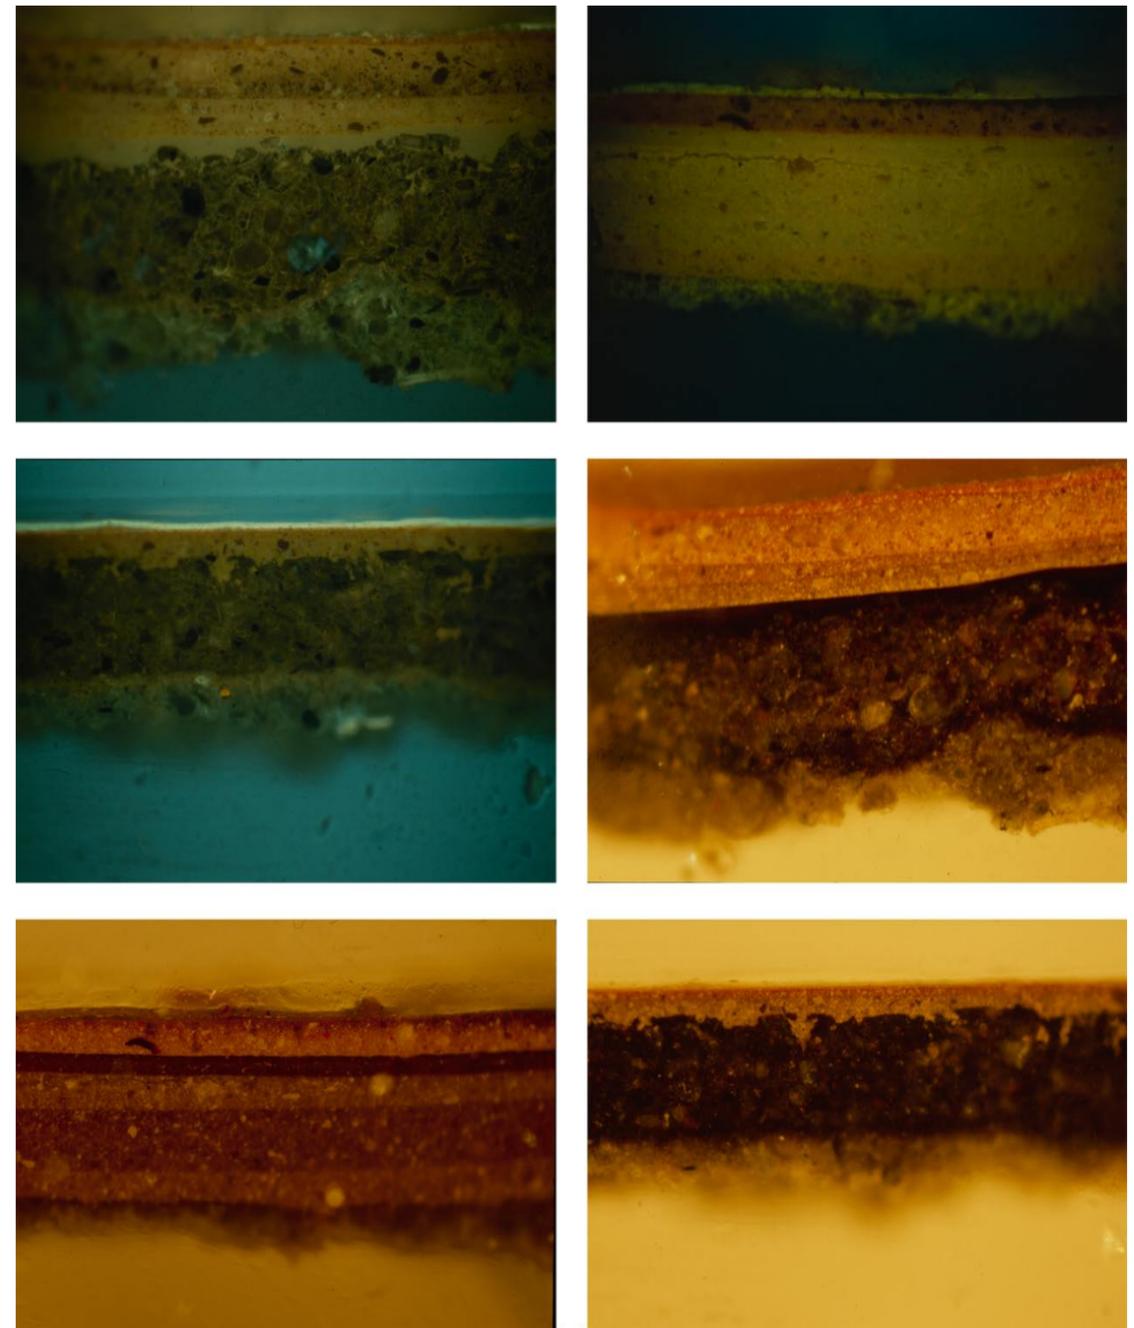
Fig. 6.26. Chart showing cross sections of lacquer layers from different parts of lacquer chair (B69M54a).

Cross-section samples then confirmed the stratigraphy of the upper lacquer layers. Two grounds were applied in the original scheme, as can be seen (fig. 6.26) under reflected light. The lower thicker ground was applied directly to the cloth to fill the weave and appeared brown gray in color with large clay particles loosely bound in a blue white fluorescent binder. FTIR identified quartz and gypsum in a protein binder. It has been noted that Chinese lacquer pastes or grounds often included some of the following:

supported the structural evidence. Samples taken from both the front and back of the cresting rail revealed a stratigraphy that differed from the original (see figure 6.26). The most immediate of these being that there was only one ground present, a brown loosely bound layer similar to the protein based grounds of original sections of the chair. The black ground bound with lacquer was not present. Above this, the first four pigmented lacquer layers contained a simple mixture of arsenic, sulfur and calcium, indicative of orpiment/and or realgar mixed with calcium based white. This was elementally different from the mixture of aluminum, silicon, potassium, calcium, iron and arsenic found in samples on the legs.

than the original work (see fig. 6.31). The theory for replacement was confirmed later by the cross sections. Mounted samples from the arms (fig. 6.26) showed many more layers than the samples from the legs, and there were strong elemental differences between the samples. SEM-EDS results also suggested a heavier use of vermilion and orpiment content to clay particles compared with the legs.

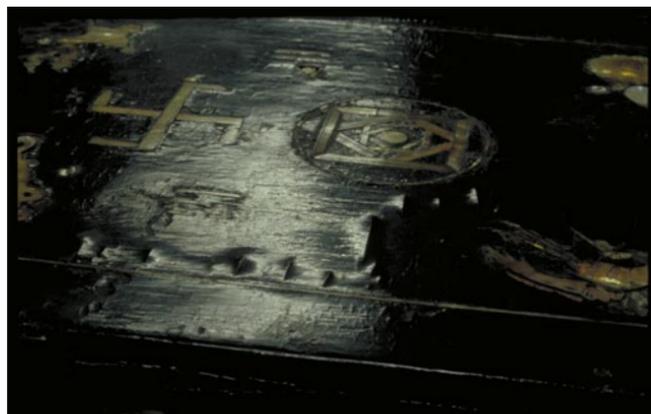
Fig. 6.02. Box (B60M292), detail of lid showing tented cracks in lacquer and faint orange-peel texture characteristic of lacquer that failed to dry properly.

This simply made box, like so many lacquered objects, shows the effects of storage, at some stage in its history, in inappropriate conditions. The lid has warped, with the upper surface curving away from the sides (fig. 6.1). Splits in the surface of the lacquer have cupped and tented, indicating shrinkage of the wooden carcass (fig. 6.2). In addition, the surface network of finer cracks suggests a weakness within the lacquer itself. In such a case, the first stage of the treatment would normally be to stabilize the object by placing it in a controlled environment of between 50% and 55% RH (relative humidity) at 20°C for as long a period as possible, three months being a likely minimum. The object should be monitored frequently to observe any changes. If the warping and shrinkage are observed to be reducing, the object should be left in the controlled environment until no further dimensional changes are observed. This object has been stored for several decades in a stable environment of approximately 55% RH, so it seems likely that this process of stabilization has already taken place. However, care should be taken to monitor the object when it is brought to the conservation laboratory for treatment. It is not unknown for storage facilities that are generally kept at stable temperature and humidity levels to have small areas where the conditions fluctuate or differ from the overall levels.

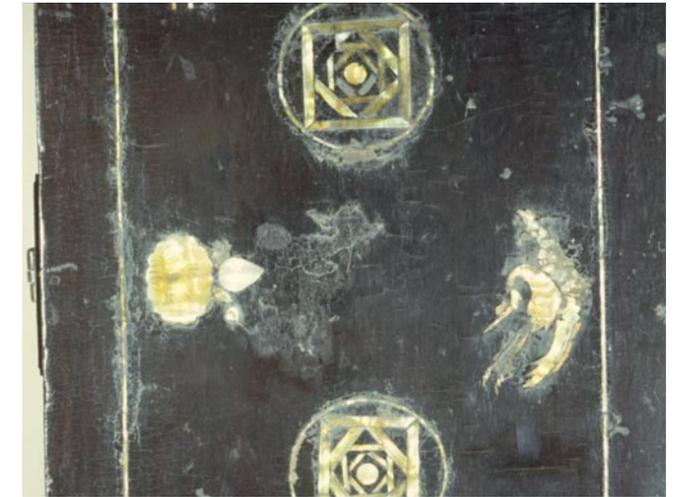
Fig. 6.4. Box (B60M292), detail of lid showing evidence of previous repairs.

for the insects to enter the wood. These insect holes are marked by the use of odd fragments of shell to fill them (fig. 6.4). The same bits of shell were applied to the wing of one bird on the lid where inlay is missing. As noted by Ms Jaeschke, a dull, dark gray material that absorbs long-wave ultraviolet light acts as a bed for these fragments and is smeared onto the lacquer surface around these losses. The same material has been smeared over and around one inlay bird on the back of the box.

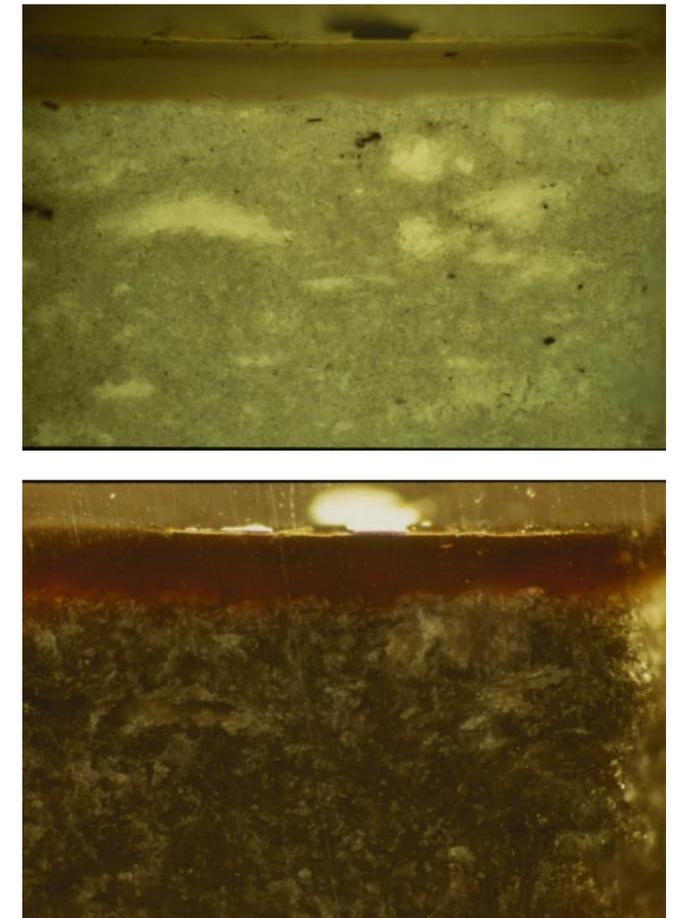
Top: fig. 6.05a. Box (B60M292), cross-section sample of surface layers shown in reflected light and ultraviolet light; photo taken at 200x magnification.

Bottom: fig. 6.05b. Box (B60M292), cross-section sample of surface layers shown in ultraviolet light; photo taken at 200x magnification.

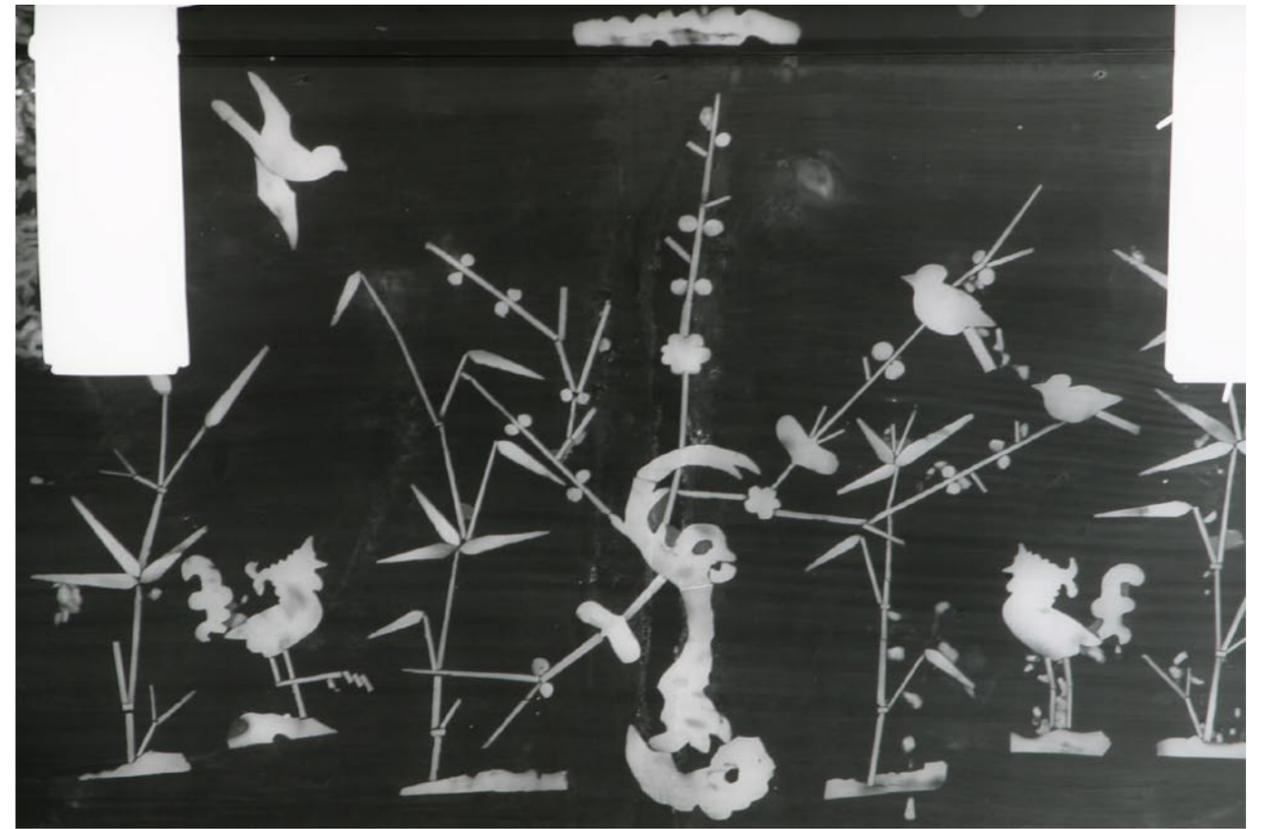
Fig. 6.7. X-radiograph of back, box (B60M292). Technical data: Gulmay X-ray unit (320 kV max.), Kodak Industrex AA film, 25 kV, 4 mA, 60 seconds, distance from tube, 36 inches.

This box was extensively restored before being accessioned by the museum. X-radiographs were very helpful in clarifying the extent of damage and location of repairs (see figs. 6.6 and 6.7). The box sustained extensive insect damage. Small (approximately 2 mm in diameter), scattered, roughly oval exit holes are found throughout the box, with extensive tunneling in localized areas such as the upper back corners. These damages were covered with fills that are more radio-opaque than the surrounding areas and were then coated with lacquer. Fills that have the same appearance as these in X-radiographs and are also coated with lacquer are found surrounding much of the inlay on the lid (see, for instance, area at the center of fig. 6.4). This suggests that mechanical damage to the lid was repaired at the same time as the insect damage. The concentration of the fills around the inlay further suggests that at least some of the inlay was replaced in this restoration. One loss to an inlay cloud on the back of the lid was filled level with the surrounding inlay and relacquered in this campaign, with no attempt to recreate the missing inlay.

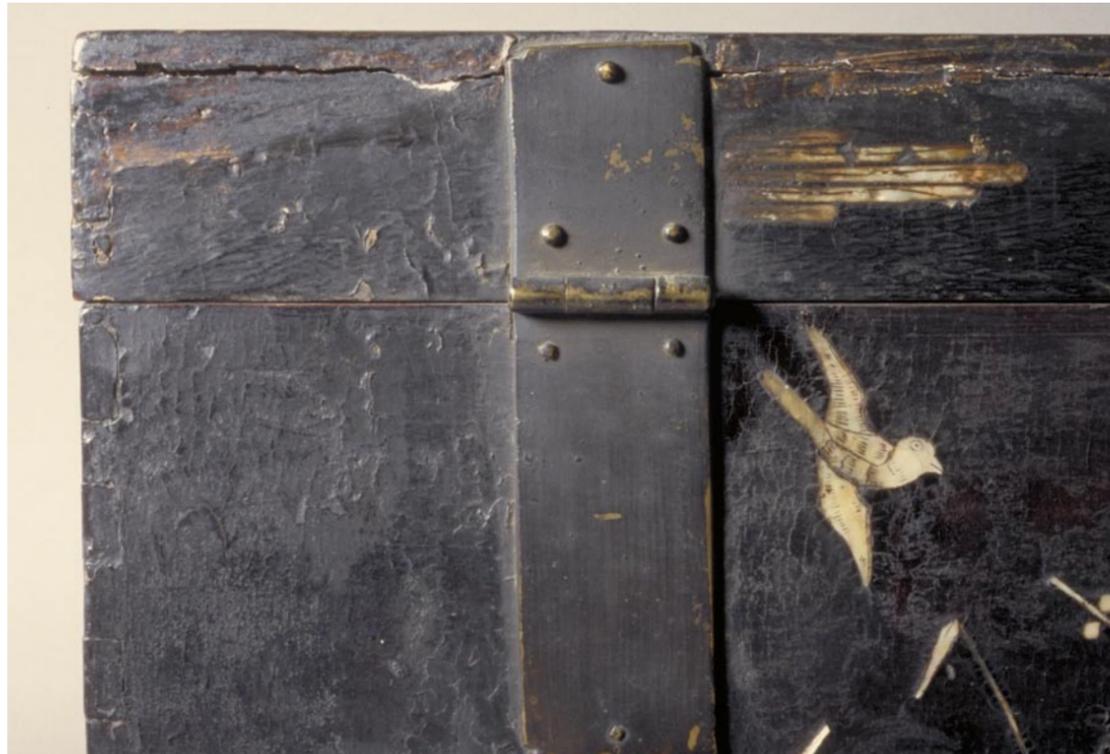
Fig. 6.8. Box (B60M292), back side.

can securely be identified as replacements. They lack the shellac coating and do not relate to the peony next to them. The phoenix on the back that is smeared with the dark fill material also lacks the shellac coating (see fig. 6.8), but it is otherwise consistent with the other inlay, so it may simply have been reattached.
