# *The Conservation of Asian Lacquer*

Case Studies at the Asian Art Museum of San Francisco

By Jane L. Williams

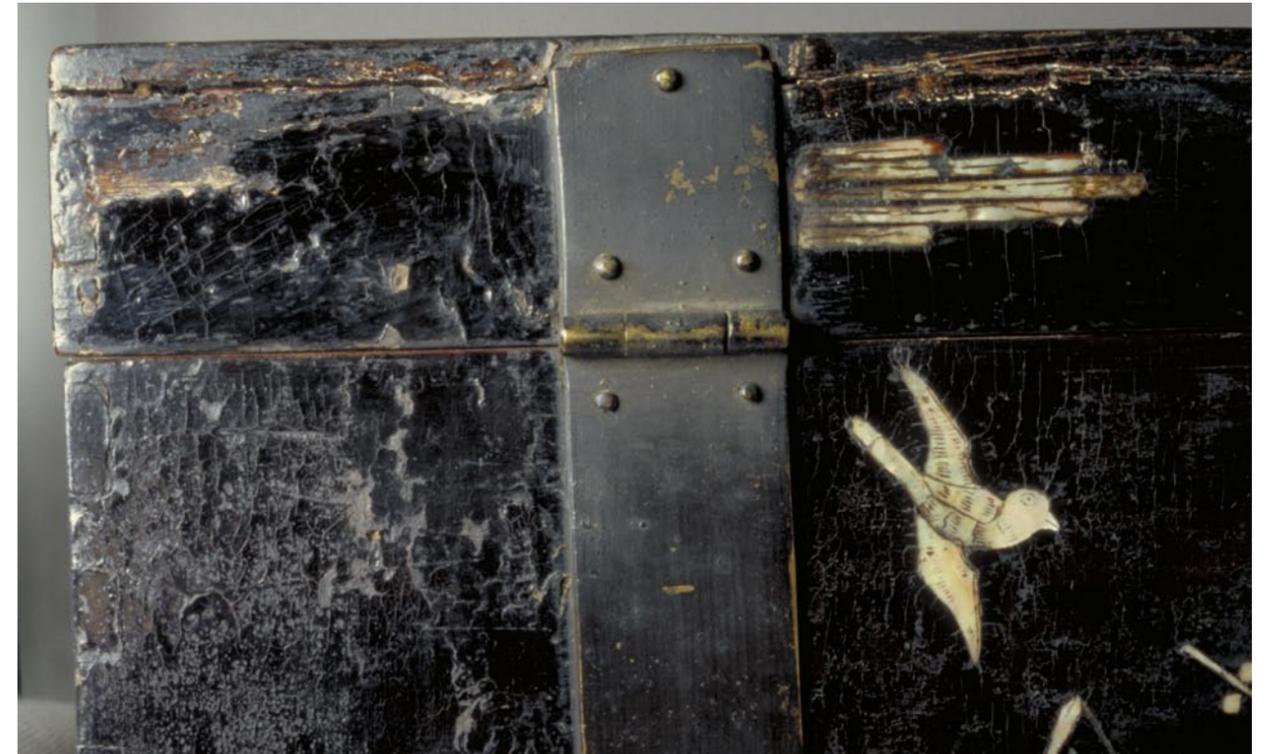
Fig. 6.9. Box (B60M292), detail of back side after cleaning test.

The old repairs and surface coatings were left in place. However, a cleaning test was done on the back to assess the condition of the underlying lacquer and to determine whether the dull, hazy surface appearance could be improved (to compare the surface before and after cleaning, see figs. 6.3 and 6.9). The sides of the box have a dull warm fluorescence in long-wave ultraviolet light that I originally attributed to a thin coating of the shellac that was applied thickly to the lid. Of the solvents tested, ethanol and Stoddard solvent were the only ones to have an effect on the surface. A combination of the two in equal parts was most effective in removing the surface coating that now appears to be a thick applica-

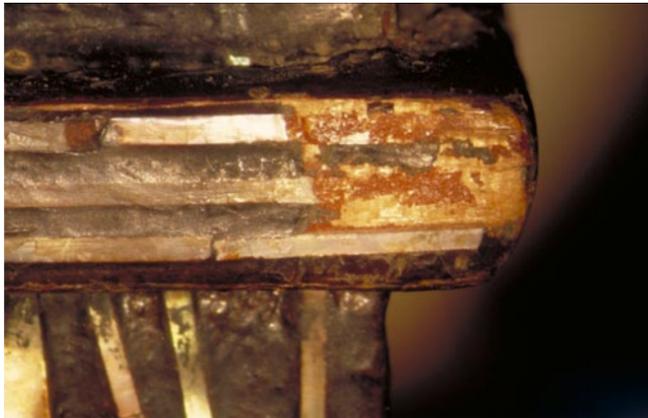
Fig. 6.11. Inkstone cabinet (B62M18), detail; note use of red ground layer applied overall prior to application of shell inlay and use of gray ground layer to fill around shell inlay before applying lacquer coating.

Losses to inlay and lacquer on this box reveal more clearly than on any of the other mother-of-pearl inlaid boxes the sequence of the surface decoration. There is no evidence of textile or paper layers on the surface. The first layer on the surface is a red ground. Ms Jaeschke noted this layer, but did not have a chance to determine whether it was original or related to a repair. With examination under magnification this layer can be found throughout the box. In cross section (see fig. 6.12) it can be seen to consist of three separate applications, identified by analysis as red clay and calcium carbonate in a protein binder, each application containing successively more binder and fewer mineral inclusions.<sup>8</sup> These red ground layers are soft and somewhat sticky—the final application served as the adhesive for the mother-of-pearl. The red clay appears to have been added to the ground to give the shell a warmer color. Once the shell was adhered in place, linear designs were incised in the shell surfaces and then a gray foundation layer was applied to bring the rest of the surface close to the level of the inlay (fig. 6.11). This layer is bulked primarily with charcoal and clay, and also has a protein binder.<sup>9</sup> Finally the surface was coated overall with thin layer of unpigmented lacquer and then polished to expose the inlay again. Some of the inlay remains partially or totally submerged in the lacquer layer, which would usually be considered evidence of relacquering. However, the cross sections taken from the lid (see fig. 6.12) and side show a single application of lacquer.

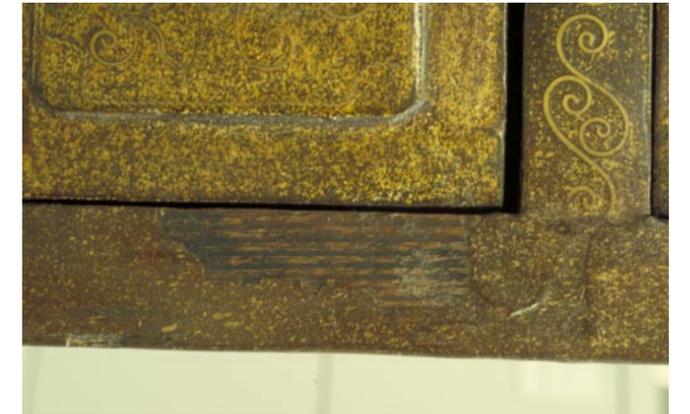
Fig. 6.15. Cabinet (B65M31), detail of surface loss showing grain of hardwood framing.

at risk of further damage if the distorted area is left unsupported. Areas of loss may be gapfilled as described for B60M292. If possible the wood of the carcass should first be documented and identified from the grain revealed (see fig. 6.15).

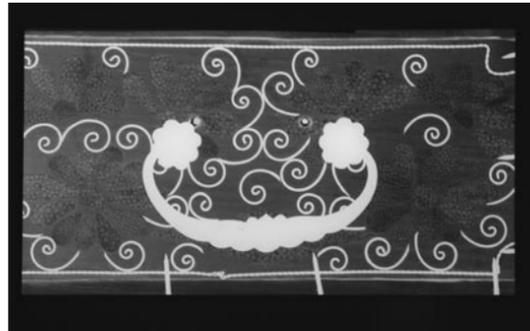
Fig. 6.16. Cabinet (B65M31), X-radiograph of drawer front; note presence of metal in holes for an earlier handle and current use of wire nails in the joints. Technical data: Gulmay X-ray unit (320 kV max.), Kodak Industrex AA film, 25 kV, 5 mA, 60 seconds, distance from tube, 36 inches.

of the drawer supports, rather than to a ground layer as is typical and is found elsewhere on this cabinet—but was considered to possibly date to a restoration. All of the drawer fronts, except those behind the large doors, are made of the same hardwood. They were carved to have a raised central panel for the wire and rayskin decoration, and their interior top edge is beveled. As evidence of some age, the drawer fronts retain holes, covered on the exterior by surface decoration, from previous, smaller drawer handles. The placement of the previous, smaller handles would have interfered less with the decoration than the current handles do. In X-radiographs (see fig. 6.16), traces of metal are visible in some of the old holes. The X-radiographs also reveal twentieth-century wire nails in the drawer joints, but these could be from repairs.

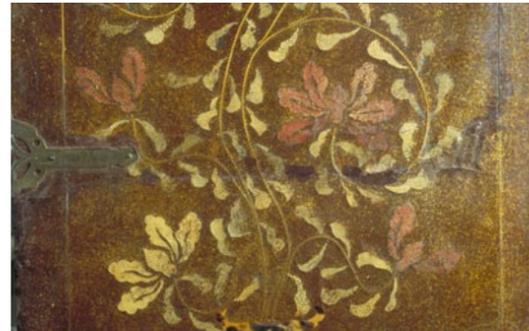
Fig. 6.17. Cabinet (B65M31), detail of side panel; the pinkish restoration follows a horizontal crack along a crossbrace where the panel is pieced.

The cabinet underwent a more superficial, though not light-handed, restoration, probably in the West. In this restoration a dark pink fill was applied to losses along the edges and along gaps that had opened at joints in the decorated panels (see fig. 6.17). A large crack and loss to the back panel was glued and patched with new wood in this repair. The fills were surfaced with dark red paint, sprinkled with fine white me-

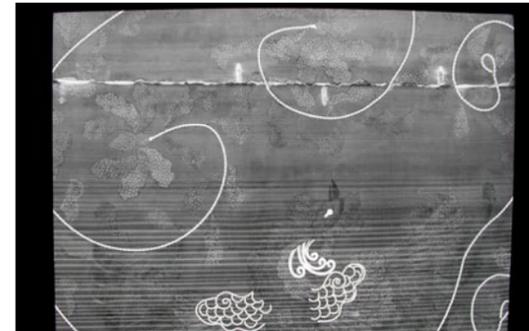
Fig. 6.18. Cabinet (B65M31), X-radiograph of lid; note discontinuous nail holes along joint in wood. Technical data: Gulmay X-ray unit (320 kV max.), Kodak Industrex AA film, 25 kV, 5 mA, 60 seconds, distance from tube, 36 inches.

corporate crossbraces. This method of construction, presumably on the doors intended to reduce warping, does a poor job of creating a solid panel for decoration. Cracks have opened in the surface of the decoration along these joints (see fig. 6.17). The interior surfaces of the side panels cannot be assessed because they have been lined with newer wood panels. The back panel also appears new. The liners and the back are crisply and crudely swan, unworn and unoxidized. The top panel, identified as pine,<sup>13</sup> is the only panel with beveled ends and a worn, dark blue paper lining, lending support to the possibility of its having some age. X-radiographs taken of the top panel and the large doors (see figs. 6.18 and 6.19) provided the final proof that the cabinet is a modern assemblage. The X-radiographs showed that the decoration on these panels, too, was applied to pieces of wood reused from another object or objects. What looks like a crack in the paper lining and wood of the top is actually a joint between two pieces of wood that were not originally joined. Nail holes are visible on one side of the joint and not on the other (see

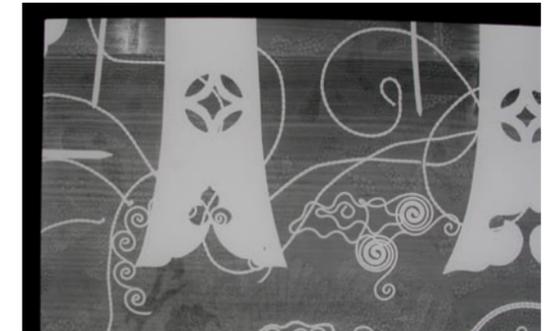
Fig. 6.19. Cabinet (B65M31), X-radiograph of large door; note discontinuous nail holes along wood joints and current use of wire nails in these joints. Technical data: Gulmay X-ray unit (320 kV max.), Kodak Industrex AA film, 25 kV, 5 mA, 60 seconds, distance from tube, 36 inches.

fig. 6.18). The large doors show the same reuse of wood from another object (see fig. 6.19). The wire nails visible in these X-radiographs are now understood as part of the modern assemblage.

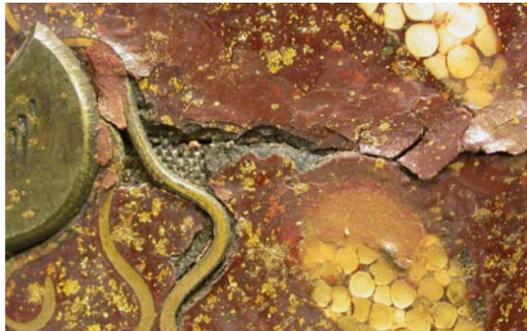
Fig. 6.20. Cabinet (B65M31), detail of front surface showing metal wire and rayskin inlay applied to the textile underlayer.

rectly to the textile (see fig. 6.20). Drawn wires were used—one of the wires lifting from the surface on the stand was clearly formed with a drawplate.<sup>16</sup> Tortoiseshell inlay appears only on the cabinet sides and the interiors of the large doors. On the sides and one of the doors it appears to have paper behind it, but on the other door the plain-weave textile is clearly visible behind the shell. The rayskin inlays are colored yellow, green, and red—the colorants were not analyzed.<sup>17</sup> In X-radiographs of the small door, it looks as though the bat-shaped rayskin inlay pieces have been repositioned.

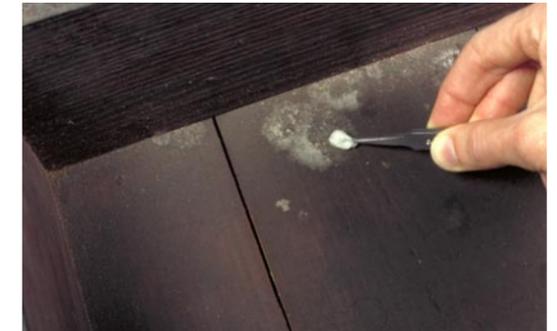
Fig. 22. Removal of mold from interior drawer of cabinet (B65M31), using adhesive.

Once it was determined that the cabinet is a modern pastiche, the decision was made to not treat it. The only treatment undertaken was to remove the mold from the interiors of the drawers. On the advice of the museum's paper conservator, Debra Fox, to contain the spread of the mold spores into the air, the mold was lifted from the surface using wads of a tacky, dried adhesive<sup>20</sup> wrapped around tweezers to form a wand (see fig. 6.22). The drawers were then cleaned using a vacuum equipped with a HEPA filter and wiped with cotton Webril Handi-pads moistened with isopropanol. Custom Tyvek covers (as shown for the chair in fig. 6.36) were stitched for the cabinet and its base. □

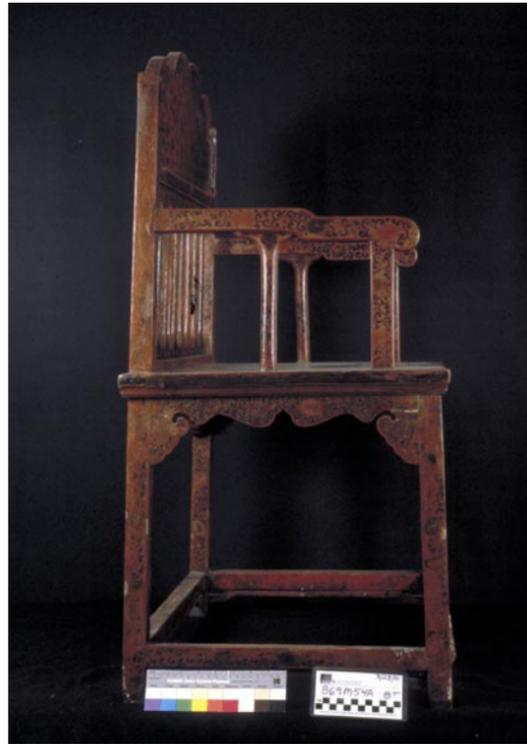
Fig. 6.24. Lacquer chair (B69M54a), proper right view before treatment; note losses down edges of legs.

This piece is one of a matching pair with an unusual asymmetric design in red and brown lacquer. There appear to have been several phases of repair, most using a powdery white gapfill (resembling plaster of Paris) that has been painted to match (fig. 6.24). Any examination of this item should be carried out in conjunction with the matching chair.

Again, the choice and extent of the treatment will depend on the assessment of the nature and importance of the repairs. If they are to be retained, the repairs themselves may require consolidation with a solution of an acrylic resin such as Paraloid B-72 in acetone or a similar suitable solvent (as described for B60M292) to protect them from further loss. It may be necessary to explore small areas of the repairs to discover whether they obscure a damaged original surface or whether they were applied to the bare surface of the foundation or the wood carcass. If they are to be removed, they will need to be documented and the material removed kept for reference, as described for the repair inlays on B60M292. Mechanical cleaning with a polished scalpel may be sufficient to remove the rather powdery gapfill, possibly followed by cleaning with swabs of a suitable cleaning solution. Distilled water and acetone have both proved useful in the past for removing plaster of Paris, but any solution used must be tested on the area carefully before use. The surface of the remaining lacquer appears considerably worn and may require very careful cleaning to ensure that no traces of what remains of the original surface are removed.

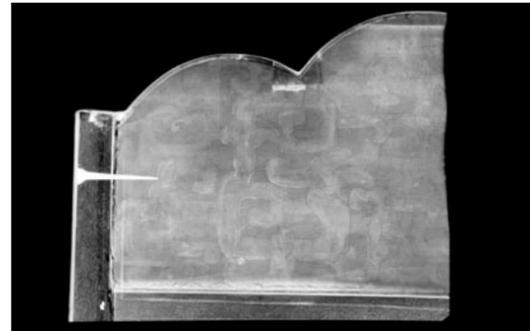
X-radiographs and analysis of cross sections provided the evidence for this restoration. The cresting rail was more radio opaque than the rest of the chair indicating that a different timber or surface coatings had been used. We also found on the X-radiographs outlines of old mortises that had been filled with wood (see fig. 6.28). Two of these were at the top of each stile; suggesting that a rail crossed at this point and the stiles had been cut down. Two further former mortises appeared at the junction of the first and second lobes of the cresting rail suggesting that this piece of timber was taken from an existing object and lacquered to match the scheme of the chair. Furthermore, attachment of the cresting rail to the stiles was by means of two ferrous metal (2.5 inches/64 mm) cut nails driven rather than the common cabinet making techniques found elsewhere on the chair.

Fig. 6.28. X-ray of cresting rail on lacquer chair (B69M54a), showing use of handmade ferrous nails. Technical data: Norelco X-ray unit (150 kV max.), Kodak Industrex AA film, 45 kV, 5 mA, 120 seconds, distance from tube, 36 inches.

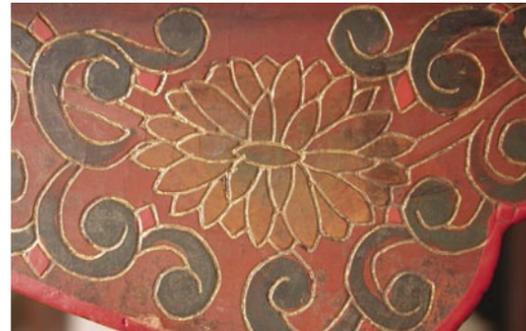
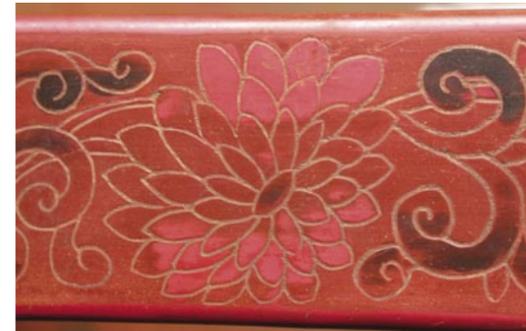
Cleaning the Western coatings and toning from the chair revealed that the appearance and condition of the arms and their supports was quite different from the original sections of the chair and from the cresting rail. The arms appeared in a relatively good condition with few losses to the surface, and the lacquer was noticeably redder in color from the orange brown tones of the rest of the chair. In addition, the scroll work was executed in black lacquer as opposed to green, there was no gilding present in the incised lines, and the execution of the scroll and flower decoration was stylistically different (compare figures 6.29 and 6.30).

Fig. 6.29 Lacquer chair (B69M54a), detail of scrollwork from legs showing original decoration.

Fig. 6.30. Lacquer chair (B69M54a), detail of scrollwork from replaced arms.

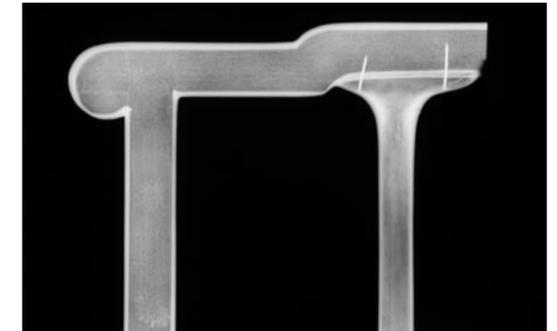
Fig. 6.31. X radiograph of arm on lacquer chair (B69M54a); note fineness of decoration. Technical data: Norelco X-ray unit (150 kV max.), Kodak Industrex AA film, 45 kV, 5 mA, 120 seconds, distance from tube, 36 inches.

than the original work (see fig. 6.31). The theory for replacement was confirmed later by the cross sections. Mounted samples from the arms (fig. 6.26) showed many more layers than the samples from the legs, and there were strong elemental differences between the samples. SEM-EDS results also suggested a heavier use of vermilion and orpiment content to clay particles compared with the legs.

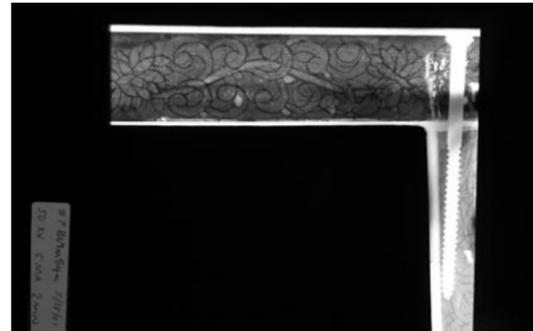
(See fig. 6.32) The countersink appeared to be filled with sawdust and an adhesive which was water soluble and had the characteristic crystalline appearance of aged hide glue. This had also been applied to many edge losses and over the gray insoluble filler found around the base of the arms. Although, it also had remained stable, some of these fills were reduced during the cleaning process.

Fig. 6.32. X radiograph of arm on lacquer chair (B69M54a), showing attachment using a modern 3/16-inch screw. Technical data: Norelco X-ray unit (150 kV max.), Kodak Industrex AA film, 50 kV, 5 mA, 120 seconds, distance from tube, 36 inches.

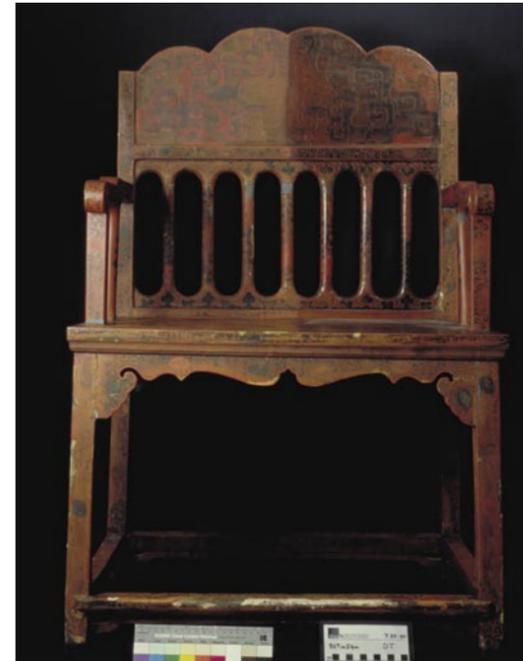
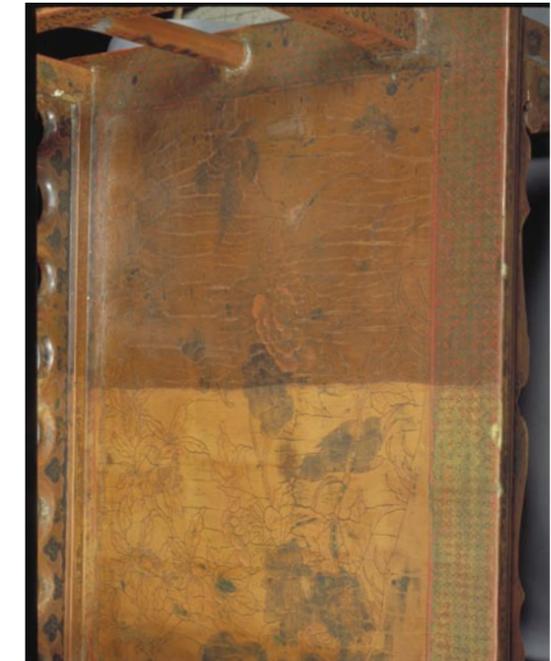
Fig. 6.33. Lacquer chair (B69M54a), half-cleaned front view

Fig. 6.34. Lacquer chair (B69M54a), half-cleaned seat

swabbing by holding the solvent ethanol in a 2% Klucel GF gel. This was no more satisfactory. Due to the relative insolubility of this coating we decided its removal was necessary and chose N-methyl-2 pyrrolidinone because it quickly removed both coatings, thereby limiting exposure of the surface to solvent and not damaging the lacquer surface. Due to the slow evaporation of this solvent, once applied, it was quickly removed with Webril Handi-pads to prevent excessive exposure of the surface to the solvent. All solvent cleaning was performed with extraction. Removing the Western coatings revealed that the lacquer was in fact an orange brown color, much lighter in appearance than before (see figs. 6.33 and 6.34). In addition, the lacquer

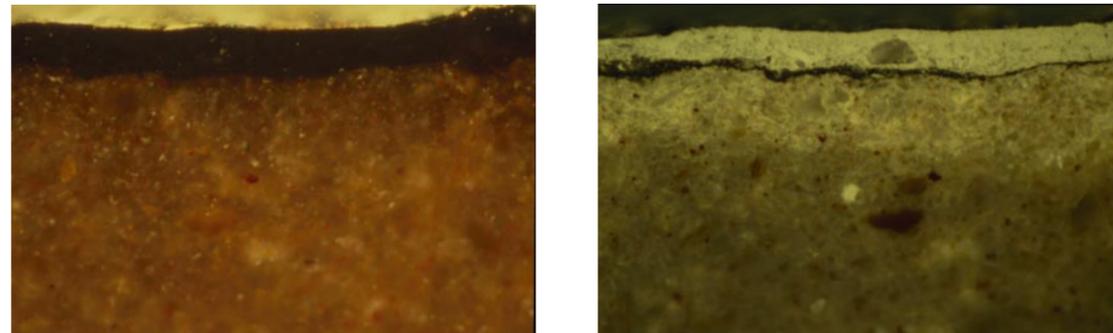
There are multiple layers of preparatory grounds, lacquer, and gilding on the sculpture (see fig. 7.7). The lowest (oldest) visible surface layers consist of a pinkish ground identified as mainly kaolin and quartz in a protein binder, covered with a thin dark lacquer and gilding (fig. 7.8). In one area traces of a second thin application of gilded lacquer are visible. Most of what remains on the figure, however, is a later, thick, gray preparatory ground layer, covered with a reddish brown lacquer, and then gilding.

Fig. 7.8 Cross-section sample of surface layers on Sho Kannon (B6oS420) shown in reflected light (left) and ultraviolet light (right); photo taken at 400x magnification.

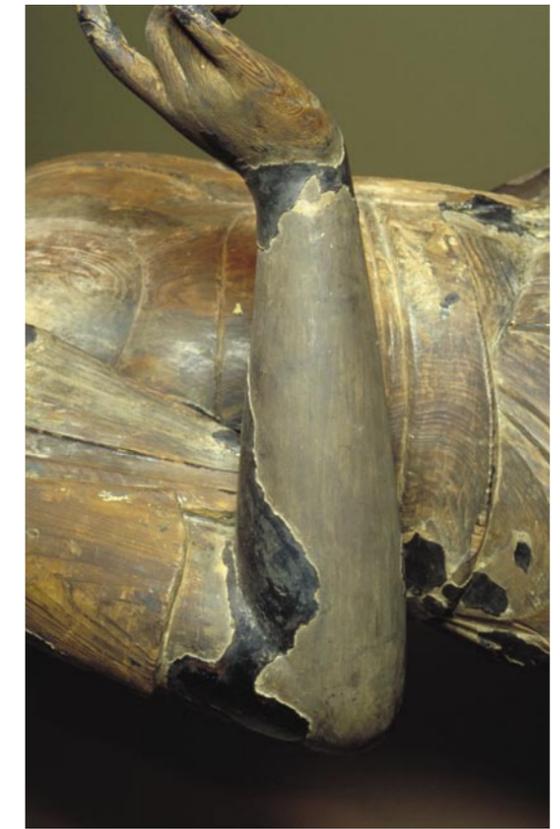
Perhaps at the same time the black coating was applied, the pinkish ground now exposed at the joints was painted to look like wood. The right forearm is a replacement. It is also entirely covered with this faux wood-grain finish (see fig. 7.9) and has a much lower radiodensity than the adjacent wood. In many areas, there is evidence of attempts to remove the later layers (from the thick gray ground layer up) with a sharp tool (see fig. 7.7). It is likely that this proved to be too time-consuming and the uneven patches of remaining gilding and exposed ground layers were instead covered with black paint and wood graining.

Fig. 7.9. Replacement forearm on Sho Kannon (B6oS420).

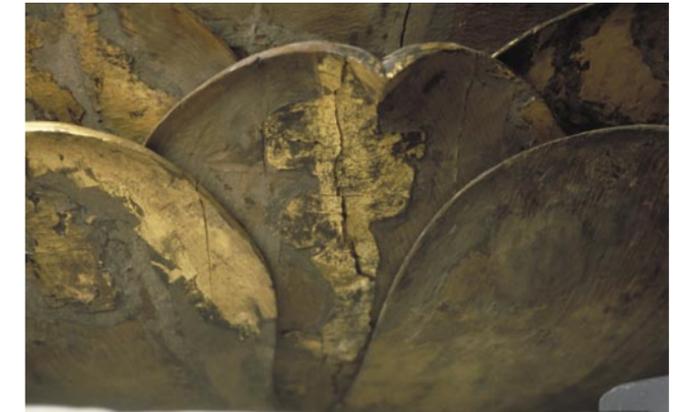
Fig. 7.12. *Amida sculpture (B6oS10+)*, detail showing splits in wood and cracked and lifting surface layers on a lotus petal on the base, before treatment.

ing to lift and flake in numerous places. In 1997 treatment focused on the sculpture itself. Currently the most actively flaking gilded lacquer is found on the older, upper four tiers of the base. On these tiers, the gilding and lacquer generally remain well adhered to the shitaji, which is thick and appears to be well bound. These layers are separating from the wood in large sections at the interface of the shitaji and the wood. The worst flaking is on the petals of the lotus (rengé), where large areas of lacquer are curling and pulling away from the wood. Some damage has occurred to the floral plate (keban), where lacquer covers a convex surface and shrinkage of the wood has left a shell of unsupported lacquer that has been cracked and crushed at some point. There is another area of damaged lacquer on the floral plate, where the underlying wood shrank and split open, causing the lacquer to split and become unsupported over the wide crack (see fig. 7.12).

The two wide-open splits bridged by unsupported lacquer, one in the same lotus petal just described (see figs. 7.12 and 7.21) and the other in the underside of the floral, bridged by unsupported lacquer were filled with a weak mixture of cellulose powder with just enough methyl cellulose to hold it together. The splits are not posing a risk of greater structural damage, but cannot be closed and will probably continue to move, so I was looking for a weak, compressible material to fill the gaps and support the lacquer surface. If there were greater access to the gaps, I might use a piece of soft, polyethylene foam. However, since the lacquer largely covered the gaps, I needed a fill mixture I could insert through the open cracks in the lacquer. The lacquer and ground layers on the figure and base were found to be unaffected by water, ethanol, acetone, Stoddard solvent, and xylene. Lifting lacquer on the base and figure was consolidated with hide glue. The unstable lacquer was distorted and my preference was to use moisture rather than heat to relax the lacquer layers. Hide glue was chosen because it had been used before and the specific areas known to have been consolidated with it (those documented in 1997) have remained stable. PVA emulsion had been used as well, but some of the areas where it appears to have been used had released again before the 1997 treatment and were released now. Because the lacquer on the figure was likely to continue to be a problem, I also felt that hide glue provided more options for future

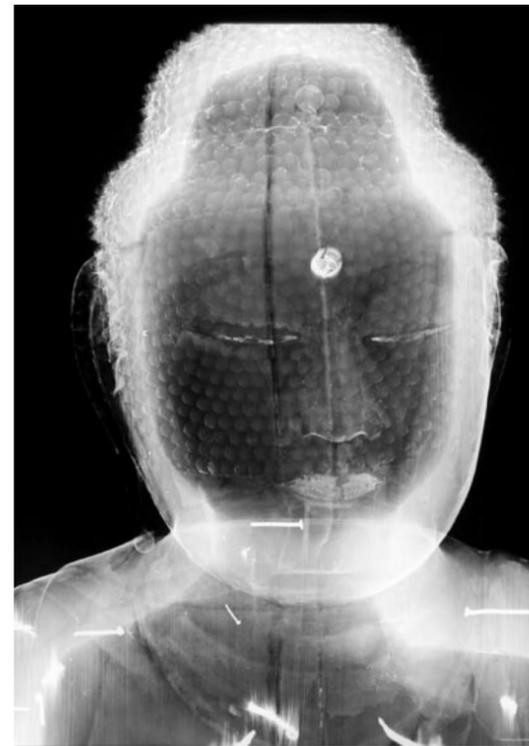
Fig. 7.14. Amida sculpture (B60S10+), X-radiograph of head. Technical data: Gulmay X-ray unit (320 kV max.), Kodak Industrex AA film, 35 kV, 5 mA, 60 seconds, distance from tube, 36 inches.

In X-radiographs, it is possible to see that both bamboo or wood dowels and hand-forged, now heavily corroded, nails were used to secure most of the joints in the body (see figs. 7.14 and 7.15). It is not known which hardware was used in the original construction and which dates to a previous restoration. Coarse plain-weave textile strips at one time reinforced all of the joints on the interior of the sculpture, except the joint through the

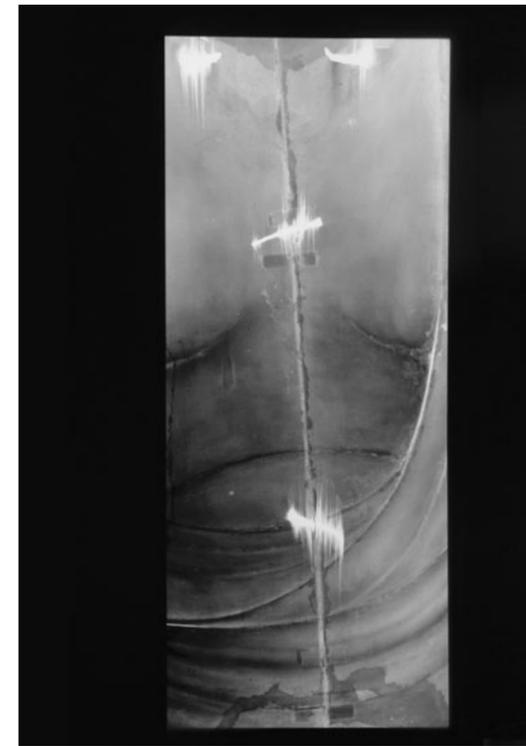
Fig. 7.15. Amida sculpture (B60S10+), X-radiograph of front of torso. Technical data: Gulmay X-ray unit (320 kV max.), Kodak Industrex AA film, 25 kV, 5 mA, 60 seconds, distance from tube, 36 inches.

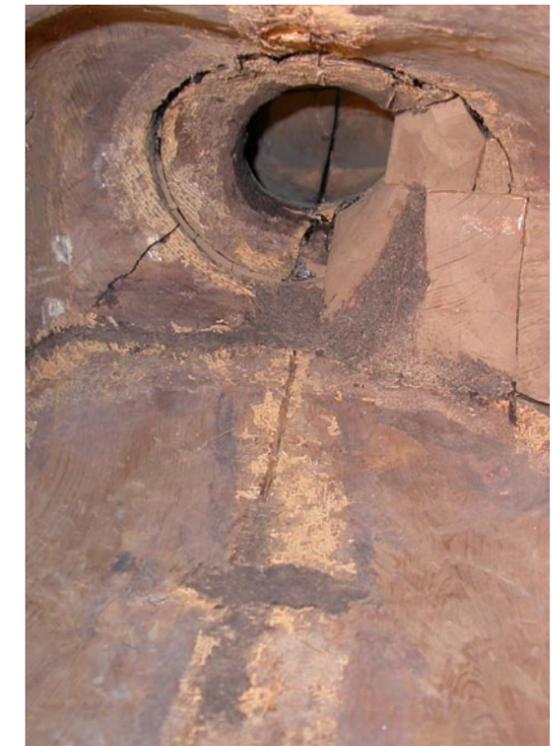
center of the head. The textile was applied with a natural adhesive, perhaps starch based, that was particularly appealing to insects. Where the textile was applied to the interior, the wood surface is very specifically and very extensively damaged by insects (see fig. 7.16). The exterior was covered entirely with a layer of loose (10 threads per cm), plain-weave textile. Cross-section samples of the layers covering the textile from various locations on the figure were compared. Unlike the Sho Kannon (B60S420), on this sculpture only one scheme of surface decoration was found

Fig. 7.16. Amida sculpture (B60S10+), interior of upper torso.

Probably in the twentieth century and most likely in Japan the sculpture was taken apart and reassembled, with wire nails (almost all visible in only X-radiographs) and a coarse paste that looks like kokuso used as an adhesive and filler (see fig. 7.16).

der. The shoulder was reconstructed from a clumsy assemblage of blocks (see fig. 7.16), two of which are held together by a wire nail. The blocks are glued together with what appears to be an emulsion-based wood glue: in visible light it is a semiopaque tan color and in UV light it fluoresces a hazy whitish color. In order to fit the replacement wood into the shoulder, the restorers apparently made many adjustments to the head and neck. Thin wedges of the same replacement wood were fitted in between original blocks on the other side of the neck. The two original halves of the head were split in half vertically along the axis of the ears, then the ears were sawn out on roughly rectangular sections and fitted back in with clumsy wedges (see figs. 7.18 and 7.19). The current joins in the head were secured with a dark resin, rather than the kokuso found elsewhere. It is only clear that all the pieces of the head are original to the head because the wood grain continues across the side joins and the ears. The head appears to be original to the body because the join between the two is reinforced with the same insect-damaged textile found on the rest of the original joins.

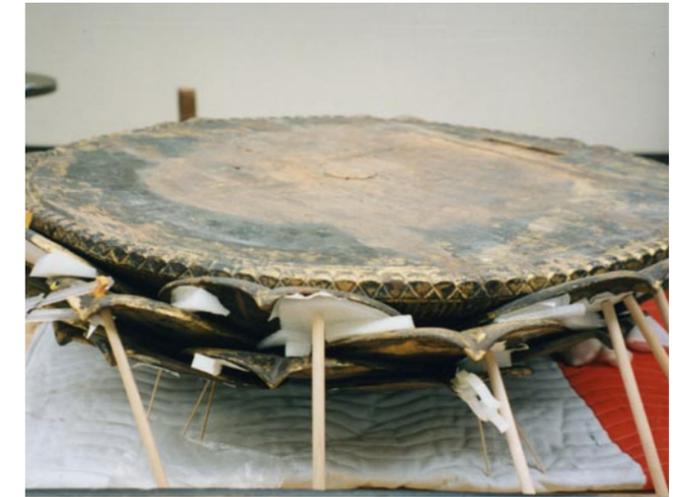
Fig. 7.22. *Lotus base of Amida sculpture (B6oS10+)* during treatment, showing clamps and wood dowels used to apply pressure during surface consolidation

retreatment. PVA emulsions, particularly when applied thickly as they have been on this sculpture, create a somewhat sealed surface, resistant to penetration or dissolution by a range of solvents. The ground in the area with lifting lacquer was preconsolidated with dilute hide glue with a few drops of alcohol. After about twenty-four hours the lacquer was set down with more concentrated hide glue. On the base I used a combination of small clamps and wood dowels set up on the same principle as shinbari (see fig. 7.22). At the time I did not have a better range of wood dowels or bamboo sticks of various thicknesses for applying pressure and nor did I have the space or time to construct a framework that could accommodate the sculpture or base and apply pressure in three dimensions. However, even with my rudimentary setup, the wood dowels were very useful for applying pressure to the surface. On the few spots of thin, lifting lacquer that I consolidated on the figure itself, I was able to use finger clamp-

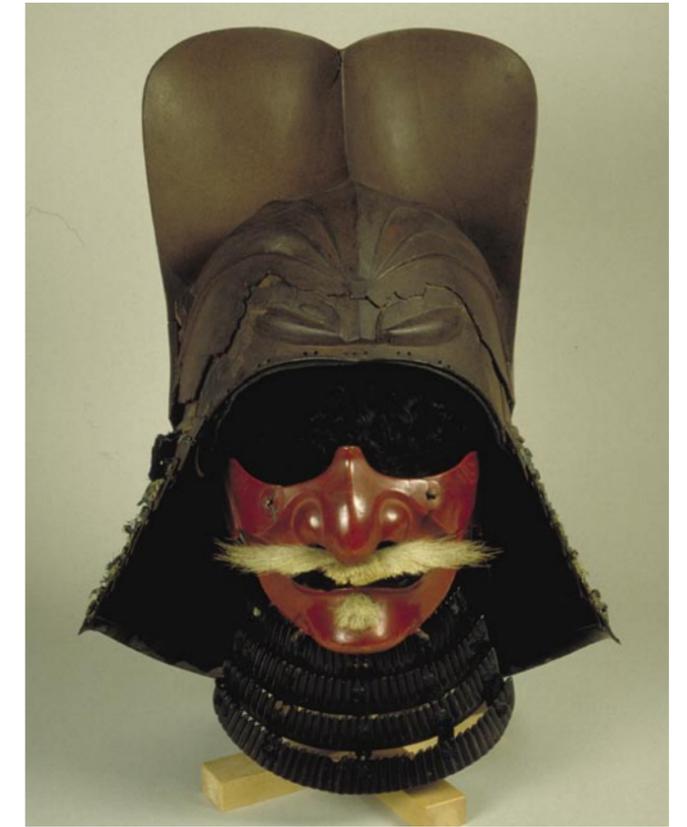
The lacquer layers are detached overall, cracked, and lifting (see fig. 7.27). Significant areas have been lost. The urushi layers on the

Fig. 7.27 Helmet and half-face mask (B87M22a,b), before treatment.

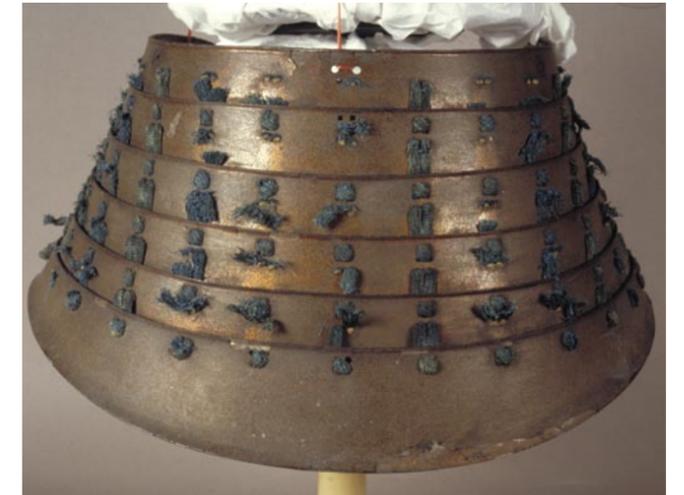
The six-lamellae neck guard (*shikoro*) is finished to match the helmet and presents a similar dull and dusty appearance. It is in somewhat better condition but is actively flaking in many places and has suffered some losses to the *urushi* coatings, especially along the uppermost and lowest lamella. The indigo silk braids supporting the neck guard are degraded, have snapped in several places (see fig. 7.29), and parts have been lost.

Fig. 7.29. *Neck guard of helmet (B87M22a)*, showing damaged braids.

The silk braids supporting the neck guard (shikoro) are degraded and several have torn. In most Japanese and some Western collections, weak and degraded braids are replaced with specially made duplicates. Western practice usually demands that the braids are retained in situ and various methods are used to achieve this. They can be chemically consolidated, but this often alters their appearance and reduces flexibility. They can be individually reinforced with textile supports held in place with adhesives or fine stitches, but this rarely strengthens the areas of greatest wear. A more sympathetic method is to

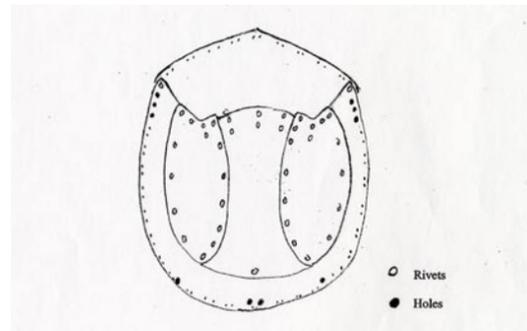
Fig. 7.30. *Helmet (B87M22a)*, diagram of iron helmet bowl construction.

The iron structure of the helmet bowl, or hachi, is completely obscured by the surface coatings. It can, however, be seen and felt through a large rip in the cap lining. The bowl is constructed of five iron plates that are riveted together (see fig. 7.30). Forging was used to raised brow ridges in the front of the bowl. The composition of laminated paper (harikake) structure that was then attached to the iron bowl is partially visible where the lacquer has cracked. Laminated paper is also visible in cross-section samples taken from damaged areas (see figs. 7.31 and 7.32). The layers of fibrous paper would have been pasted together over a wooden form and dried. When

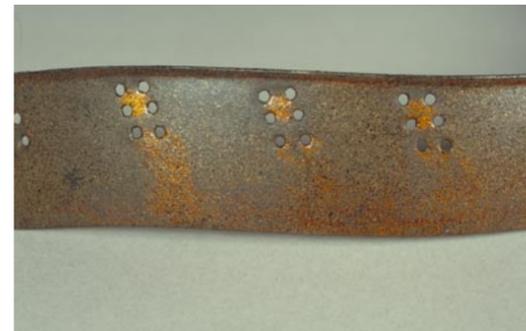
Fig. 7.31. *Helmet (B87M22a)*, detail of neck guard showing difference between protected and exposed nashiji finish.

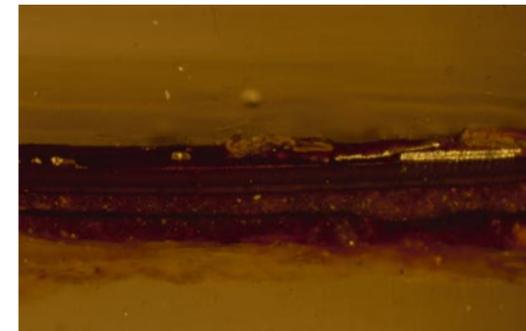
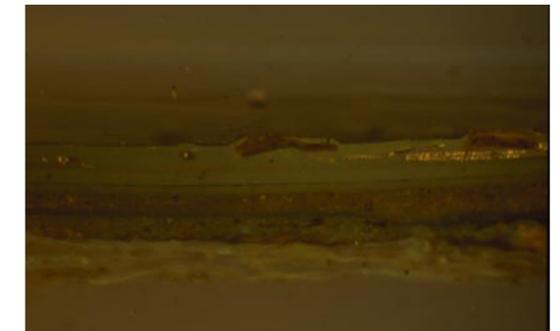
Fig. 7.32. *Helmet (B87M22a)*, cross-section sample of surface layers on front shown in reflected light (left) and ultraviolet light (right); photo taken at 200x magnification.

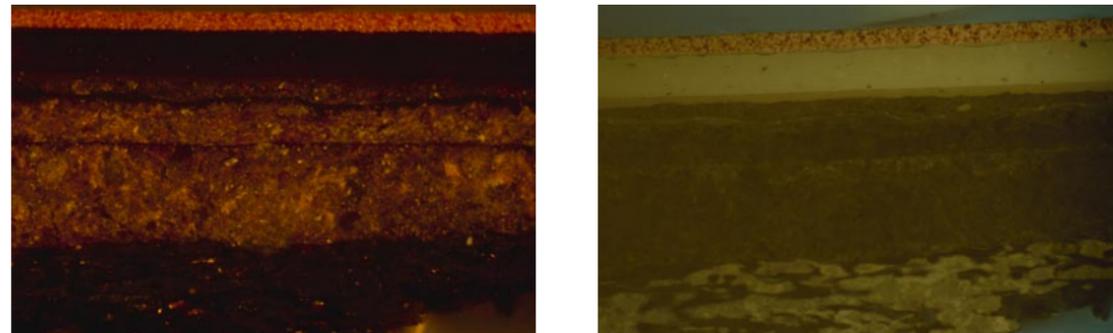
Fig. 7.33. Helmet (B87M22a), cross-section sample of surface layers on reverse shown in reflected light (left) and ultraviolet light (right); photo taken at 200x magnification.

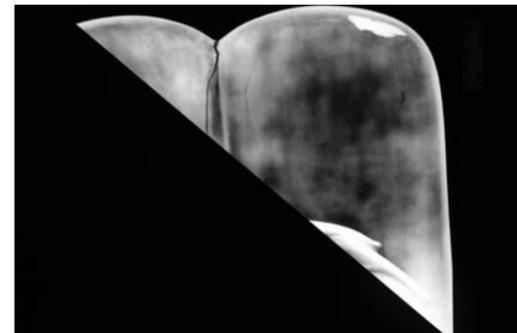
glossy brown black lacquer was visible under the red lacquer on the back of the helmet in a circular loss and along the edge where it meets the nashiji finish. X-radiographs of the laminated-paper part of the helmet (fig. 7.34) confirmed this supposition, by revealing a fill and a loss underlying the intact red lacquer. The aged, brown lacquer finish on the reverse was recoated with red lacquer, which explains why, as Mr. Minney noted, the back does not appear to have had the light exposure and aging that the front has. The helmet and neck guard would have originally matched, with nashiji on the front and unpigmented lacquer on the back. In many of the cracks and gaps on the red-lacquered areas of the helmet there is a thin residue of a fine, white, powdery material, possibly the residue of a fill now covered by the red coating. The red front of the face mask may also have been relacquered. There are a few spots on the nose and chin where the top layer of lacquer has spalled off and exposed another red layer.

Fig. 7.34. Helmet (B87M22a), X-radiograph of laminated paper superstructure. Technical data: Norelco X-ray unit (150 kV max.), Kodak Industrex AA film, 40 kV, 6 mA, 60 seconds, distance from tube, 36 inches.

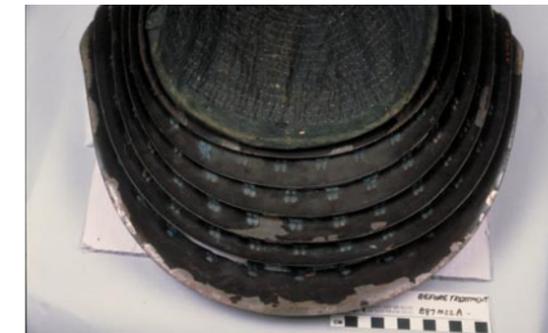
with thin brown or orange corrosion. The worst corrosion is found on the lower back edge of the helmet, where the laminated paper has separated from the metal, and on the reverse of the neck guard, where the lacquer is applied very thinly. Here large areas of lacquer are actively flaking and there are numerous detached or missing flakes (see fig. 7.35). There are also isolated warts of corrosion beginning to erupt through the lacquer. The laminated paper (harikake) and lacquer layers are cracked all around the helmet where they meet the helmet bowl, and are completely detached on the lower back. Across the lower front there is a wide horizontal crack through these layers and substantial losses to the lacquer, but the surface is still adhered to the metal in some places. There are large open vertical cracks on the sides of the superstructure and another through the top center that has sprung out of alignment. There are additional, closed cracks throughout the laminated paper superstructure.

Fig. 7.35. Reverse of neck guard before treatment, helmet (B87M22a).

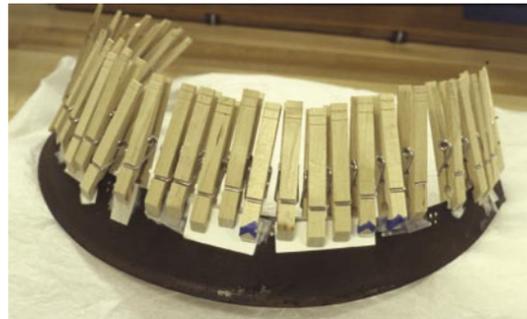
Fig. 7.36. Neck guard of helmet (B87M22a), showing clamping during consolidation of lacquer surface.

will bond well to the iron plates. Many conservators consider it to be stronger and more flexible than B-72. It also has good aging characteristics and should remain reversible over the long term. Although in some circumstances I still use PVA resins, their acidity makes them less suitable for metals. The lacquer on the neck guard retains enough flexibility where it is lifting to be flattened out without cracking and to regain good contact with the metal surface. Warts of corrosion under intact lacquer leave the surface uneven in many areas. The resin was introduced under the flaking areas with a small brush. A 5% solution in acetone was introduced first. When this had dried, a thicker, 15% to 20% solution in acetone (the highest concentration that would still flow under the lacquer) was introduced with a small brush. The lacquer was clamped in place (see fig. 7.36). The most effective clamps were small rare earth magnets, carbon-rod clamps, or wood clothespins used over stacked pieces of cotton blotter, to distribute the pressure evenly, and silicon-release Mylar. In some areas the consolidation had to be repeated.

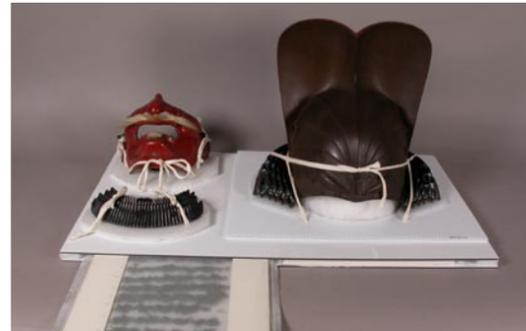
Fig. 7.37. Helmet and face mask (B87M22a,b), after treatment, showing storage support.

mount. If the silk braids were left as they are, as Mr. Minney suggested, even with support from a mount, the fraying and disintegrating silk fibers would continue to coat the lacquer surface and the area around the helmet, so containment of the braids was necessary. Because satisfactory adhesive methods for consolidating silk have not yet been found, I planned to encase each braid in a folded strip of silk crepe lined in place. In order to insert the crepe, the paper plugs would need to be removed from the lacing holes. I tried a test with one area and found that the manipulation needed caused additional losses both to the braids and to the surrounding lacquer (which could not be thoroughly consolidated with the braids in place). Thus I decided, given their extremely poor condition, to document the braids carefully, remove them, retain them, and replace them with like braids. In future treatments, I would always try first to preserve original textile elements in place. (An article written by conservators working for the Royal Armouries Museum, Leeds, England, gives excellent arguments and practical suggestions for retaining and supporting deteriorated textile components of Japanese armor in situ). Custom-made braids were thought to be the best way to match the color and weight of the existing braid. Fortunately, Setsuko Kawazu, a Japanese paintings conservator who was working in the lab, had learned to use a takadai (see note 25) and was willing to take on the task of making new braid. She used custom-dyed silk yarn and made samples until she had a braid of comparable weight and width to the existing braid and that would fit through the existing holes. A padded folder was made to house the braid remnants (see fig. 7.37). A shelf was made for the braid folders in the storage box made

The bent hairs on the mustache and imperial were straightened as much as possible by dampening individual hairs with a small sable brush dipped in deionized water and using tweezers to reposition them. The missing pins (hachi-tsukebyo) that connected the neck guard to the helmet were replaced with simple domed-head brass pins with split shanks. Padding was placed between the pins and the original surfaces. The missing tying cord (shinobi-no-o) and loops (shinobi-ne-o) to secure it to the kabuto were not replaced. Because the large tear in the cap lining allows access to interior of the helmet for examination and study, the decision was made not to repair it but simply to cover it with a layer of spun-bonded polyester. The padded display mount looks like a traditional wood helmet mount, but supports the helmet by its lower edge, so there will no longer be stress placed on the cap lining. When in storage, the helmet will rest on its lower edge on a padded support, with the neck guard extended flat behind it (see fig. 7.37). □

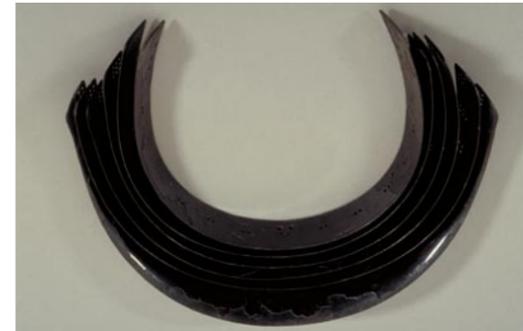
Fig. 7.38. Reverse of neck guard after treatment, helmet (B87M22a).

Instead I decided to apply a protective fill just to the edges of the remaining lacquer (about 2 to 3 mm from the lacquer) to make a gradual slope between the lacquer and metal. The fill would also support areas where slightly more of the ground layer than the lacquer had been lost, leaving the lacquer unsupported at the edge. A mixture of 20% B-72 in acetone bulked with Champagne chalk and dry pigments was used for the fill. This mixture was applied with a tiny spatula and smoothed with a spatula dampened with acetone. The exposed metal was cleaned with acetone and cotton swabs and, under magnification, rough corrosion was reduced carefully with a scalpel. I then coated the metal with pigmented B-72 in acetone (see fig. 7.38).

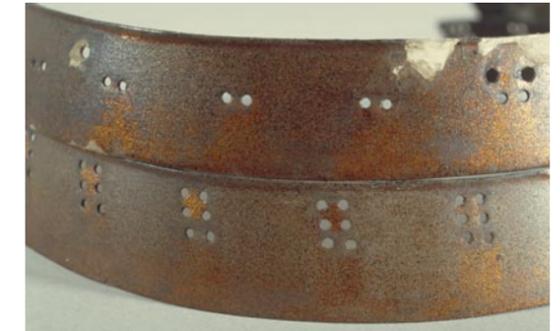
Fig. 7.39. Two lames of the neck guard of helmet (B87M22a); the top lame has been coated with 3% Paraloid B-72 in xylenes; the bottom lame is shown before coating.

the surface untreated. The surface was brushed with two applications of 3% B-72 in xylene, allowing time for drying between applications. B-72 was chosen as the consolidant for its stability and its good performance as a protective coating for metal. In this slow-evaporating solvent and at this concentration, the B-72 should penetrate the cracks in the lacquer well. It was not wiped with solvent afterward, but was left on the surface to coat the exposed metal flakes. B-72 does not do a good job of replicating the surface sheen of lacquer, but that was not the goal of this treatment. So little resin was deposited on the surface with the two brush applications that the treatment had little effect on the surface gloss, only slightly saturating the color (see fig. 7.39, which shows one lame before and another after consolidation).

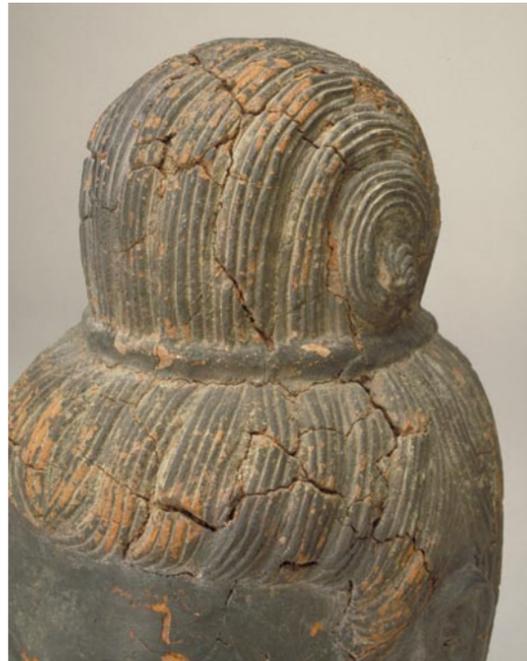
The body is brittle and friable, the surface coatings are loose, flaking in places, and have suffered some losses. Several deep cracks penetrate the coatings through to the intermediate textile layer especially in the area of the hair (see

Fig. 7.41. Head of a Bodhisattva (B60S14+); detail of cracks in the hair.

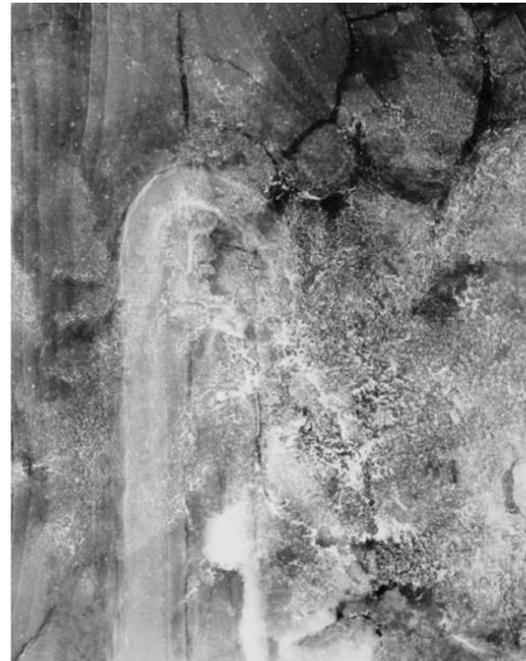
Fig. 7.42. Head of a Bodhisattva (B60S14+); X-radiograph showing vertical seam remaining from fabrication in two-part mold. Technical data: Norelco X-ray unit (150 kV max.), Kodak Industrex M film, 35 kV, 4 mA, 90 seconds, distance from tube, 36 inches.

When the textile and lacquer paste had dried and hardened, the clay mold was removed, leaving the hardened textile layers as the primary support. This head, however, appears to have been made in a two-part mold. X-radiographs (see fig. 7.40) helped to identify a seam bisecting the head vertically through the axis of the ears. It was then also detected on the interior surface (see fig. 7.41). The textile layer is not continuous, but consists of separate pieces that overlap at the seam. The textile protrudes to the interior at the top of the head. The textile is a coarse (10–11 threads per cm), bast-fiber plain-weave. The putty, which consists of a thick, orange brown mixture of clay, sawdust, and an unknown binder, was pressed into negative molds and reinforced with a single textile layer. The putty lining the interior is of the same consistency and approximate thickness as the putty on the exterior, and has the texture and appearance of having been pressed onto the textile. A traditional Chinese dry-lacquer sculpture might have traces of a clay model on

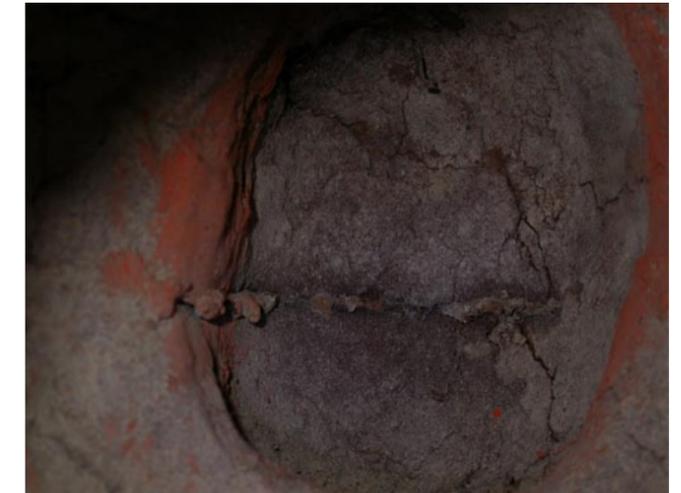
Fig. 7.43. Interior of head of a Bodhisattva (B60S14+), showing seam at top.

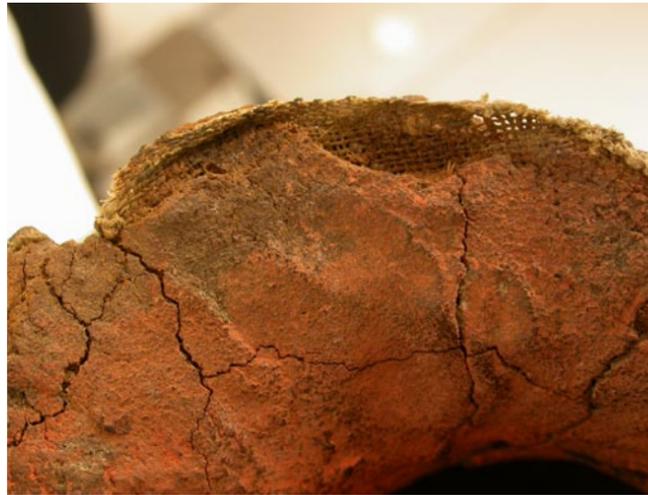
Fig. 7.44. Interior edge of head of a Bodhisattva (B6oS14+), with seldge edge of textile support exposed.

its interior, but it would not have a discreetly applied putty layer. Additionally, although the surface layers around the neck edge are broken and incomplete, the exposed textile support (see fig. 7.42) has a seldge edge, suggesting the head was made as a head and not as part of a full sculpture.

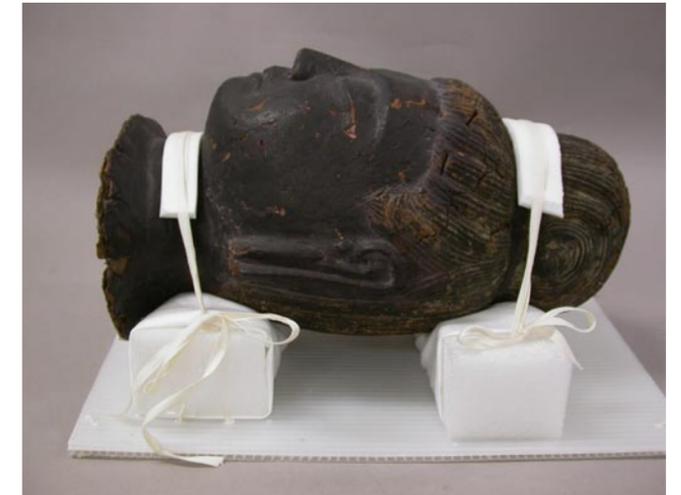
Fig. 7.45. Head of a Bodhisattva (B6oS14+), showing support used for transporting and storing sculpture.

A passive support was constructed for the head to secure it during the move and to minimize contact with and handling of its fragile surface. The head had previously been stored resting on its back, which cracked the layers of putty at the neck and abraded the hair. The head now rests on supports made of polyethylene foam covered with cotton sheeting (see fig. 7.43). It is tied down to the support with Volara closed-cell polyethylene foam sheet laced through cotton twill tape. With this support the head traveled to the new museum facility undamaged. □
