# *The Conservation of Asian Lacquer*

Case Studies at the Asian Art Museum of San Francisco

By Jane L. Williams

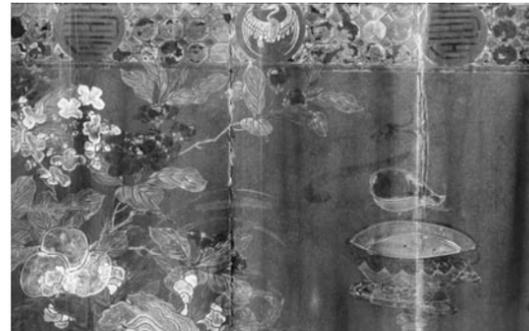
Fig. 8.7. X-radiograph of screen (B69M52), showing bamboo dowels and radio-opaque putty. Technical data: Norelco X-ray unit (150 kV max.); Kodak Industrex AA film; 40 kV, 5 mA, 30 seconds; distance from tube, 36 inches.

The wood structure was identified as *Cryptomeria japonica* (Japanese cypress). As Ms. Webb has noted, vertical cracks reflect the panels' construction from multiple boards. X-radiographs (see fig. 8.7) showed that the panels are constructed of vertical planks edge-joined with horizontal bamboo dowels. Glue is not discernible on exposed join edges, but it is likely that the planks were glued together. The widely spaced dowels (more than 15 cm apart) would not have been strong enough on their own. The width of the central planks varies along their length by up to 5 cm, but they are sawn to fit together tightly. A horizontal crosspiece is secured across the top edge with vertical wood dowels and across the bottom between the extended side panels that form the feet. They must impart some structural stability to the nearly three-meter-long planks, but these crossbraces have also contributed to the vertical cracking in the panels. All of the cracks through the lacquer

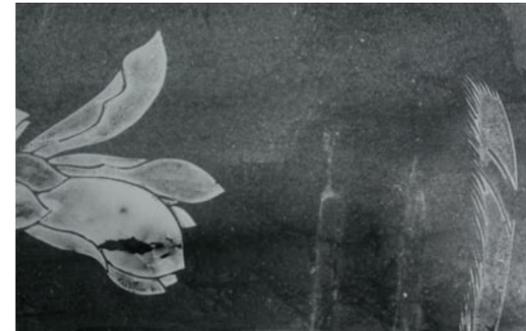
Fig. 8.8. X-radiograph of screen (B69M52), showing filled holes along edge for old hinges. Technical data: Norelco X-ray unit (150 kV max.); Kodak Industrex AA film; 40 kV, 5 mA, 30 seconds; distance from tube, 36 inches.

The individual panels were connected originally with simple loop-and-pin hinges, which allow the panels to be moved and handled separately. Paired holes, now covered over with wood and fills, for the attachment of two hinges per edge, are discernible in X-radiographs (fig. 8.8).

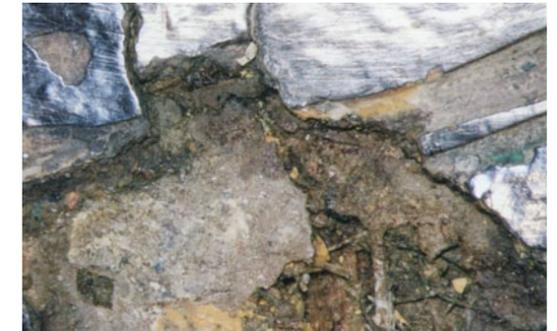
Fig. 8.9. Detail of damaged area on screen (B69M52), showing paper layer between the lower ground layer that included large, loose fibers in it and the subsequent, finer ground layer.

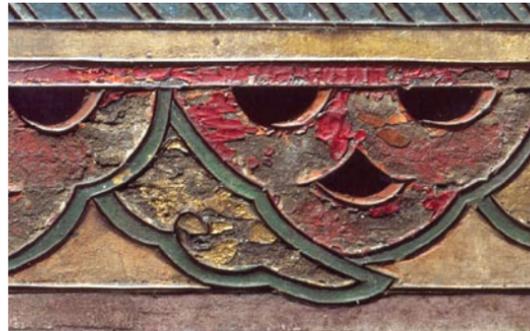
Fig. 8.13. Red paint on screen (B69M52), after consolidation.

For the reasons just described, the same consolidant and two-part application was used to consolidate the lifting paint and gilding. Aqueous adhesives would pose the additional problem in the polychrome areas of partially removing the water-soluble darkened coating on their surfaces during cleanup. An aqueous adhesive might have helped to relax the cupped paint, but instead I flowed the B-72 solution under the cupped paint with a small brush, and then used a heated spatula over silicon-coated Mylar to relax the cupping and tack down the flakes by speeding the evaporation of the solvent. Figs. 8.5 and 8.13 show an area of the cupped red paint before and after consolidation.

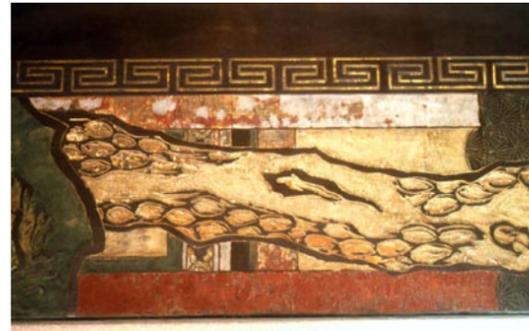
Fig. 8.14. Detail, screen (B69M52), after treatment; this image shows the area of the screen to which test fills using Japanese tissue were applied to losses on the red and gold painted areas.

well with the acrylic inks, so generally I applied the initial coats of acrylic ink and then mixed diluted Primal WS-24 with the final coats of ink. Figs. 8.4 and 8.14 show a detail of one panel of the screen before and after treatment.

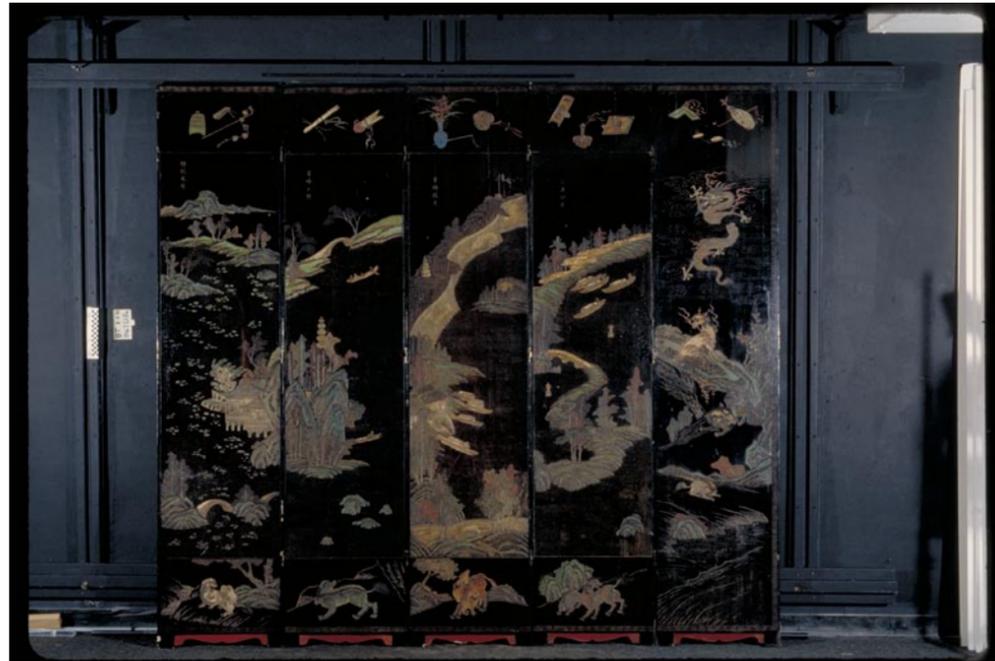
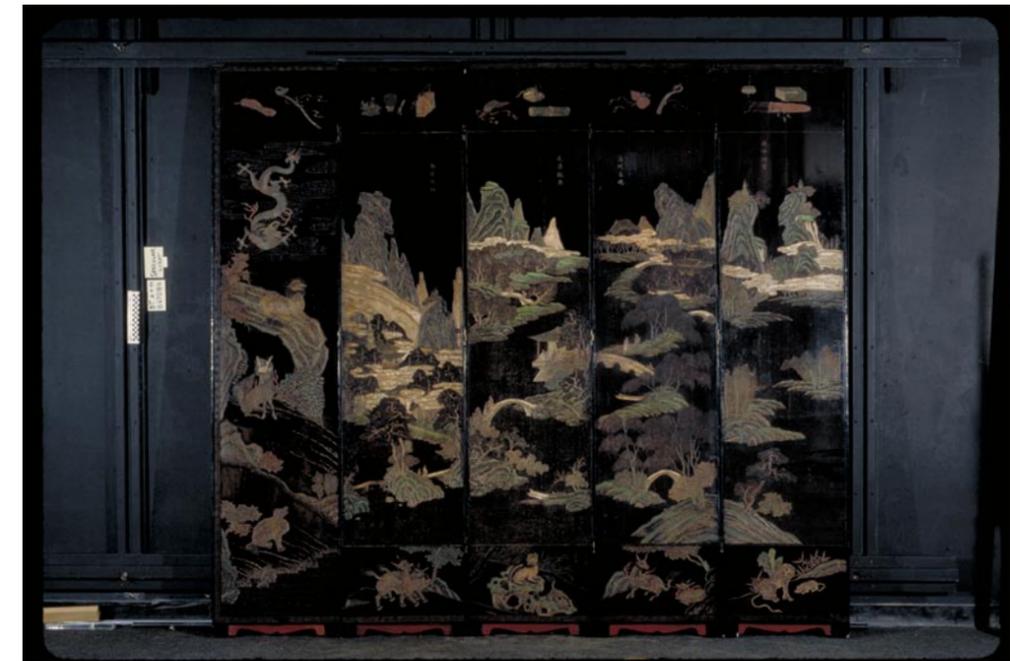
Fig. 8.15a. Screen (B67M8+), before treatment—first section.

Fig. 8.15b. Screen (B67M8+), before treatment—second section.

The screen has suffered the same fate as the twelve-panel screen (B69M52), with cracking caused by changes in relative humidity, light damage, and previous restorations. The cracking pattern between the boards reveals the underlying structure and shows that the panels have a rectangular frame holding several vertical boards. There are cracks between the horizontal top pieces and the vertical boards; see figs. 8.15 and 8.16.

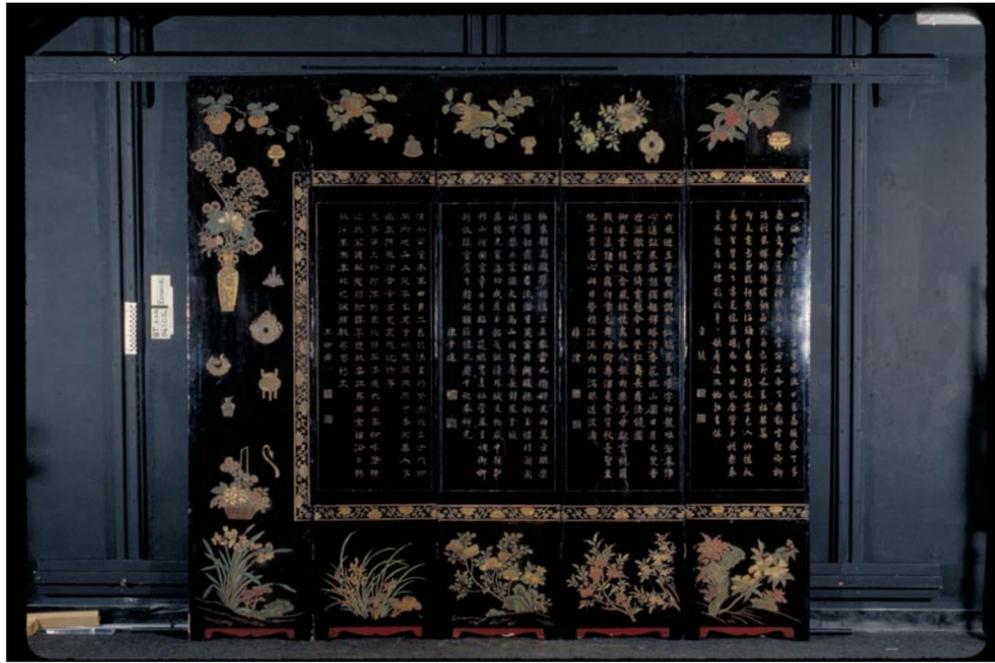
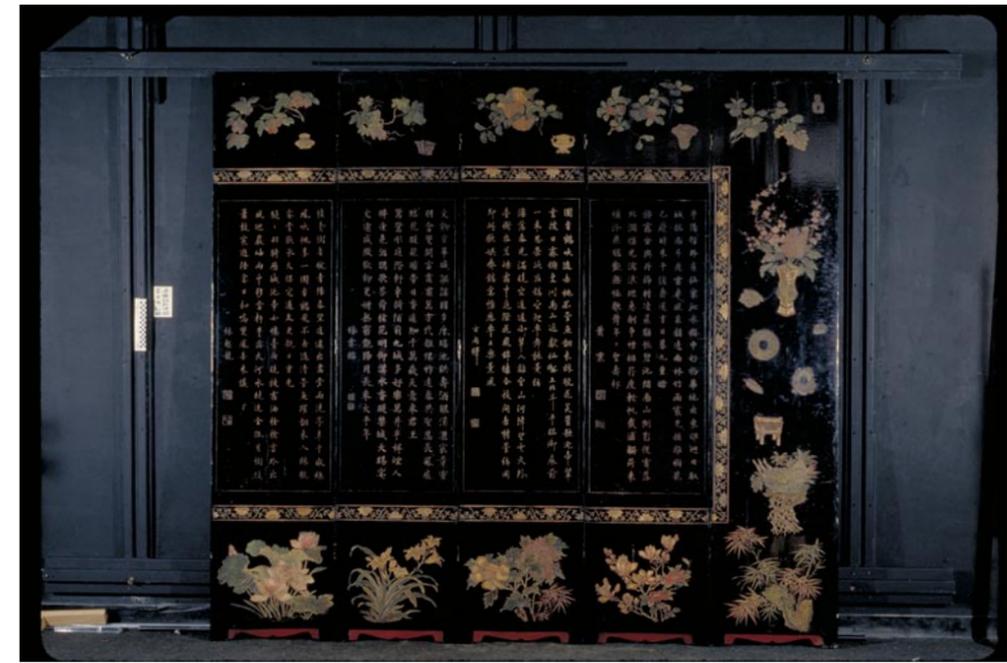
Fig. 8.16a. Screen (B67M8+), after treatment—first section, reverse.

Fig. 8.16a. Screen (B67M8+), after treatment—second section, reverse.

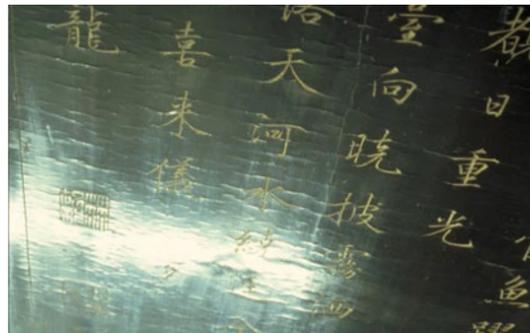
On the backs of the panels is a series of cracks perpendicular to the grain of the underlying wood, see fig. 8.17. These have not, as one might assume, been caused by changing relative humidity, but by stress within the lacquer layers that developed during the original manufacture. As lacquer dries there is a small degree of shrinkage, which produces tension in the lacquer layers. This tension is equal in all directions, both across the grain and with the grain of the underlying wood. If the wood core dries out, as often happens with lacquer exported to the West, the tension across the grain is relieved as the wood shrinks. But, because wood shrinks very little along the length of the grain, the stress remains in this direction. Eventually the stress overcomes the strength of the lacquer surface, resulting in a

series of cracks across the grain. In lacquerware, these parallel cracks are usually quite uniform in their spacing, appearing approximately one centimeter apart.

Fig. 8.17 Detail, screen (B67M8+), showing one long crack along joint in wood and finer cracks perpendicular to the wood grain.

The treatment of this screen should follow the same pattern as that for B69M52, with a few changes. Although the fish glue may work just as well, another option for the consolidation of the horizontal cracks in this screen is the use of Rhoplex AC 234. These cracks often occur quite early in the history of the piece and have a

Rhoplex at full strength is brushed on the open cracks, where it penetrates into the ground, and is allowed to dry until the adhesive turns clear. The lifting lacquer can then be adhered flat with a warm tacking iron. The use of silicone-coated Mylar is recommended both

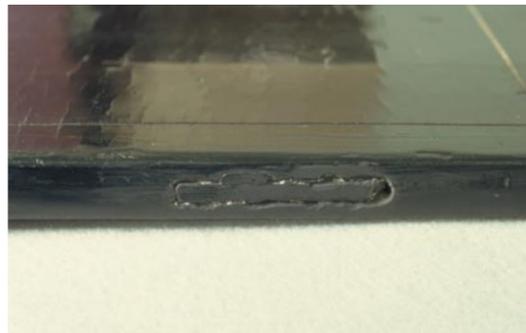
Other structural changes include the application of Western hinges. On the edges the grooves that once held the pins or loops have been filled and overpainted, see fig. 8.18.

Fig. 8.18. Detail, screen (B67M8+), showing wood filling old hinge holes and groove.

The hinges should be removed. For a strong structural fill that will allow the attachment of new hinges, the holes should be filled with epoxy and microballoons. As recommended for B69M52, new hinges should be made that allow each panel to be handled separately.

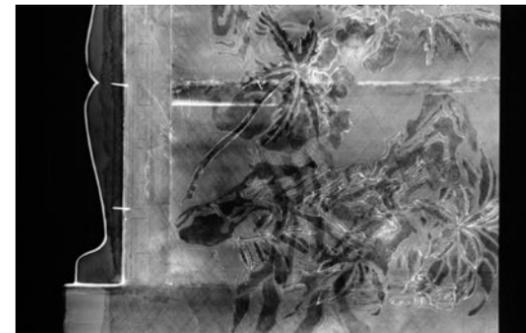
Fig. 8.19. X-radiograph, screen (B67M8+). Technical data: Norelco X-ray unit (150 kV max.); Kodak Industrex AA film; 45 kV, 5 mA, 60 seconds; distance from tube, 36 inches.

of pins or dowels securing the boards. Like B69M52, the end planks extend longer to make the feet, and the panel has crossbraces along the top and across the bottom between the feet (see fig. 8.19 <Sc/B67M8/5>). A separate piece of wood forms the shallow, decorative socle set into slots in the feet and lower crossbrace. The X-radiographs show small wire nails securing the socle, likely dating to a modern repair. The screen now has European brass screen hinges. In the X-radiographs the sites of traditional pin and loop hinges are visible. The insets for the old hinges have been plugged with nailed-on wood strips.

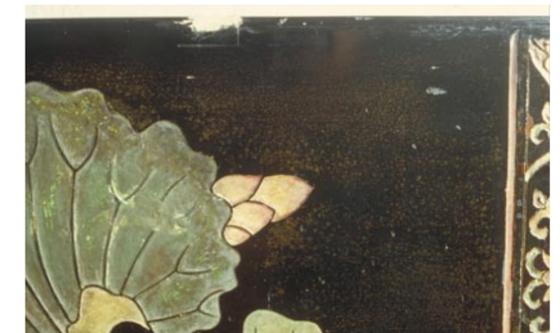
Fig. 8.20. Detail, screen (B67M8+), showing fills and yellow spattered coating.

design field has an overall light-colored speckling and a clear coating, both of which have a strong yellow fluorescence in near ultraviolet light. The speckling appears in the same location on all of the panels appears to have been applied deliberately, like an imitation nashiji (see fig. 8.20). The clear coating was also applied along the top edge. The rest of the front surface has a clear coating that has a bright orange fluorescence, like shellac, in ultraviolet light, and slightly overlaps the yellow fluorescing coating. Localized inpainting was done with a material that fluoresces a bright white in ultraviolet light. Subsequent to the clear coatings, a dark paint was sprayed (in ultraviolet light the fine spattering is visible and appears brown) on the edges near the top and bottom. The reverse has an overall brushed-on coating with a dull grayish fluorescence. It is not possible, because of the interference of all its strongly fluorescent coating, to determine with visual examination whether this coating was also applied to the front. As a result of the number of coatings and small areas of restoration, the lacquer surface has

acetone. When this sealant had dried, the losses were filled using 6% PVOH bulked with calcium carbonate and dry pigments, as described above for B69M52. The fills were not shaped and sanded to match the surrounding surface perfectly, but were simply smoothed with a spatula or cotton swab dampened with ethanol and left untuned (fig. 8.20 shows one such edge fill as it was left).

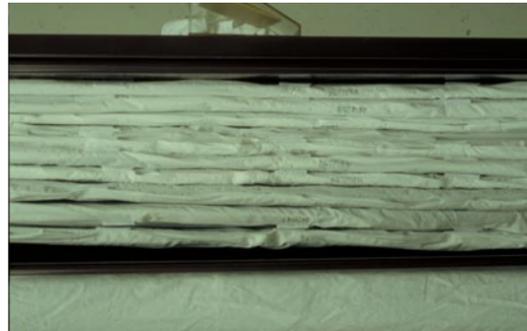
Fig. 8.21. View of screen (B67M8+) in storage in new museum building, showing muslin covers.

Each panel was encased in a custom cotton muslin cover (see fig. 8.21) like those made for B69M52. In the new museum, the screen is stored vertically with an edge facing outward so that individual panels can be taken out easily. □

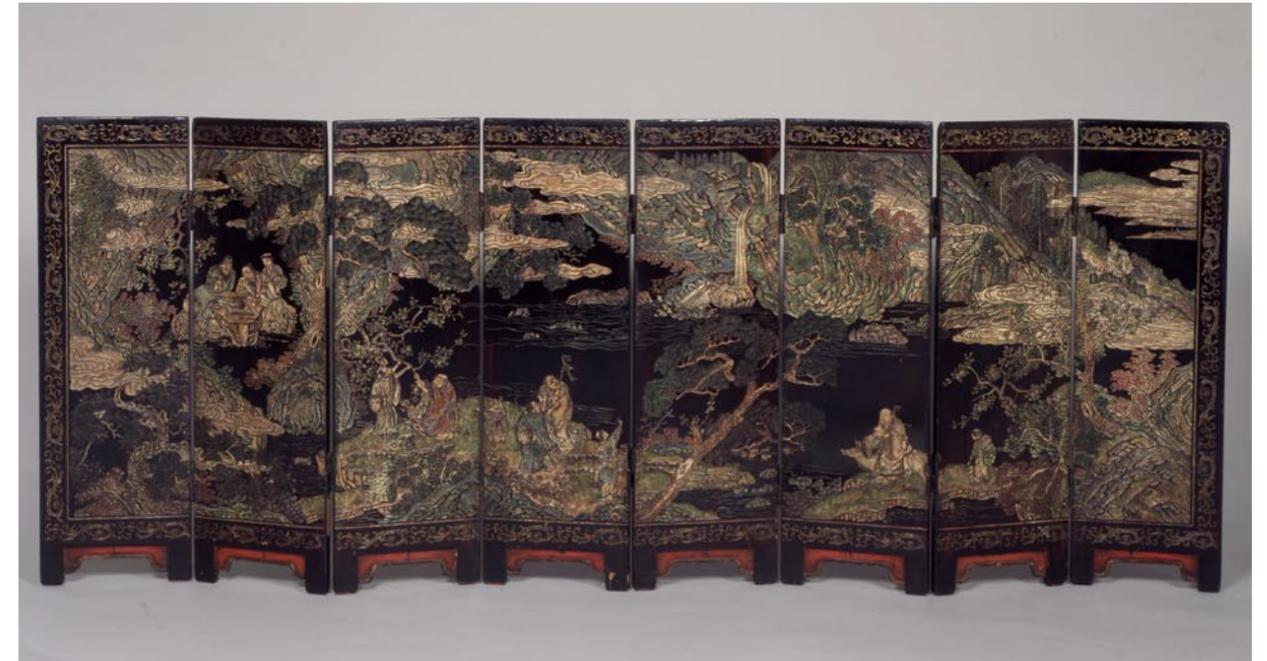
The third screen, which is only two feet high (see figs. 8.22 and 8.23), differs somewhat from the others in its small size and previous restoration history. The structure of the panel is seen by the cracking and separation of individual boards. Again, the original hinges have been replaced, but the grooves for the hinges remain. The edges of the panel show extensive chipping and losses, al-

Fig. 8.22. Screen (B64M8+), front, before treatment.

Although the methods used in the past restoration would not meet today's conservation standards, there is no reason to undo the repairs as they are stable for the most part. There would be no advantage in removing the suspected oil paint on the feet because the previous restorer has been careful not to overpaint the original surface.

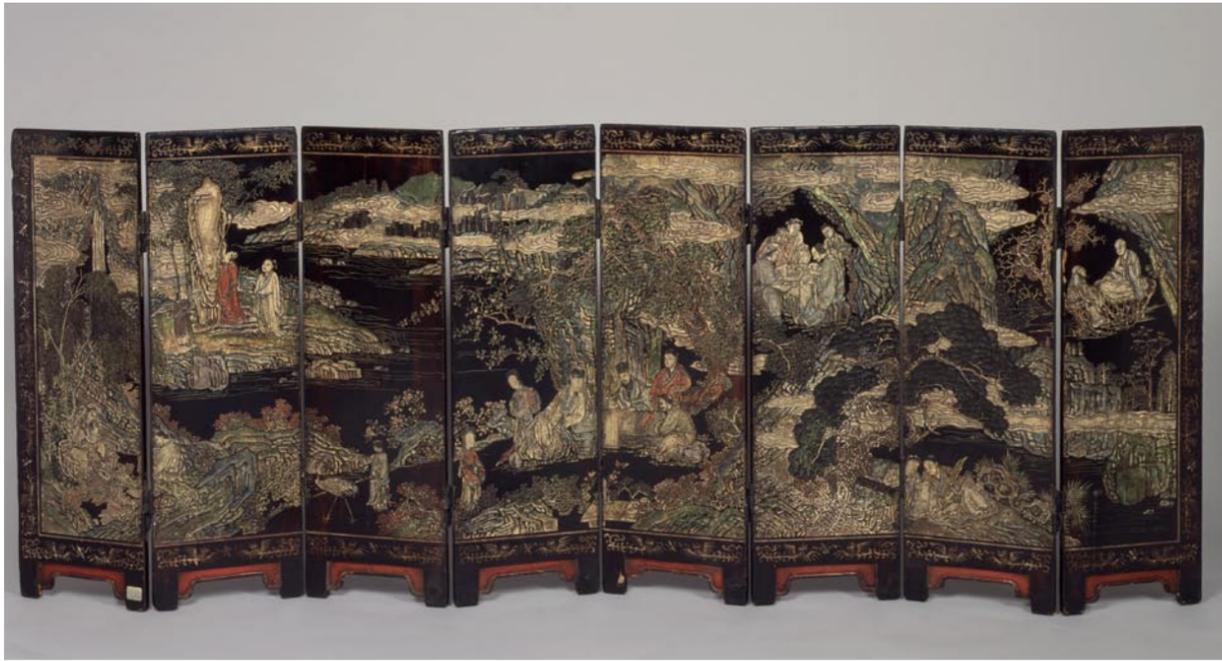
Fig. 8.23. Screen (B64M8+), reverse, before treatment.
